NCCEC, Point Nepean

29 March 2021 | Tree Logic Ref. 011175

Prepared for Monash University
Prepared by Manori Senanayake – Consultant, Tree Logic Pty. Ltd.

Summary

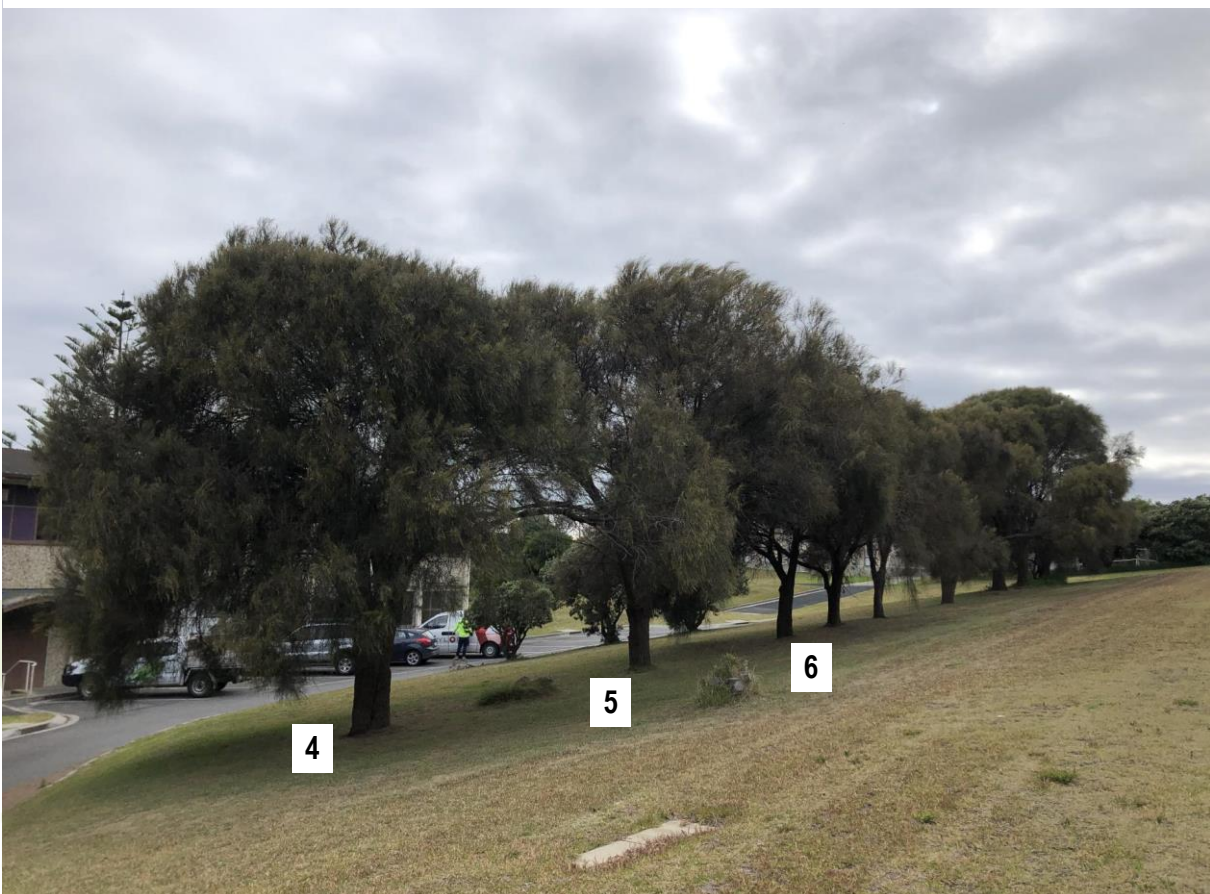
The row of Drooping She-Oaks south of Badcoe Hall are in rather varying condition with numerous trees exhibiting defects and/or dieback. Only three individual trees (6, 9 and 11) were rated Moderate B and expected to potentially have a longer life expectancy owing to health and structural condition. However as part of a massed planting the arboricultural rating of these trees tends towards a lower rating and are not a significant element of the landscape; replacement of trees in a similar condition could be accomplished within a 10 year period.

Image 2: Row of Drooping She-oaks (Trees 4-14, L-R) south of Badcoe Hall, facing east

- The indicative location “Site B” (refer to Appendix 2B) is likely to require the removals of Tree 4-14, a row of Drooping She-oaks in varying condition.

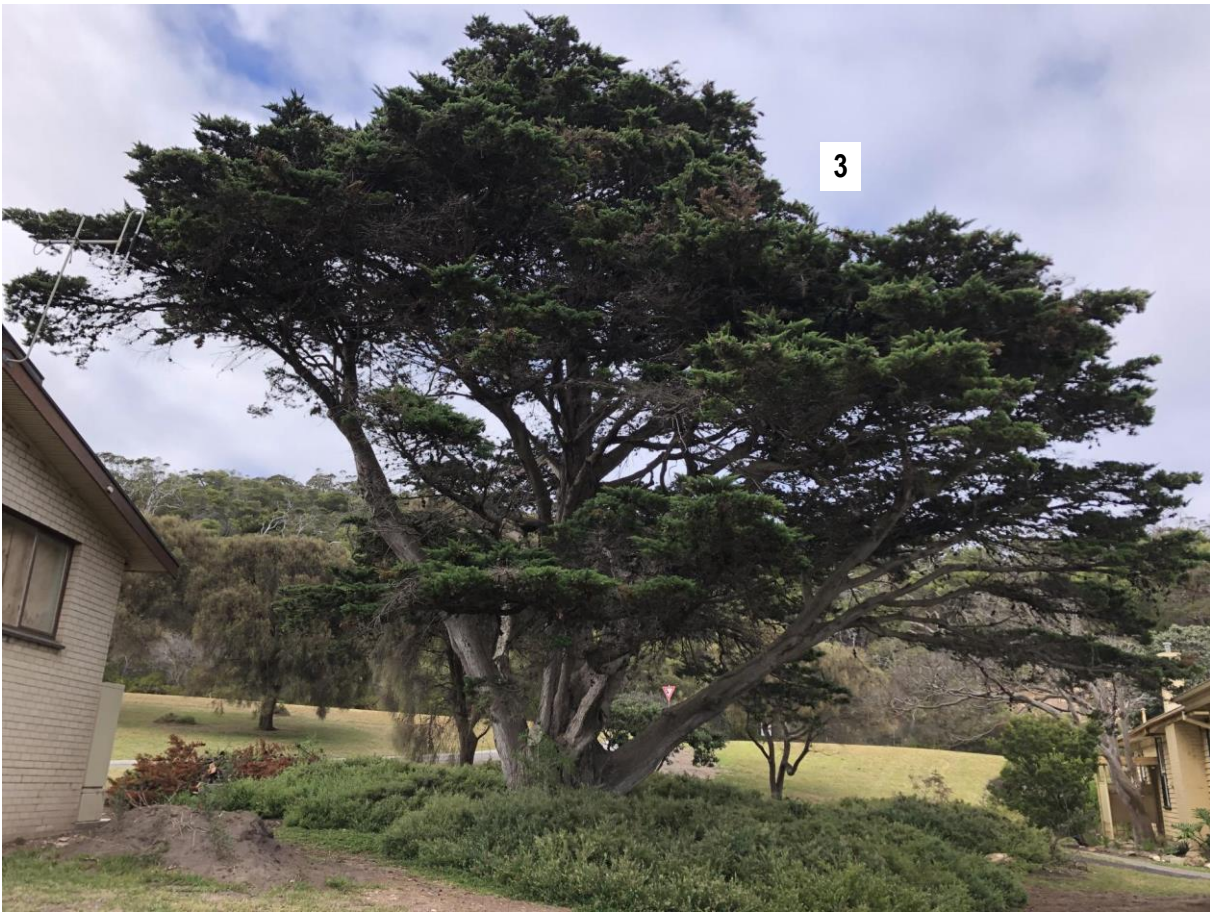
Image 3: Tree 3, maturing Monterey Cypress, facing south. Canopy gaps from past limb/branch failures. Recent failure to southeast with dead material on ground

In relation to the maturing Monterey Cypress (trees 3, 19-23), regular inspection of the trees' condition should be undertaken (preferably annually and during late winter/spring prior to elevated visitor numbers) with any remedial tree work to be conducted within the timeframe recommended by the inspecting arborist. Visual inspection for any cracks or splits after major weather events is also recommended to enable flagging of further inspection or works by qualified arborists ahead of potential tree part failure.

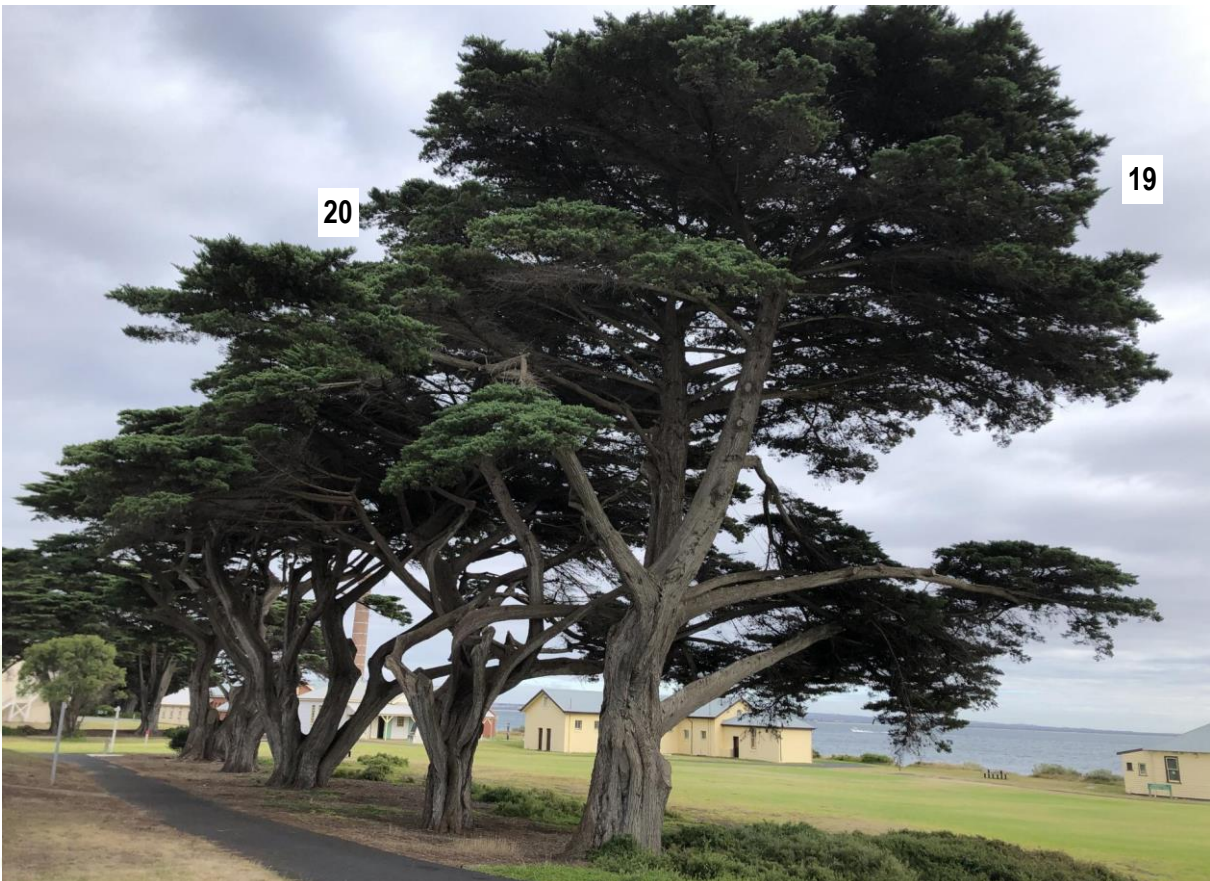
Several of the Monterey Cypress (*Cupressus macrocarpa*) have received a Moderate-C rating (Trees 20-23). The trees have a large canopy area and a bold presence in relation to the landscape and surrounding built form. The amenity of these trees is noted and there may be other sociocultural values beyond the scope of this report that would recommend the retention of these trees. However, the Moderate-C rating (as opposed to Moderate B) reflects increased input required to manage the trees's safety in relation to the level of large limb/branch failure that is typical of the species of the size and age observed in current conditions. Several cables and support systems have been installed in the canopy to mitigate risk, but with strong coastal winds and relatively little buffering of these winds, it is expected that as management inputs increase, amenity value is likely to decrease with further branch failures and associated loss of canopy/exposure of wounds to decay pathogens. It is also expected that the Moderate B-rated Monterey Cypress (Trees 3, 19) would reach a similar stage within the next 5-10 years.

Image 4: Row of maturing Monterey Cypress (Trees 19-23, front to rear) north of admin building, facing west.

Tree cables should be inspected on a 3-year cycle to ensure that the cable system continues to be functional and appropriate. If the cables currently installed have not been inspected within the last 3 years, inspection is strongly recommended within a year of this report.

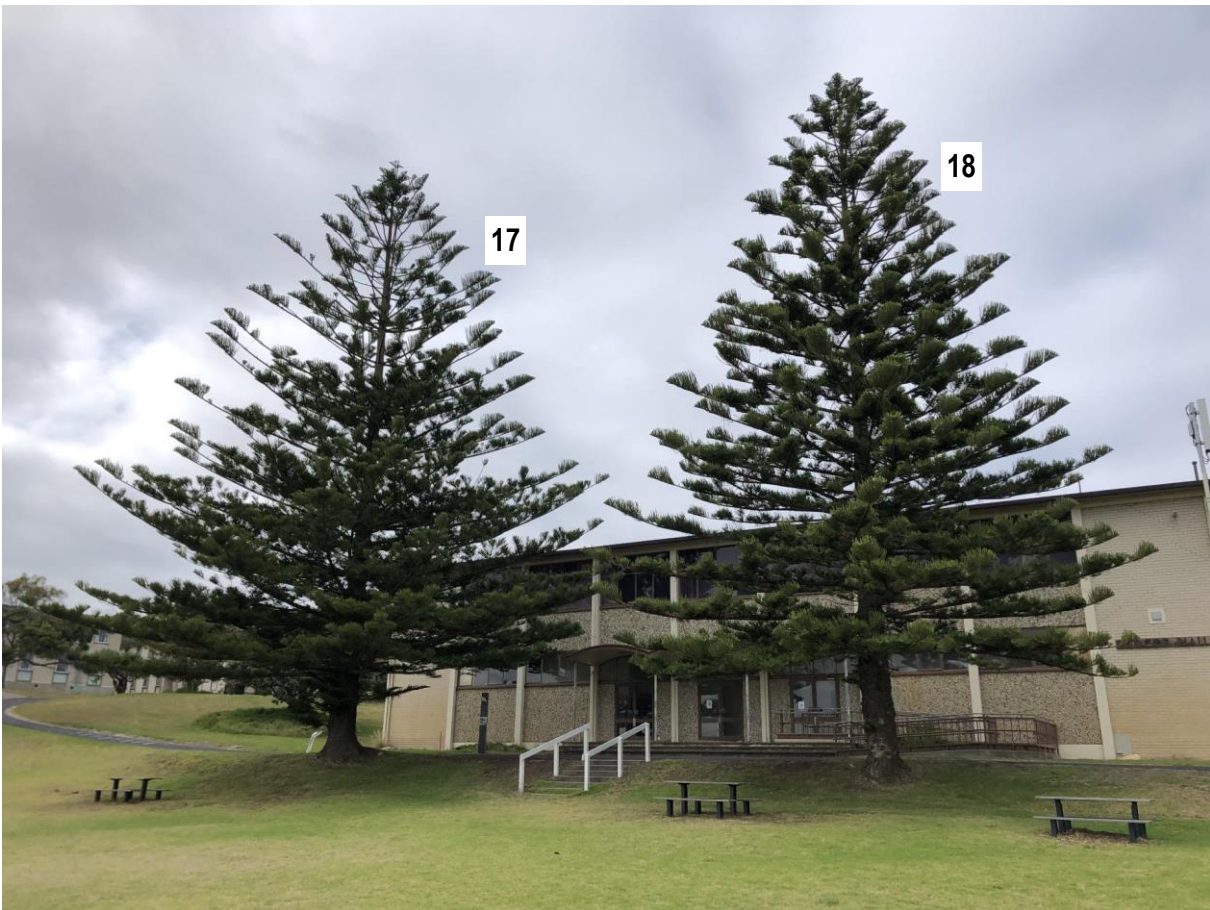
The two Moderate A trees (Trees 17 and 18) are maturing Norfolk Island Pines (*Araucaria heterophylla*) north of Badcoe Hall; these trees are anchored on the top of a slope and have no visible health or structural defects. Both trees contribute positively to the landscape and are large specimens that would not be replaced by trees with similar attributes within a short span of time. The species is not expected to accumulate structural defects within the next 10 years.

Image 5: Trees 17 and 18, maturing Norfolk Island Pines north of Badcoe Hall, facing south.

- The proposed rainwater tanks in Appendix 2C should be relocated to avoid removal of Trees 17 and 18.
- Further impact assessments are subject to detailed design/engineering plans.

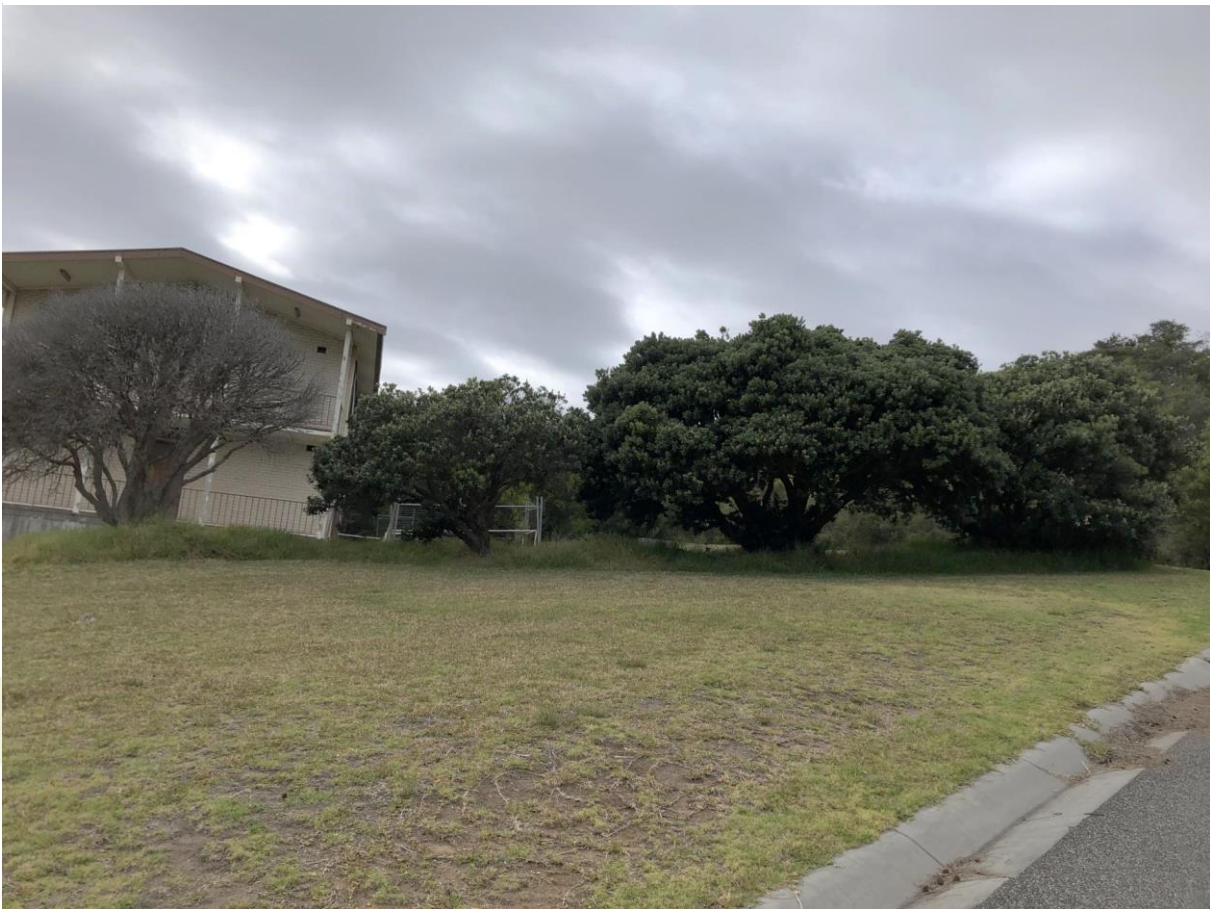
Image 6: Row of Pohutukawa shrubs (not assessed) east of Drooping Sheoaks, potentially impacted by proposed saltwater pipe alignment, facing east.

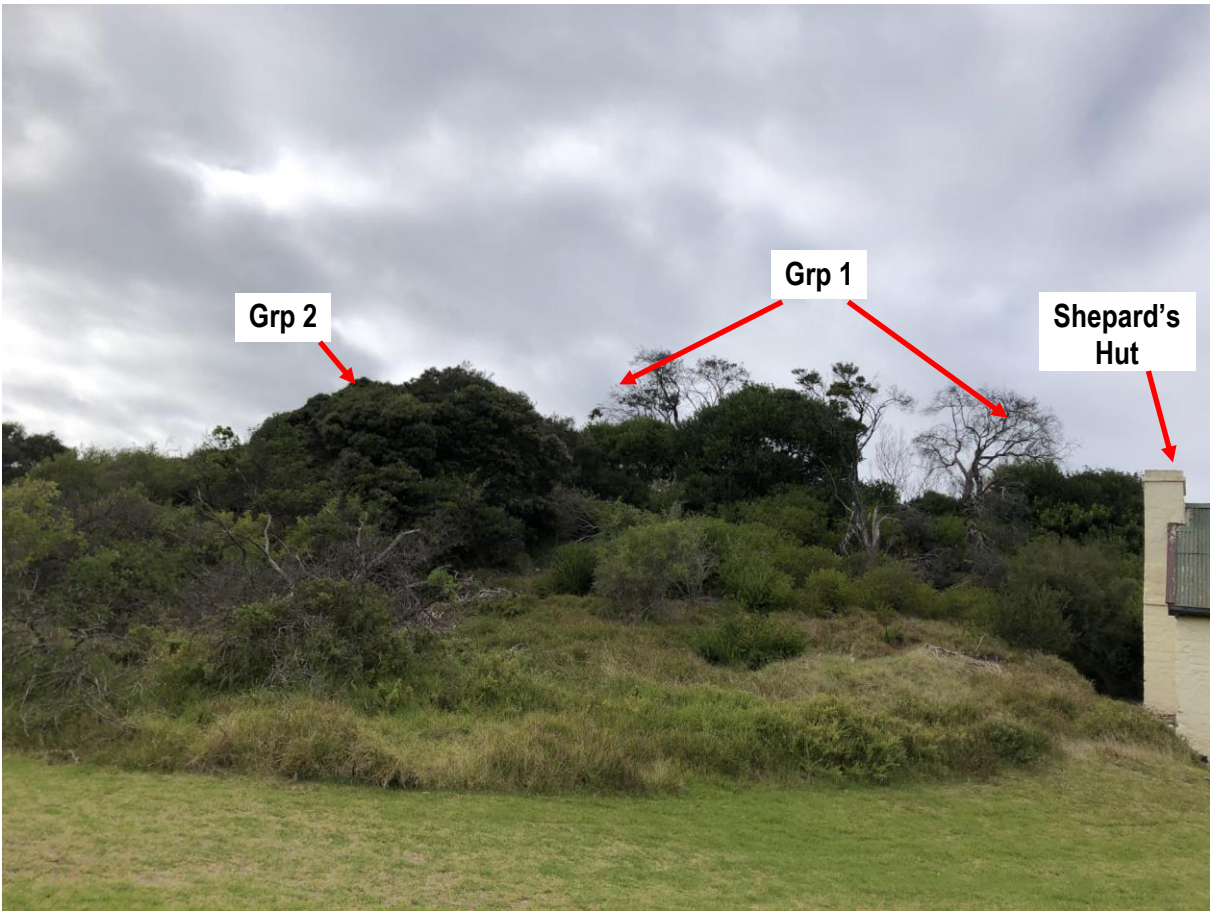
Image 7: Vegetation north of Shepard's Hut, typically grassy/shrubby with mixed weedy and indigenous species, several dead/dying shrubs at crest. Facing west

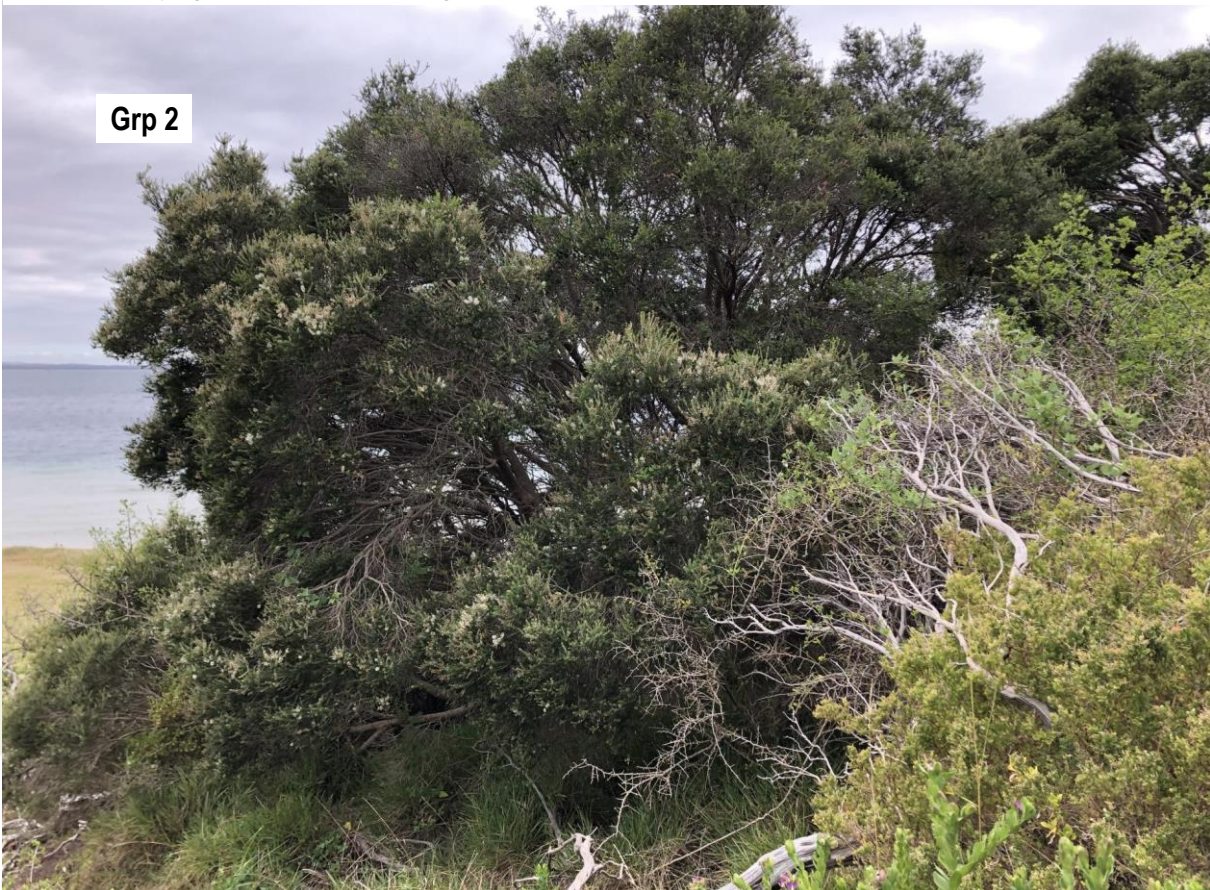
Image 8: Closeup of Group 2 (Moonah shrubs), facing north
