PRELIMINARY GEOTECHNICAL ASSESSMENT

Bulgana Wind Farm

Preliminary Geotechnical Assessment
GEOTABTF09541AA-AD

1 September 2014

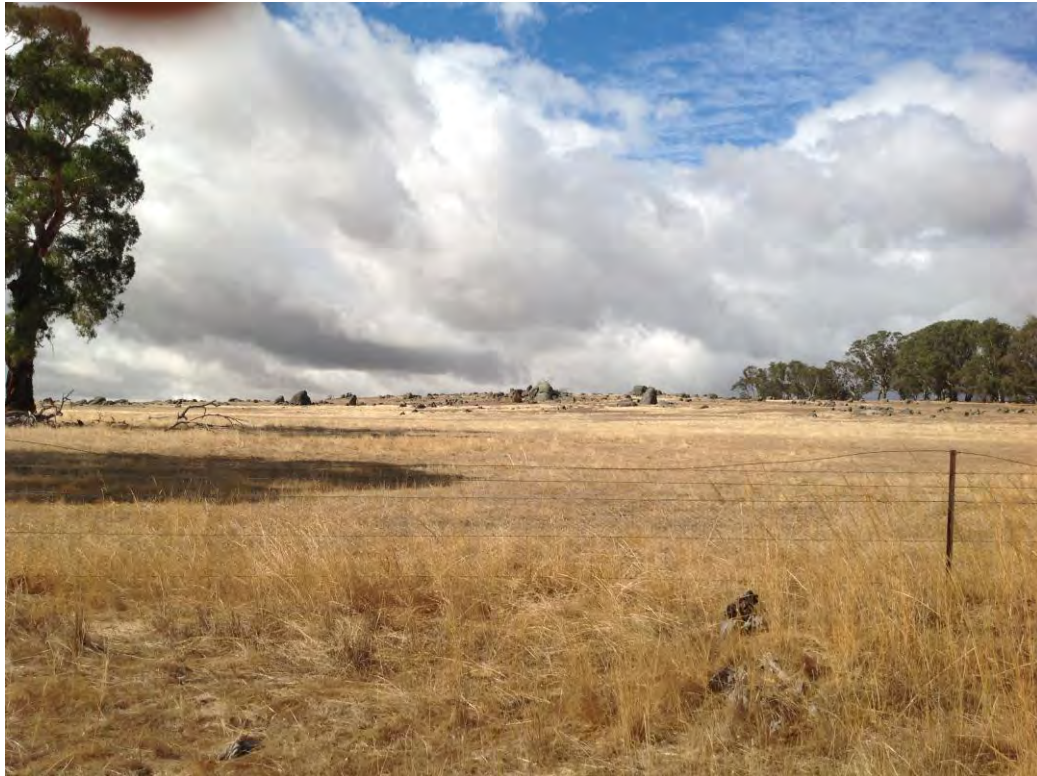
PHOTOGRAPH 1 – Granodiorite outcrop

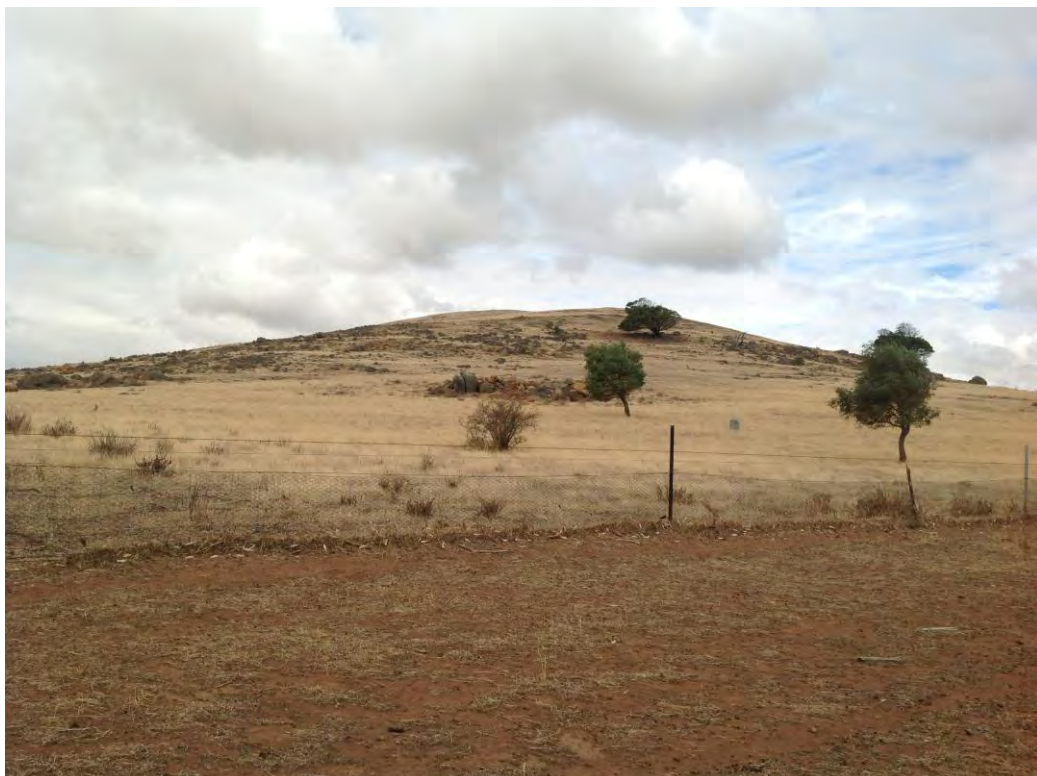
PHOTOGRAPH 2 – Proposed WTG location with sandstone outcrop

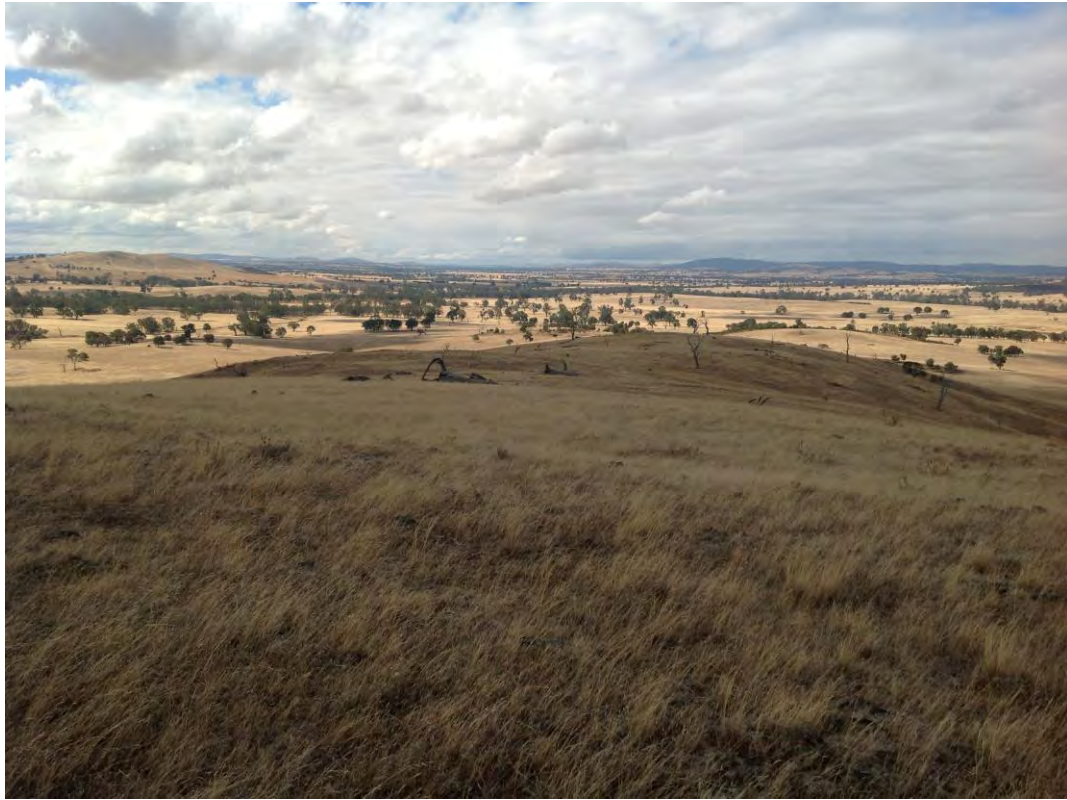
PHOTOGRAPH 3 – Ridgeline with multiple proposed WTG’s

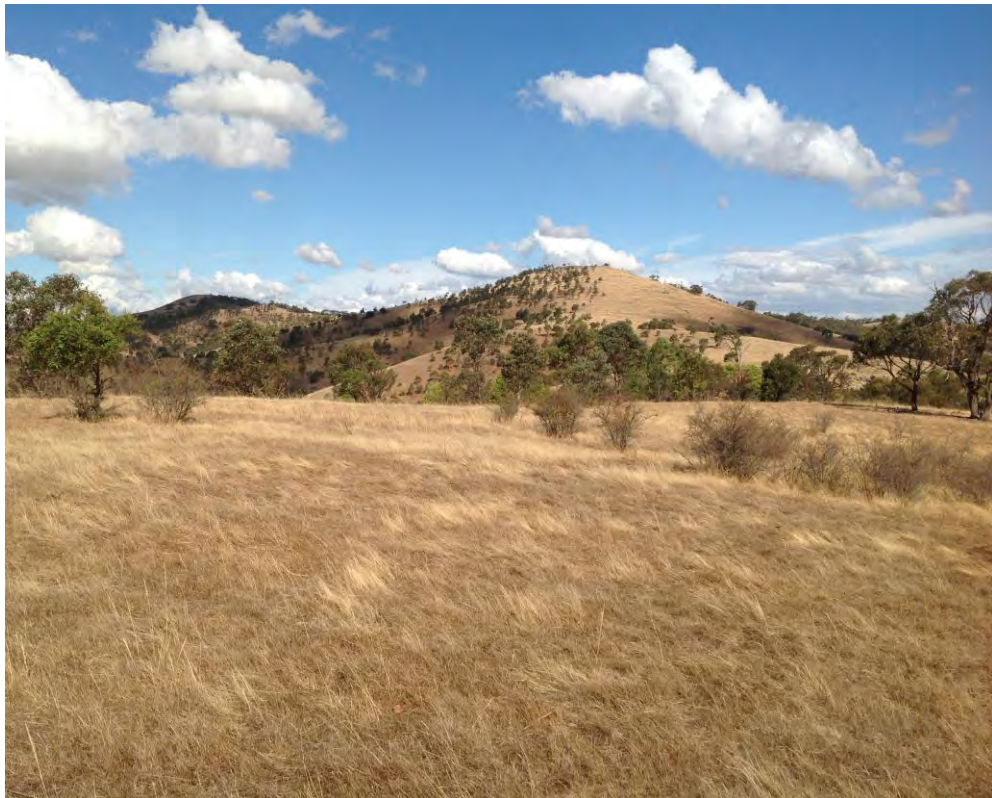
PHOTOGRAPH 4 – Ridgeline with proposed WTG’s

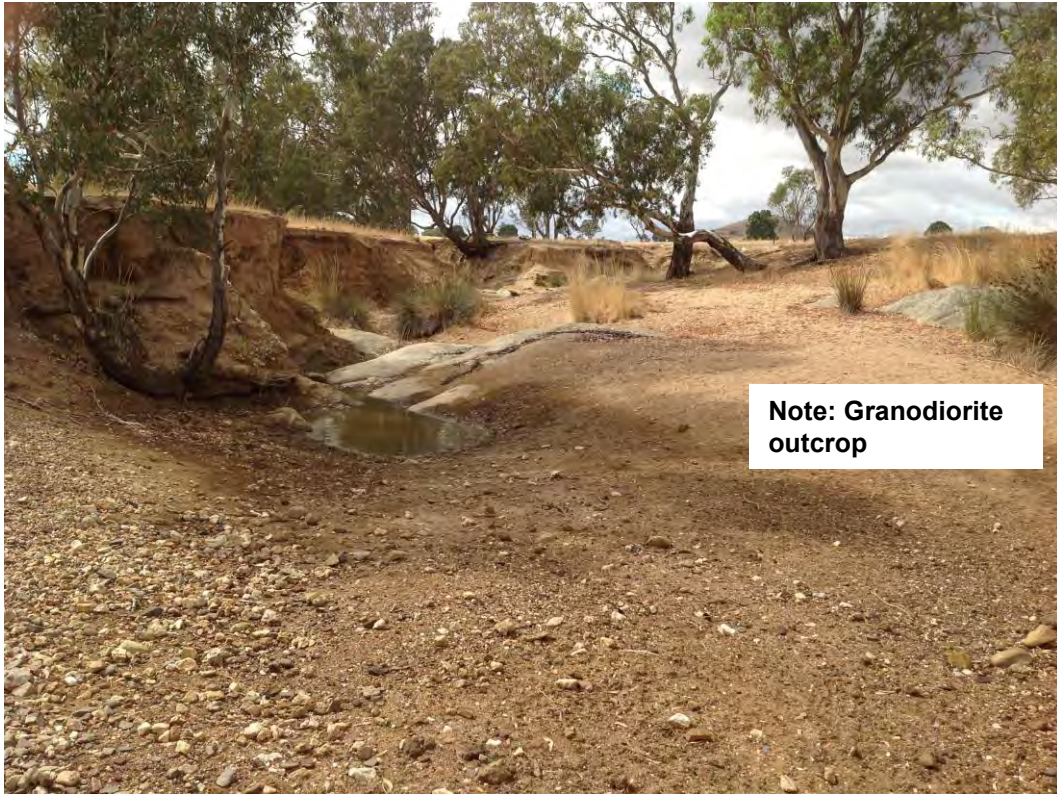
Evidence of severe erosion was observed along drainage channels indicating that the surface soils are susceptible to erosion. Due to the hilly topography it is expected that water flows along these drainage channels would be fast and erosion is likely to result. Measures to mitigate erosion during construction may include:

PHOTOGRAPH 5 – Erosion Washout in Granitic soils

- Reduce, as much as practicable, the clearing of natural vegetation and surface water runoff in the construction areas;
- Re-vegetate stripped and filled areas as soon as practicable;
- Construction of silt traps and stilling basins to slow the flow of surface runoff and to reduce the sedimentation of the natural waterways (Photograph 9 and 10 illustrate two typical sediment traps);
- Drainage channels may require protection by rock beaching, silt dams or similar.

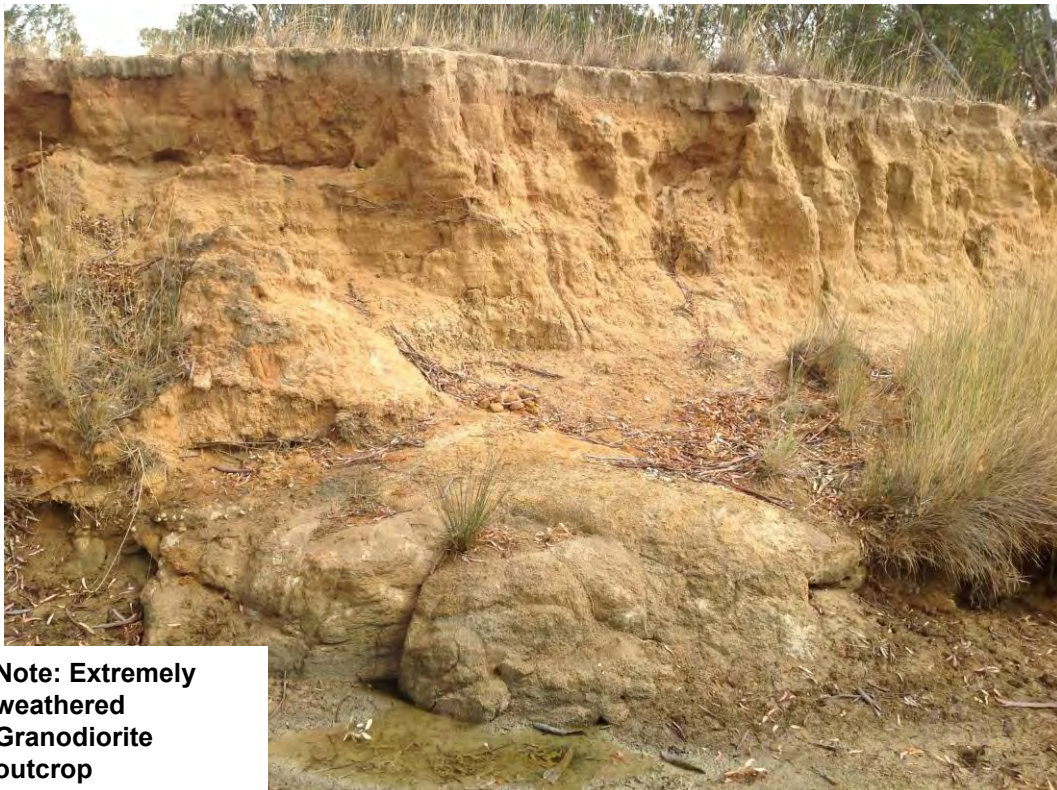
PHOTOGRAPH 6 – Soil profile in erosion washout

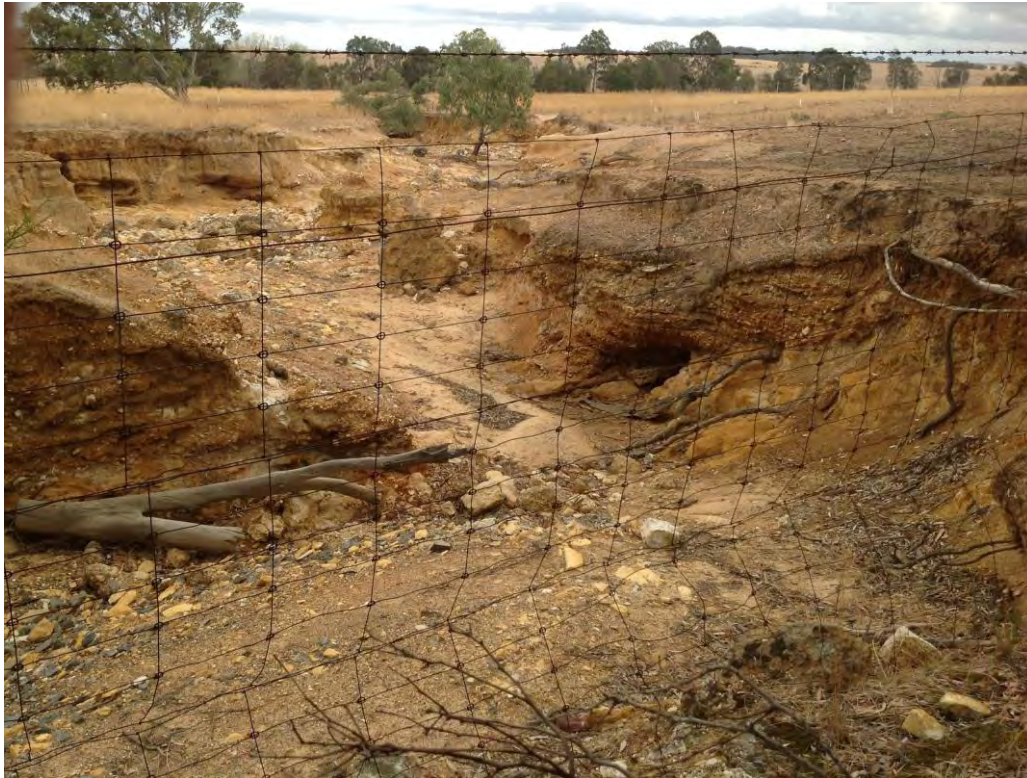
PHOTOGRAPH 7 – Erosion Washout in sedimentary units

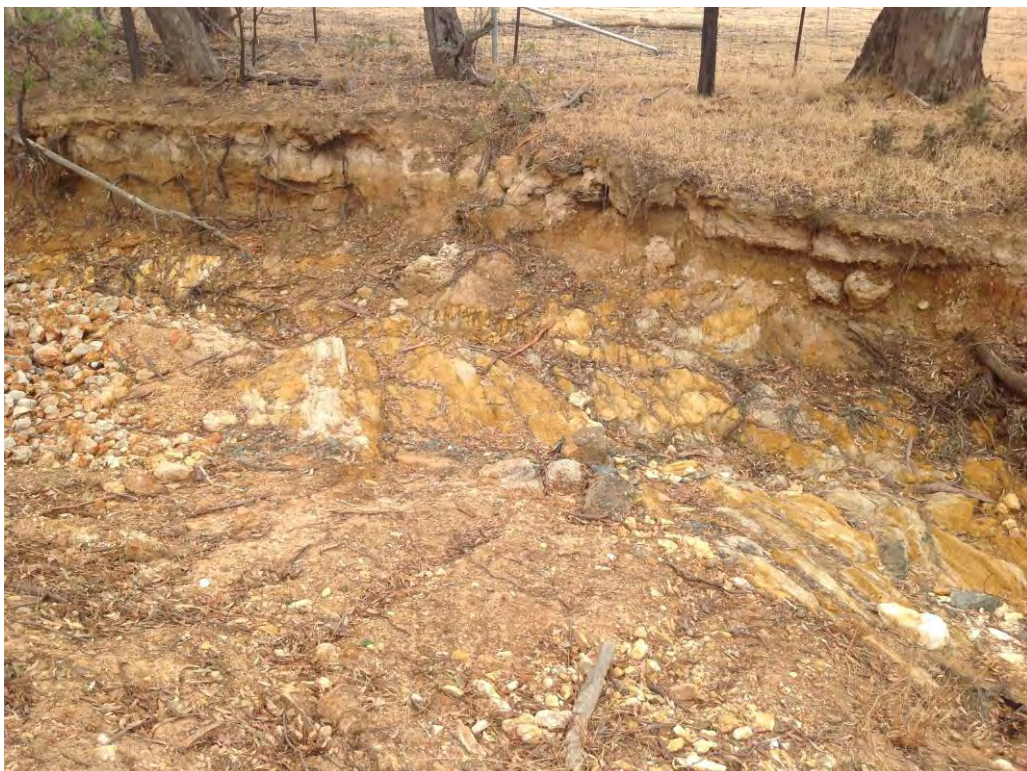
PHOTOGRAPH 8 – Soil profile in erosion washout

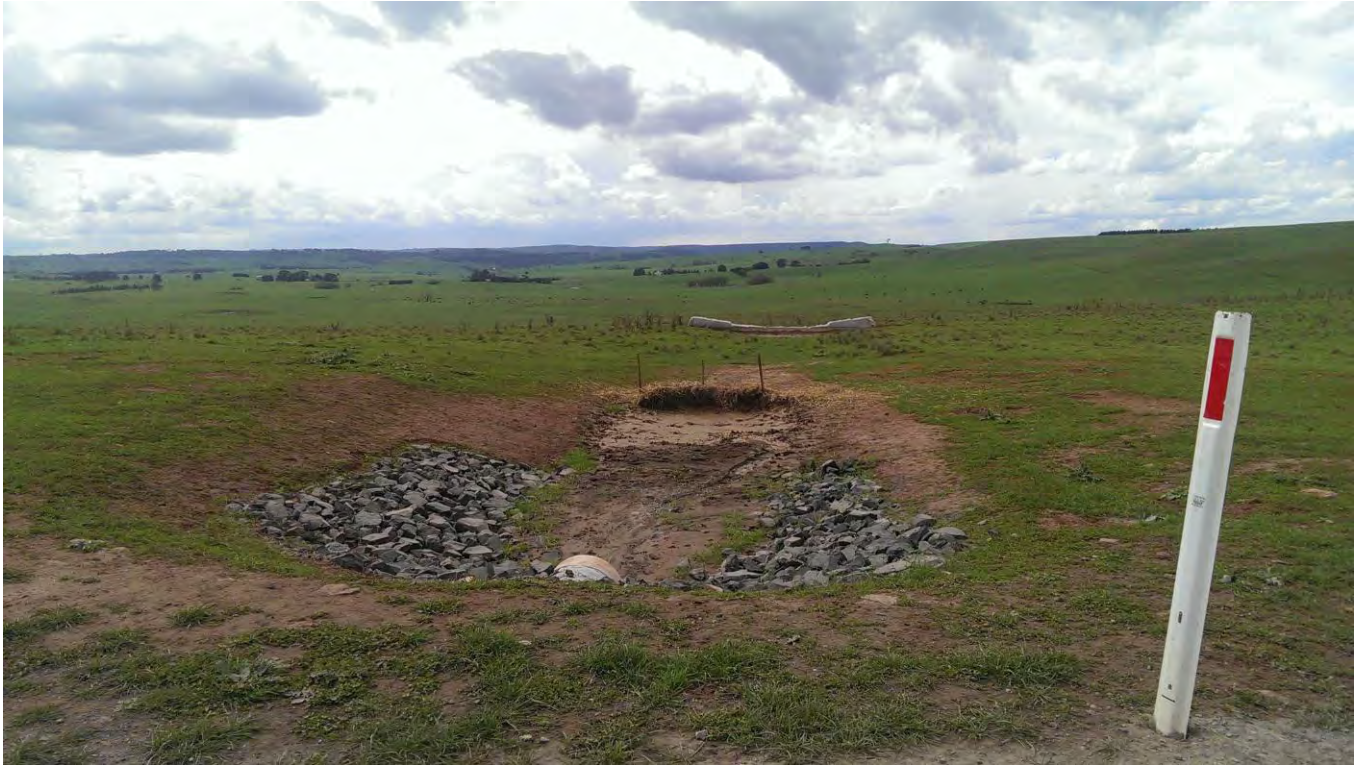
PHOTOGRAPH 9 – Sediment trap using rock beaching and hay bails

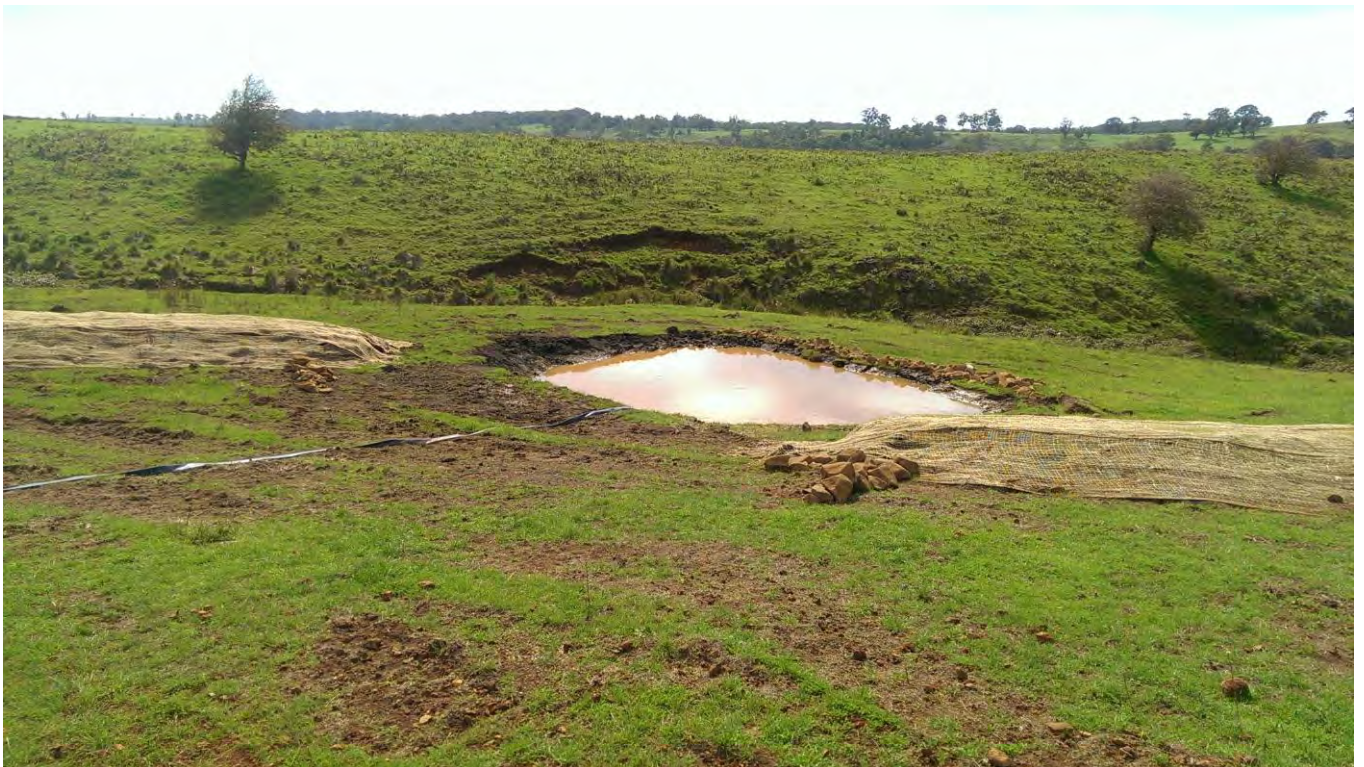
PHOTOGRAPH 10 – Stilling basin with diversion mounds
