Dwelling Analysis

Dwelling Analysis Locations Moreton Hill Wind Farm

Appendix A Dwelling Analysis locations (Map Source: VicPlan 2023)

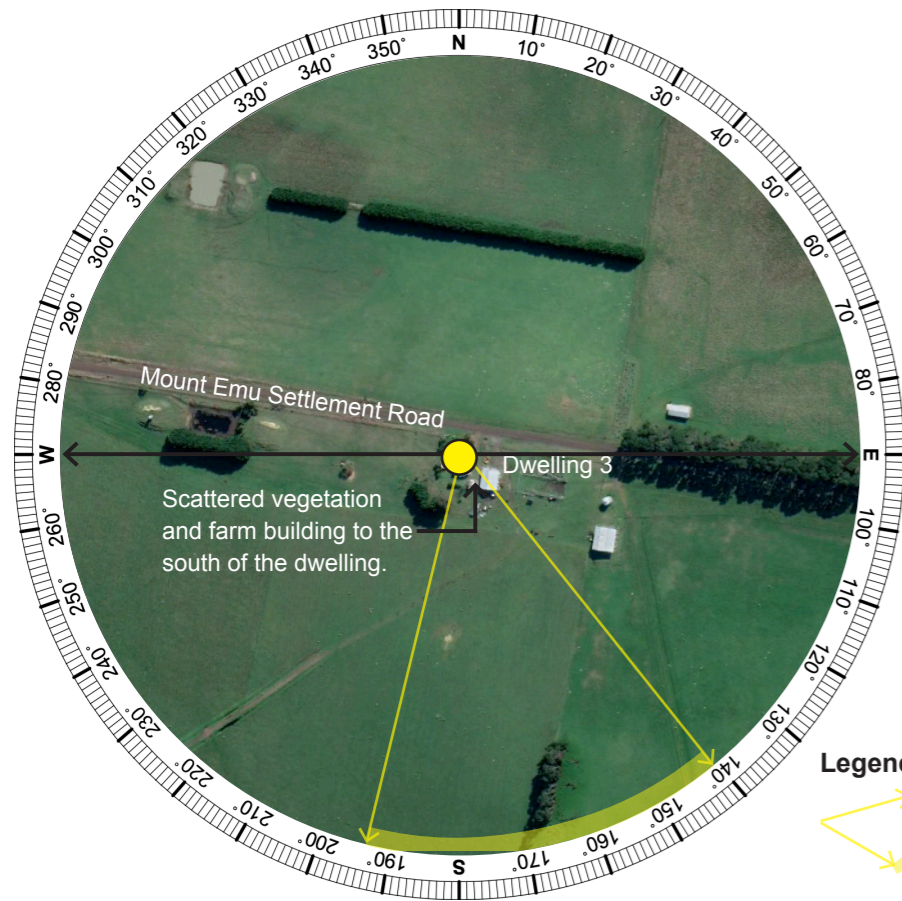
Dwelling 3 - Aerial Image
Location Plan (Image Source: Google Earth 2022)

An assessment based on topography alone suggests that all turbines are likely to be visible from Dwelling 3 which is located within 6000 m of the nearest turbine. The dwelling is located on a flat terrain. Aerial imagery indicates scattered vegetation to the south of the dwelling and an existing farm building to the south east. These are likely to assist in fragmenting views towards turbines in the direction, however some open views are likely to be available from breaks in vegetation to the south.

Distance to Nearest Turbine:	4.80 km
Number of potentially visible turbines (based on topography alone):	60 turbines (56 at hub height, 4 blade tips)

Additional screening on the southern side of the dwelling will help reduce potential visual impact. Consultation with the landowner will be required.

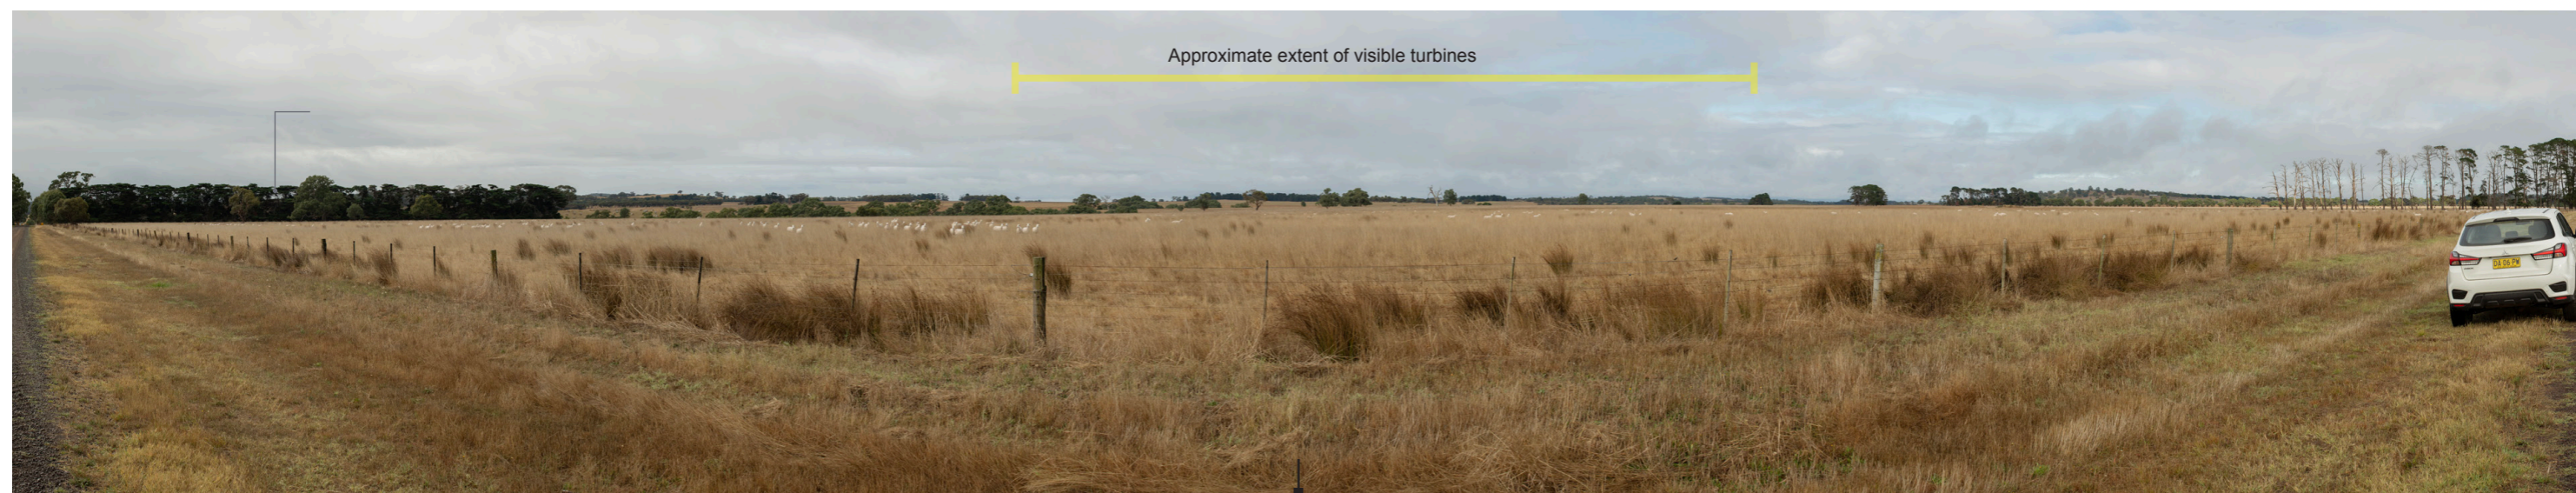
Distance to Nearest Turbine:	4.51 km
Number of potentially visible turbines (based on topography alone):	60 turbines (All at hub height)

Dwelling 4 - Existing View
View from Mount Emu Settlement Road - Darlington Road near Dwelling 4

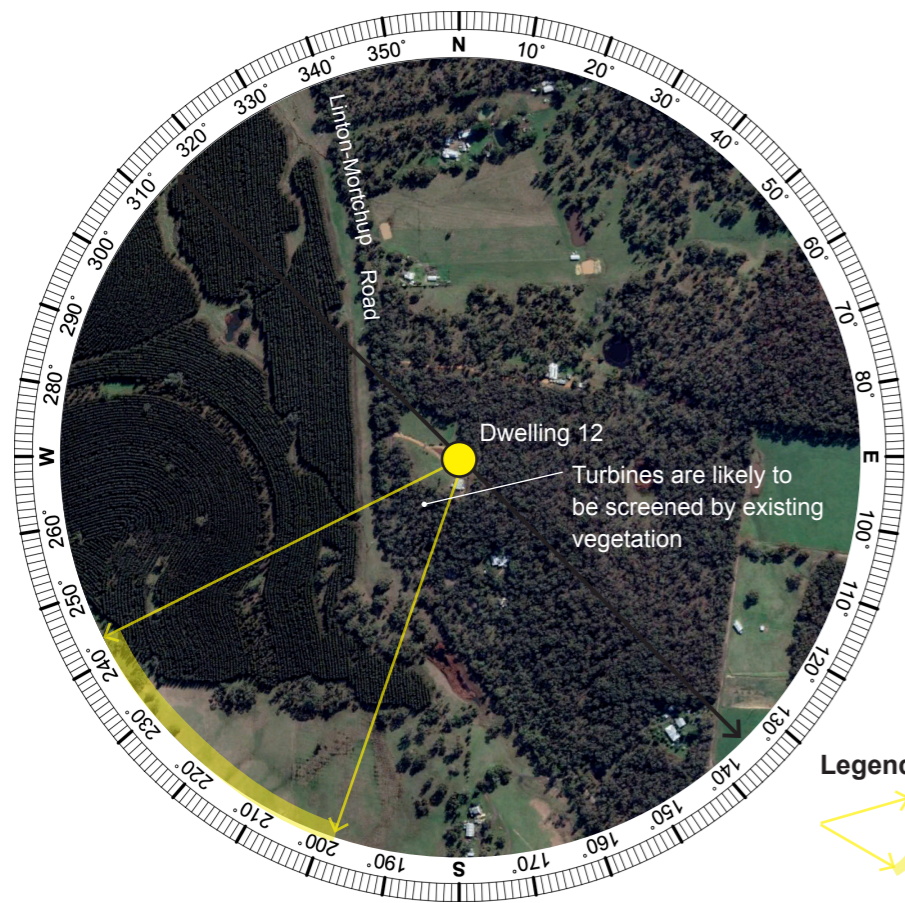
Dwelling 12 - Aerial Image
Location Plan (Image Source: Google Earth 2022)

An assessment based on topography alone suggests that all turbines are likely to be visible from Dwelling 12 which is located within 6000 m of the nearest turbine. The dwelling is located on a undulating terrain, in an elevated position. The curtilage of the dwelling have been cleared however, aerial and street view imagery indicate that it is situated within an area that is densely vegetated. This vegetation will assist in screening the Project from this dwelling.

Distance to Nearest Turbine:	4.55 km
Number of potentially visible turbines (based on topography alone):	28 turbines (All turbine blade tips)

Mitigation not deemed necessary for this dwelling.

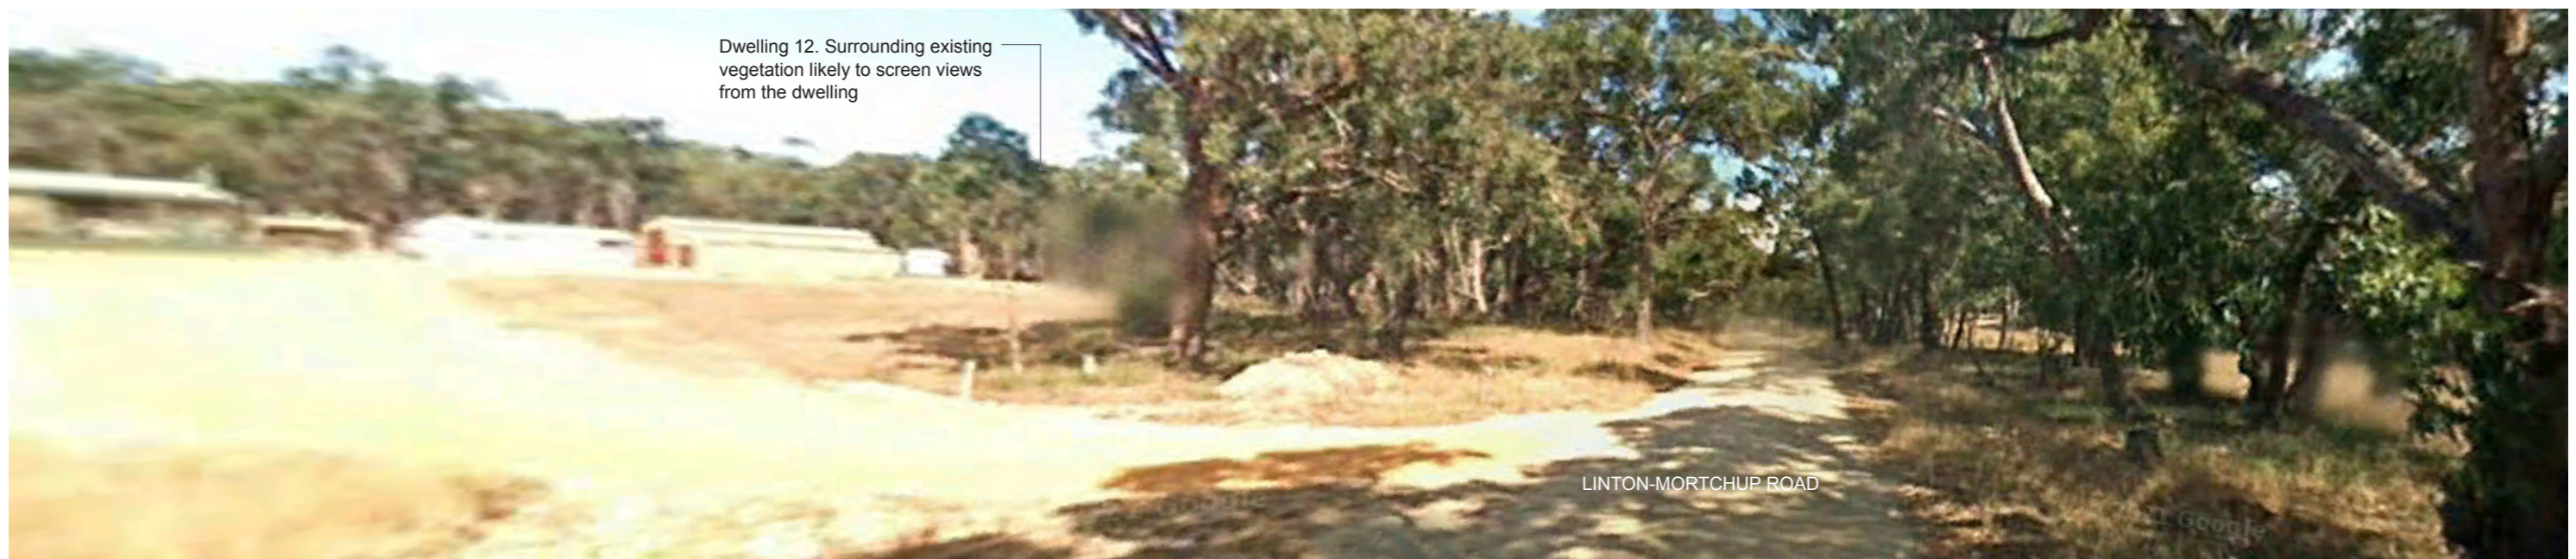
Dwelling 12 - Existing View
View from Linton-Mortchup Road near mailbox of Dwelling 12 (Image Source: Google Street View 2008)

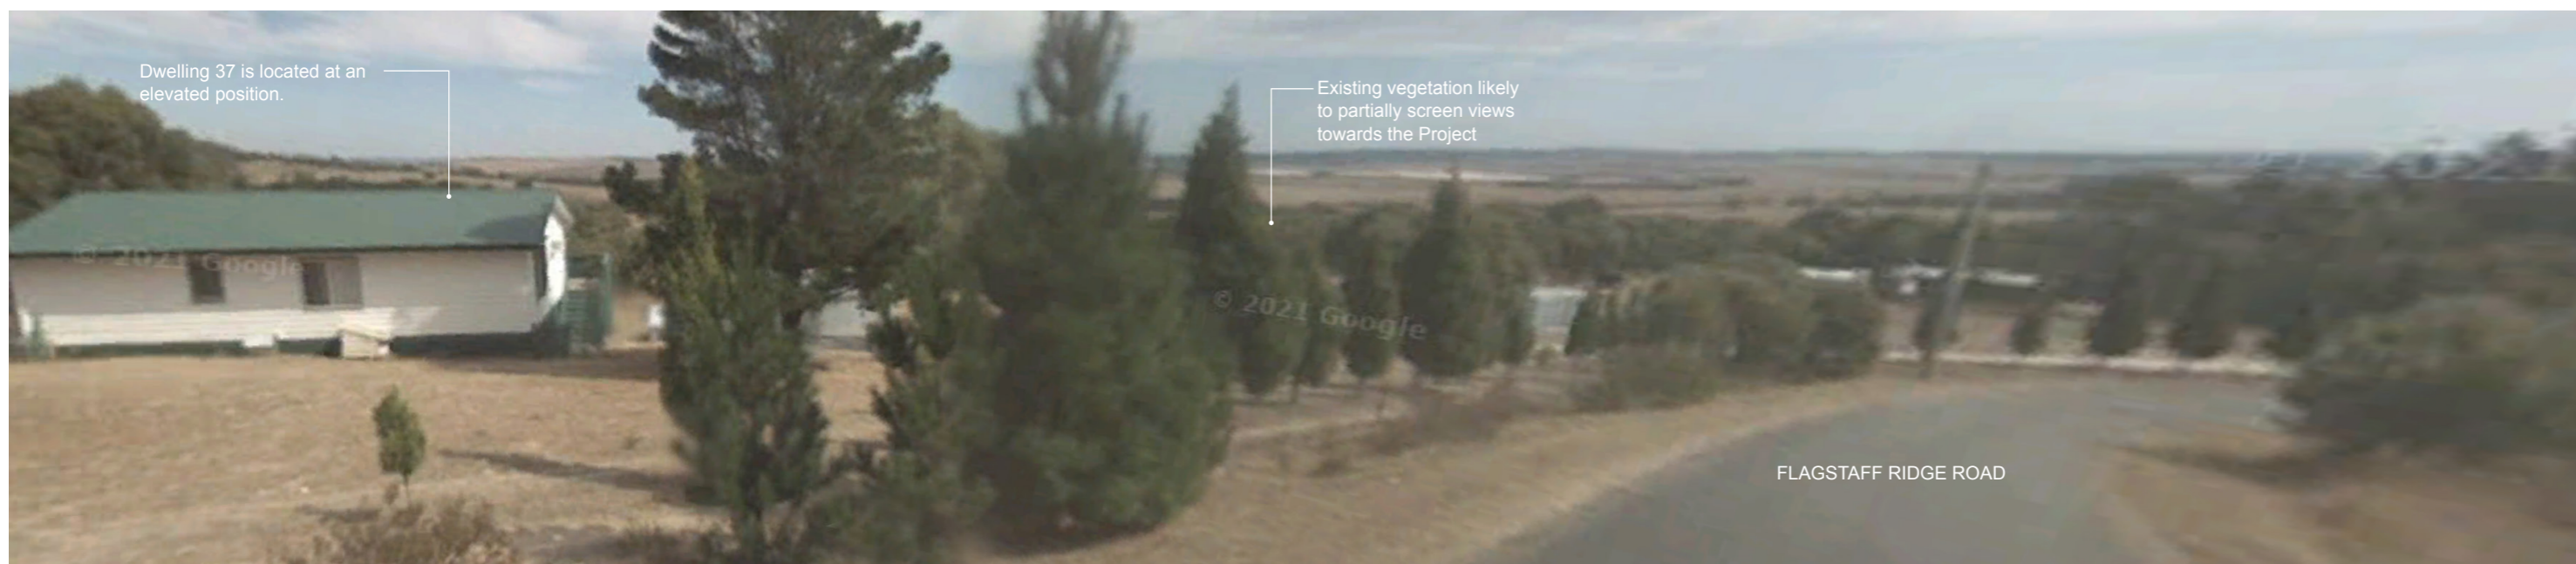
An assessment based on topography alone suggests that all turbines are likely to be visible from Dwelling 37 which is located within 4000 m of the nearest turbine. The dwelling is located on undulating terrain in an elevated position. Aerial imagery indicates existing windbreak planting on the southern and western sides of the residence and an existing farm building to the south west which will assist in limiting views towards the Project. Views toward some turbines may be possible due to the combination of distance to the closest turbine and the elevation of the dwelling.

Dwelling 37 - Existing View
View from Flagstaff Ridge Road near mailbox of Dwelling 37 (Image Source: Google Street View 2008)

Existing vegetation is likely to partially screen views towards the Project. However, the combination of distance to the closest turbine and the elevation of the dwelling may require additional screening in the immediate foreground of this dwelling. Consultation with the landowner will be required for recommending additional screen planting.

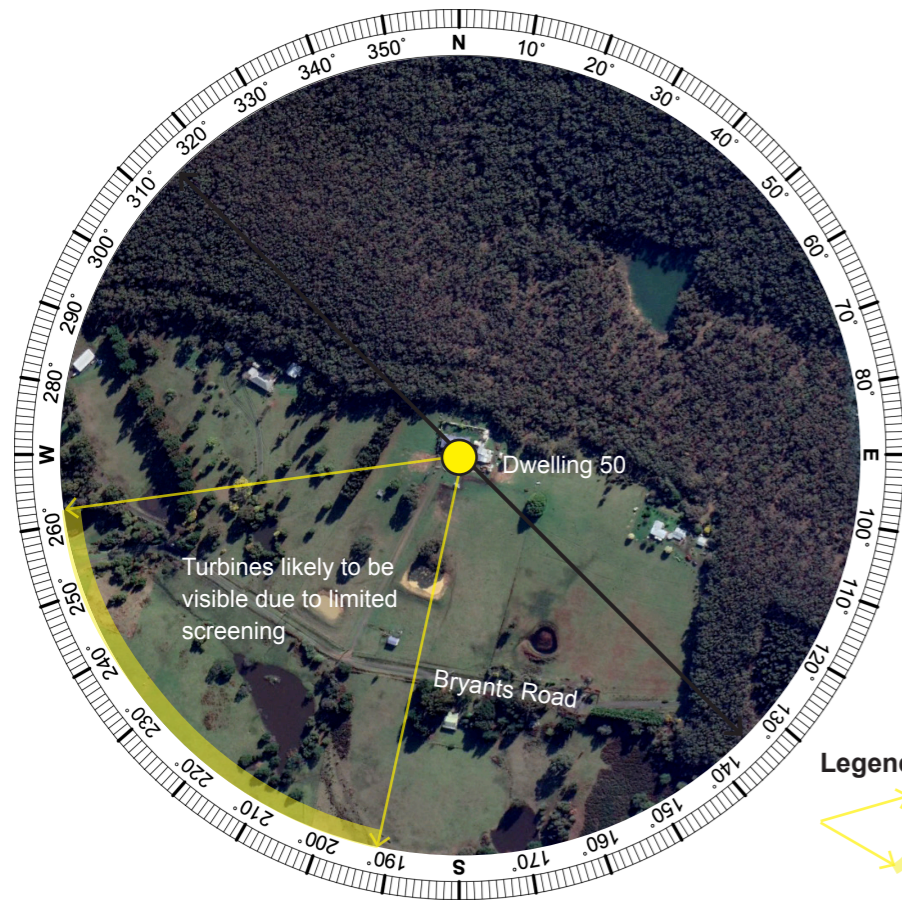
Dwelling 50 - Aerial Image
Location Plan (Image Source: Google Earth 2022)

An assessment based on topography alone suggests that all turbines are likely to be visible from Dwelling 50 which is located within 6000 m of the nearest turbine. The dwelling is located on a undulating terrain in an elevated position. Aerial imagery indicates a lack of vegetation in the immediate surrounds, however a dense windbreak vegetation is located to the west. A combination of distance, topography and vegetation along surrounding ridgelines are likely to screen views toward the majority of turbines from this location.

Distance to Nearest Turbine:	4.33 km
Number of potentially visible turbines (based on topography alone):	30 turbines (6 at hub height, 24 blade tips)

Mitigation measures not deemed necessary from this dwelling.

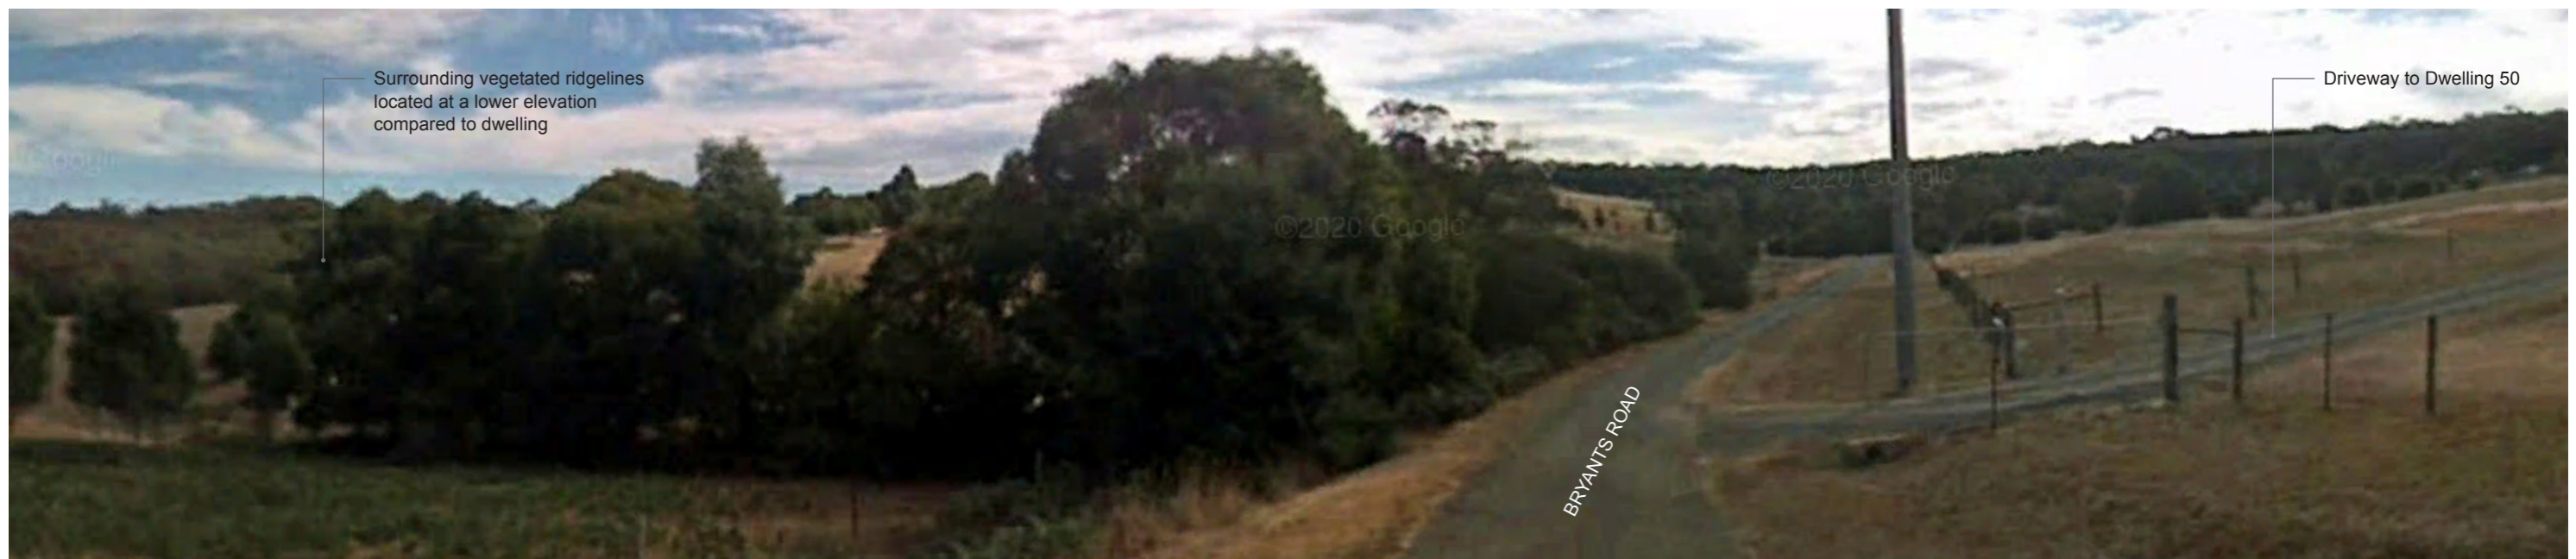
Dwelling 50 - Existing View
View from Bryants Road near mailbox of Dwelling 50 (Image Source: Google Street View 2008)

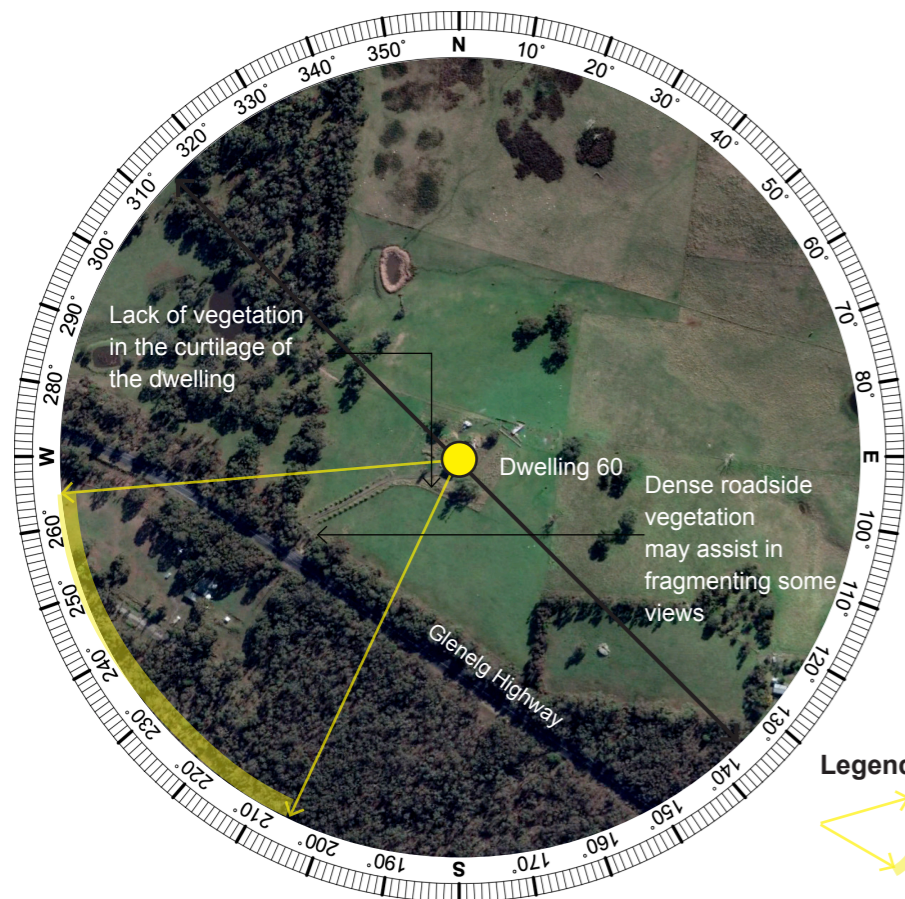
Dwelling 60 - Aerial Image
Location Plan (Image Source: Google Earth 2022)

An assessment based on topography alone suggests that all turbines are likely to be visible from Dwelling 60 which is located within 4000 m of the nearest turbine. The dwelling is located on undulating terrain at an elevated position. Aerial imagery indicate that the curtilage of the residence is generally cleared of vegetation, allowing for open views to the south west. Dense roadside vegetation located to the south may assist in fragmenting some views.

Distance to Nearest Turbine:	2.68 km
Number of potentially visible turbines (based on topography alone):	62 turbines (All at hub height)

If deemed necessary, additional screening can be provided in the immediate foreground of this dwelling. Consultation with the landowner will be required for recommending additional screen planting.

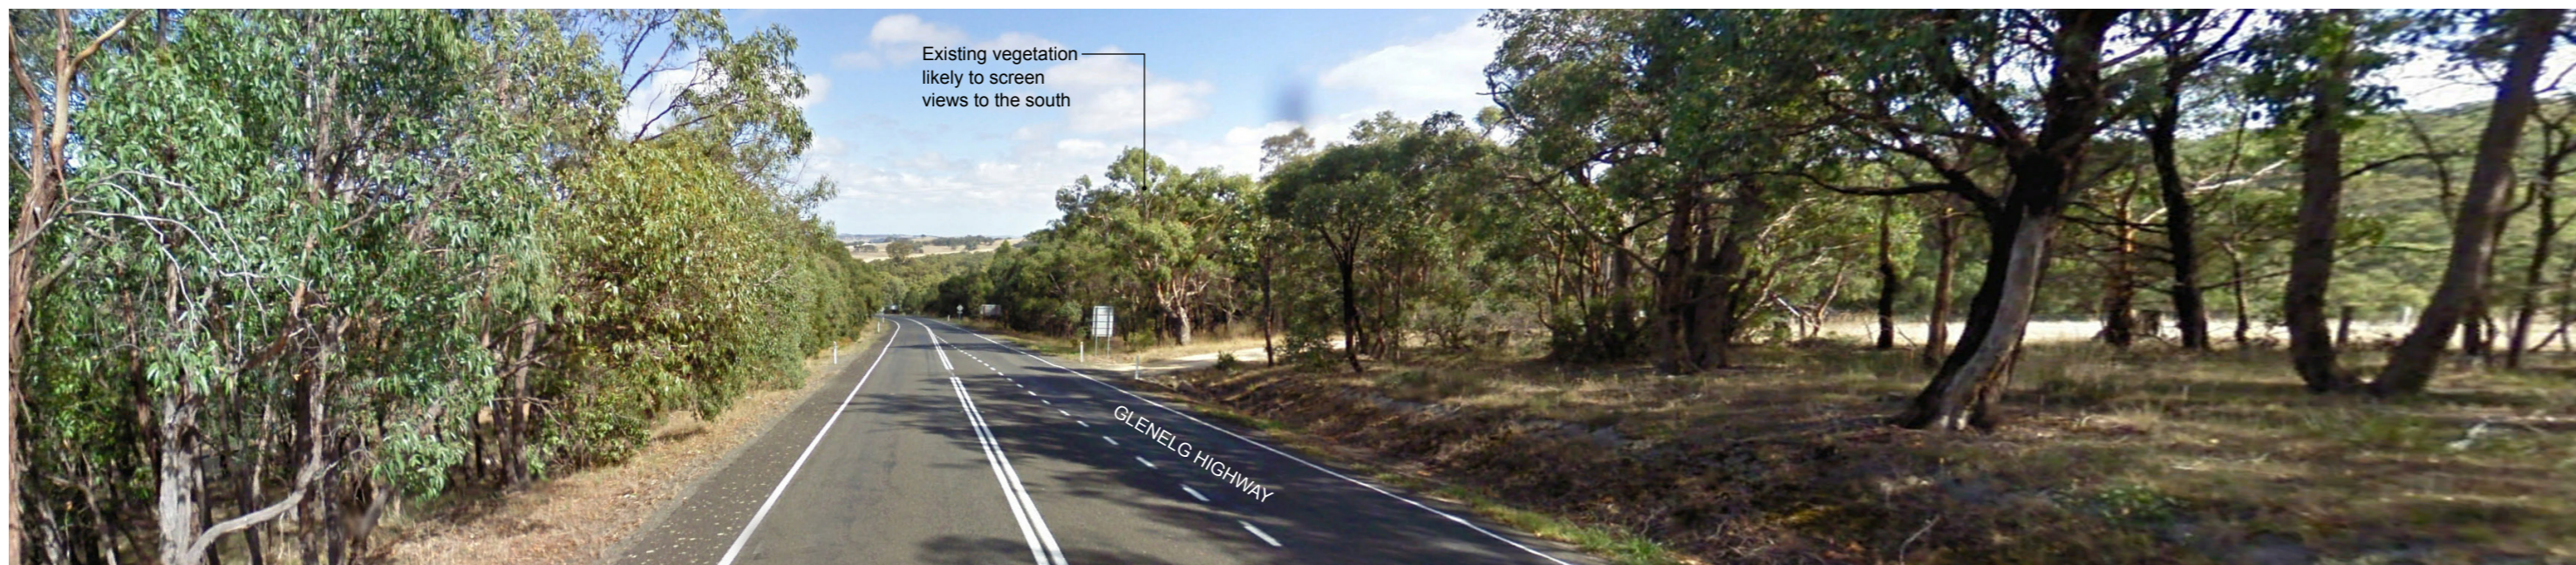
Dwelling 60 - Existing View
View from Glenelg Highway near mailbox of Dwelling 60 (Image Source: Google Street View 2010)

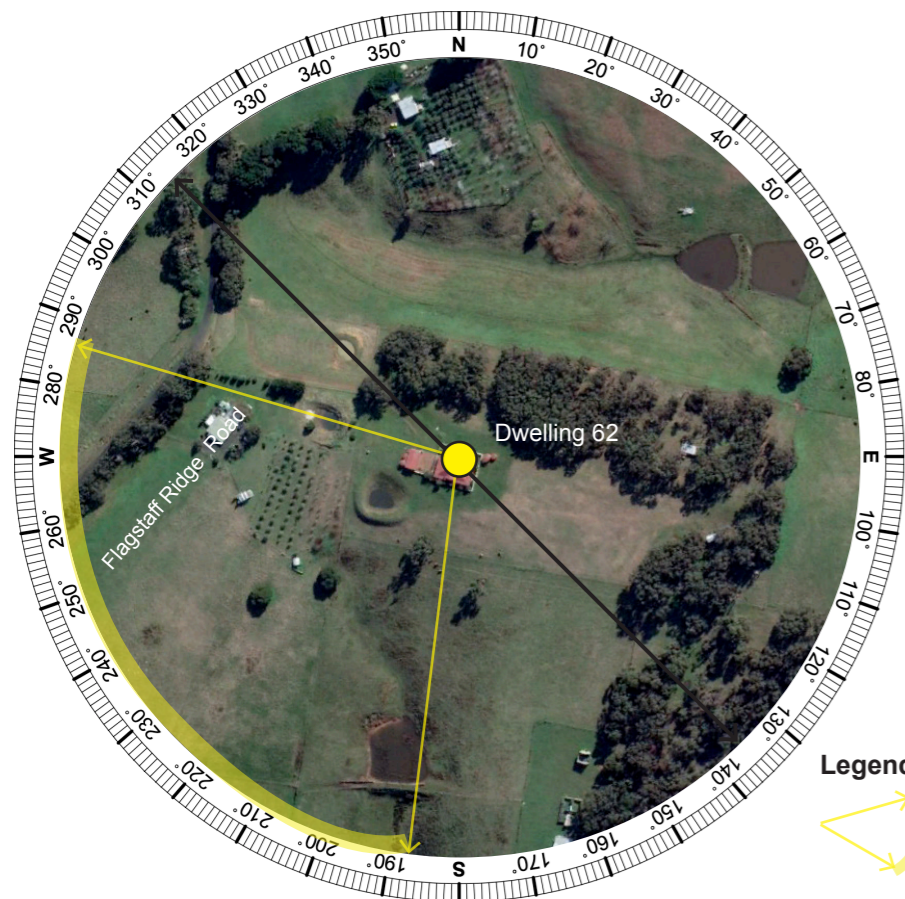
Dwelling 62 - Aerial Image
 Location Plan (Image Source: Google Earth 2022)

An assessment based on topography alone suggests that all turbines are likely to be visible from Dwelling 62, which is located within 4000 m of the nearest turbine. Aerial imagery indicates that there may be some small shrubs to the southern side of the dwelling. A combination of a farm building and topography are likely to screen views towards turbines to the west. Views south from the dwelling are likely to be limited due to the surrounding undulating terrain. The Project is likely to be visible for a portion of the view to the south west of the dwelling.

Distance to Nearest Turbine:	3.26 km
Number of potentially visible turbines (based on topography alone):	38 turbines (30 at hub height, 8 blade tips)

Additional screening on the south west side of the dwelling will help reduce potential visual impact. Consultation with the landowner will be required.

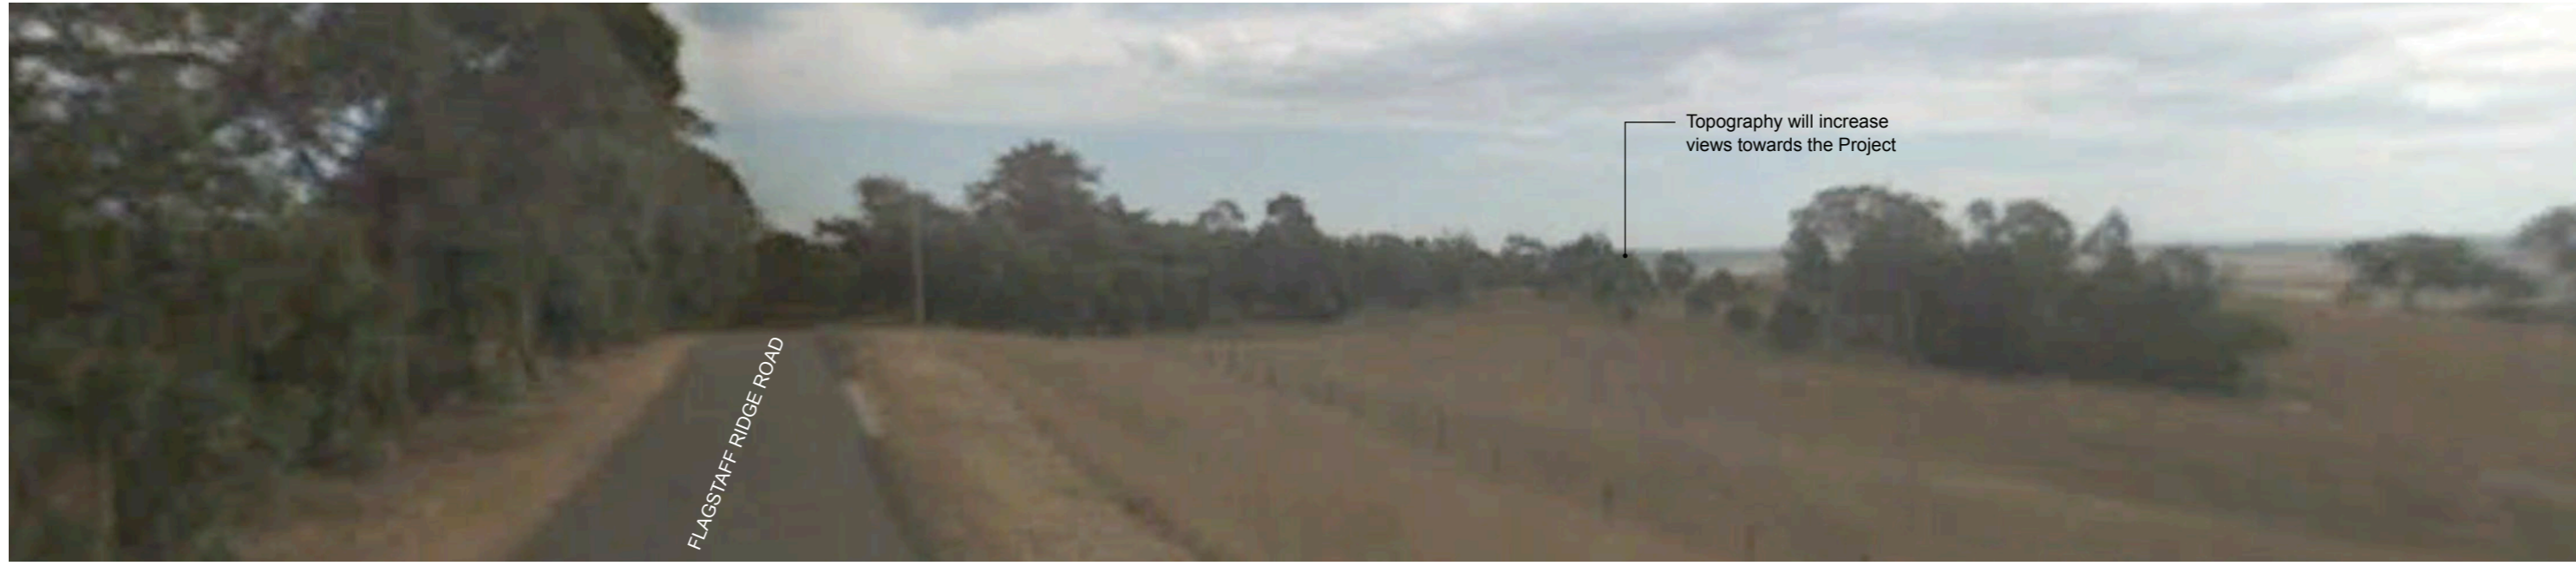
Dwelling 62 - Existing View
 View from Flagstaff Ridge Road near mailbox of Dwelling 62

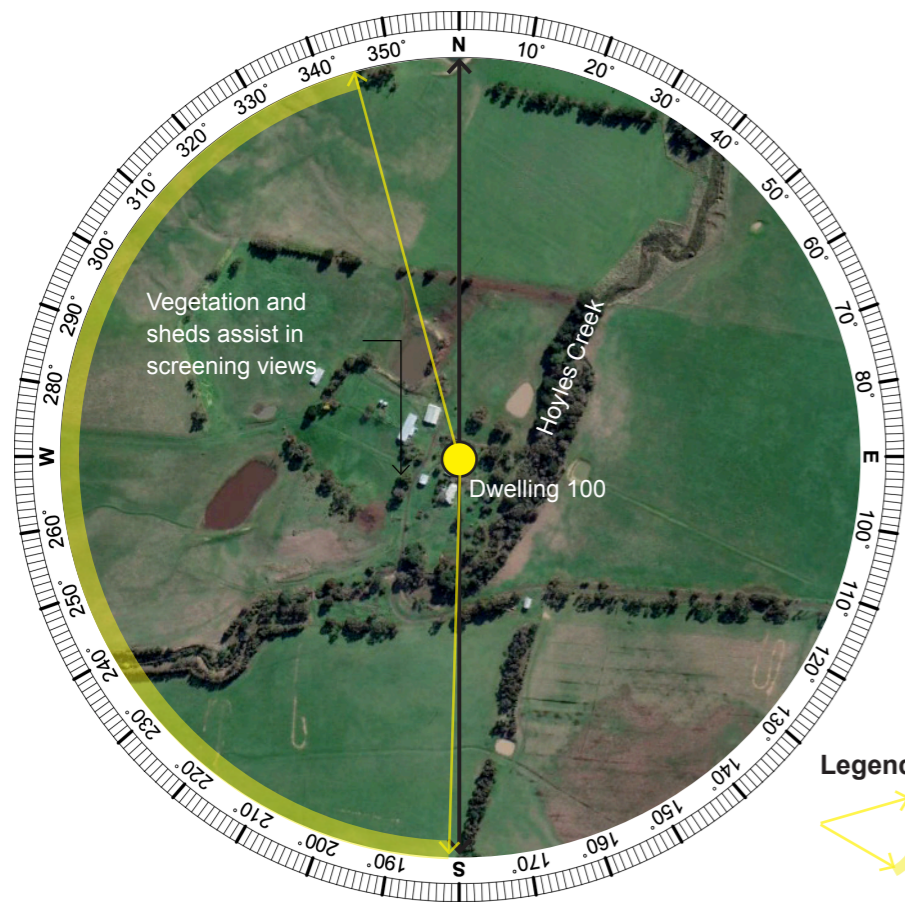
Dwelling 100 - Aerial Image
Location Plan (Image Source: Google Earth 2022)

An assessment based on topography alone suggests that majority of the turbines are likely to be visible on the western side of Dwelling 100, which is located within 2000m of the nearest turbine. The dwelling is located on flat terrain. Existing vegetation and structures surround the dwelling particularly to the north west and south west. Existing vegetation and topography to the north west is likely to fragment views of nearest turbine. The structures and vegetation surrounding the dwelling are likely to assist in screening views towards the majority of the Project from this location. However, some fragmented views may be available through breaks in vegetation.

Distance to Nearest Turbine:	1.95 km
Number of potentially visible turbines (based on topography alone):	62 turbines (All at hub height)

If deemed necessary, additional supplementary planting may provide additional screening in gaps in vegetation and where necessary. Consultation with the landowner will be required before recommending any additional planting.

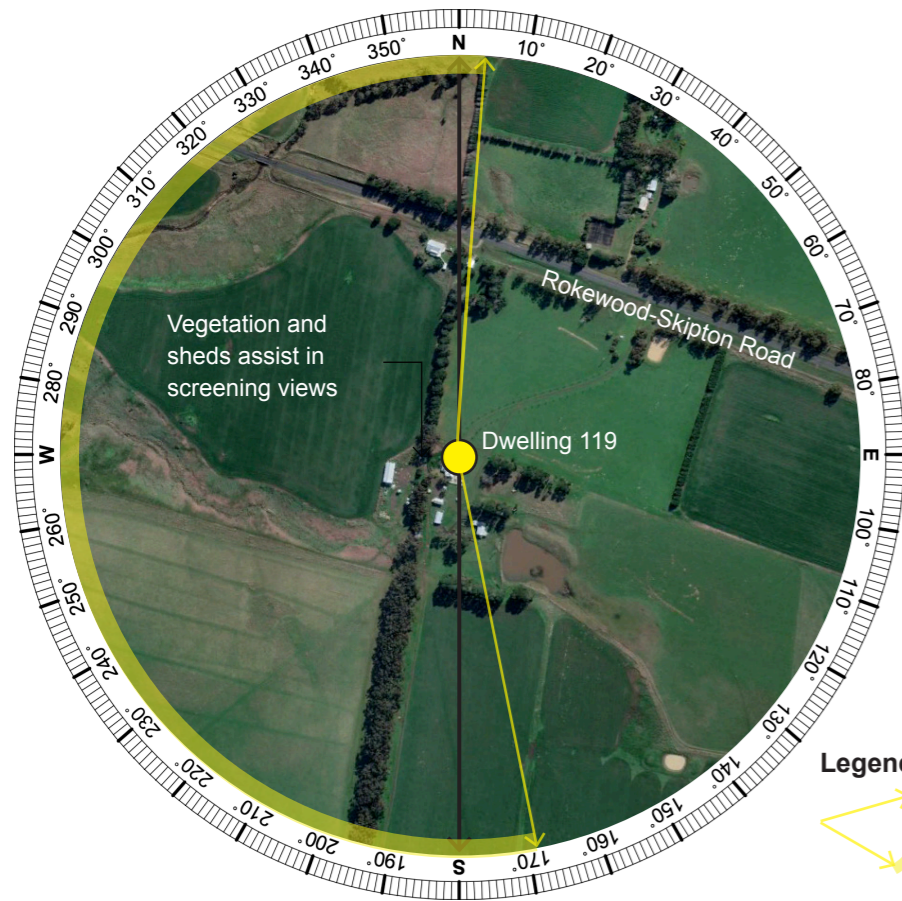
Dwelling 119 - Aerial Image
Location Plan (Image Source: Google Earth 2022)

An assessment based on topography alone suggests that all turbines are likely to be visible from Dwelling 119 which is located within 4000 m of the nearest turbine. The dwelling is located on flat terrain. Aerial imagery indicates dense windbreak or boundary vegetation to the dwelling's west. A number of farm buildings are also located to the west of the dwelling. A combination of these factors is likely to screen the majority of views from this location however views towards some turbines to the west may be available through breaks in vegetation.

Distance to Nearest Turbine:	2.97 km
Number of potentially visible turbines (based on topography alone):	62 turbines (All at hub height)

If deemed necessary, additional supplementary planting may provide additional screening in gaps in vegetation and where necessary. Consultation with the landowner will be required before recommending any additional planting.

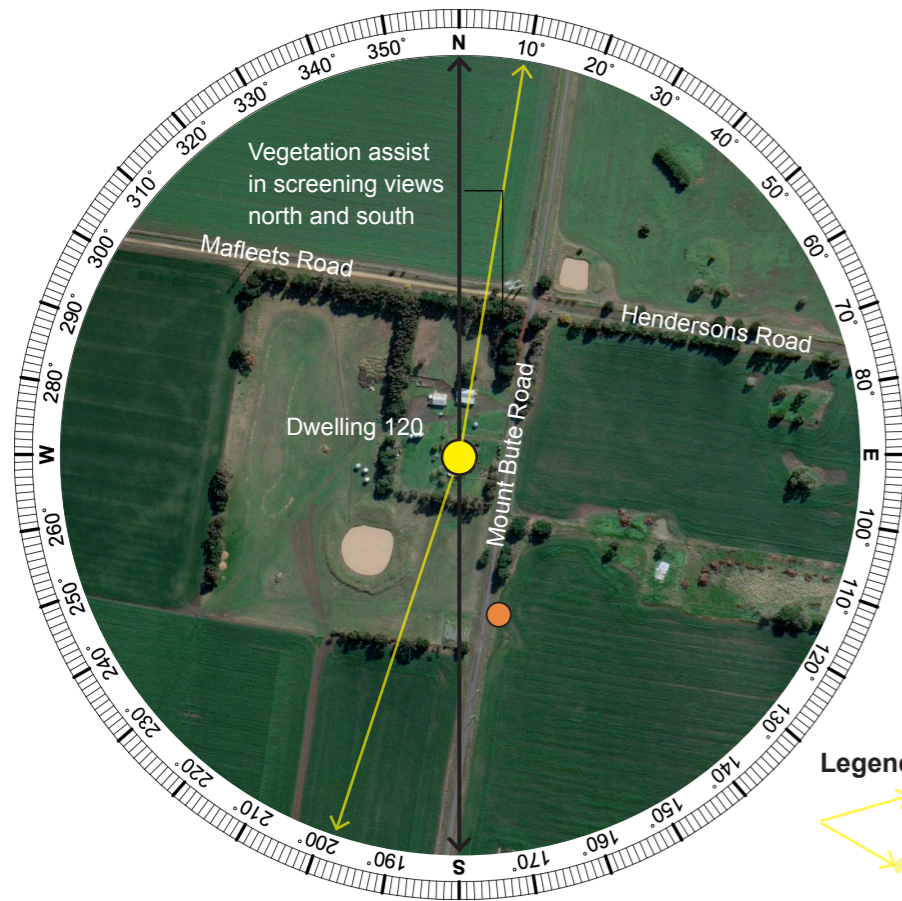
Dwelling 120 - Aerial Image
Location Plan (Image Source: Google Earth 2022)

An assessment based on topography alone suggests that all turbines are likely to be visible from Dwelling 120 which is located within 2000 m of the nearest turbine. Aerial imagery indicates that the residence is orientated north east and is surrounded by dense windbreak vegetation. This vegetation will help in screening some views north and south toward the Project. It is noted that a break in this existing vegetation is located along the eastern boundary. A combination of distance to the Project and the lack of vegetation to the east is likely to result in visibility towards turbines to the north east from this location.

Distance to Nearest Turbine:	1.50 km
Number of potentially visible turbines (based on topography alone):	48 turbines (All at hub height)

Additional screening is recommended for the dwelling's immediate foreground on the north eastern side. Consultation with the landowner will be required before recommending any additional planting.

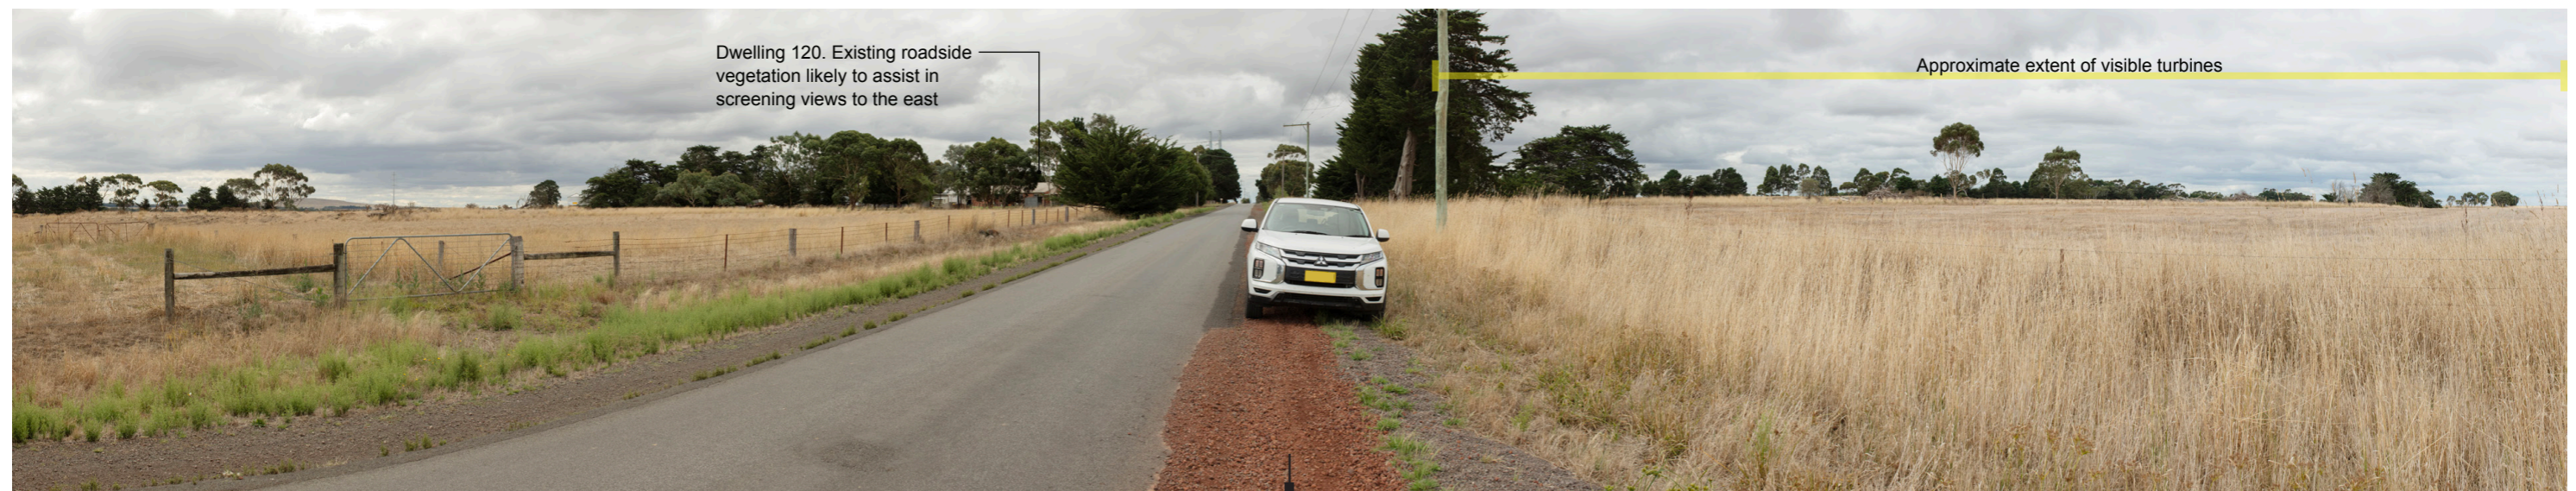
Dwelling 120 - Existing View
View from Mount Bute Road near Dwelling 120

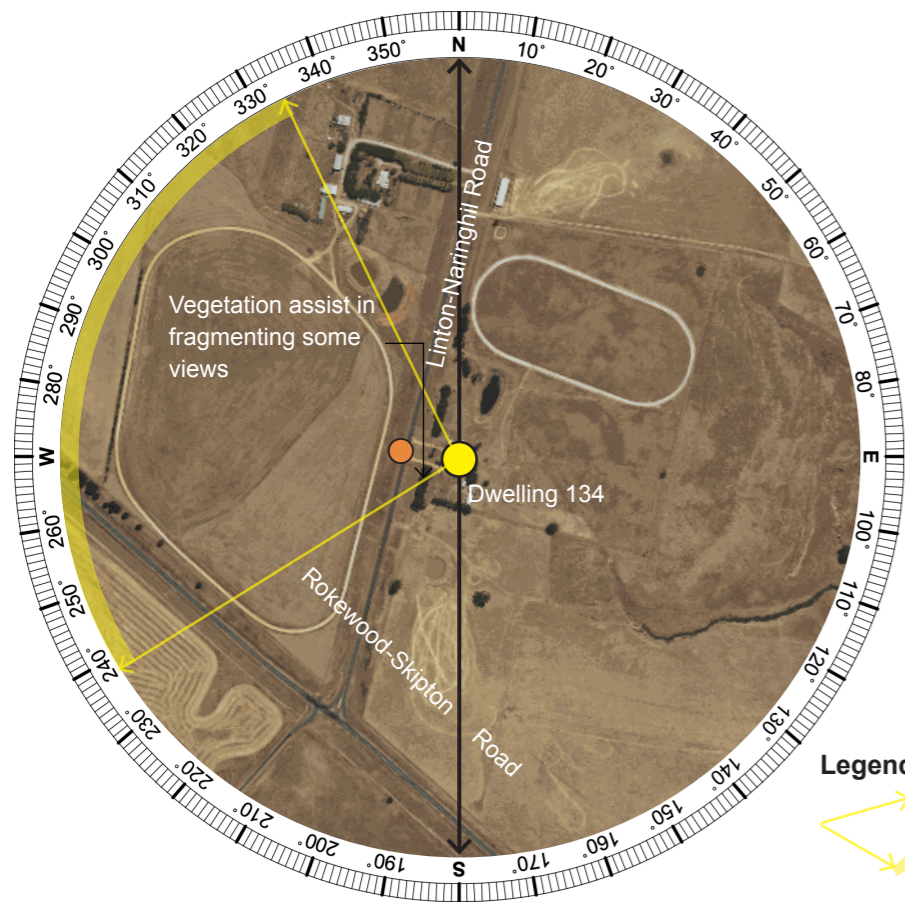
Dwelling 134 - Aerial Image
Location Plan (Image Source: VicPlan 2018)

An assessment based on topography alone suggests that all turbines are likely to be visible from Dwelling 134 which is located within 6000 m of the nearest turbine. The dwelling is located on flat terrain. Aerial imagery indicates that there is dense boundary vegetation to the dwelling's west. However, it is noted that the vegetation opens up directly to the west, allowing for views out from the dwelling in this direction. The existing vegetation is likely to fragment views towards the closest turbines from this location, however distant views are likely through the break in vegetation to the west.

Distance to Nearest Turbine:	4.58 km
Number of potentially visible turbines (based on topography alone):	16 turbines (All at hub height)

Additional screening is recommended for the dwelling's immediate foreground on the western side. Consultation with the landowner will be required before recommending any additional planting.

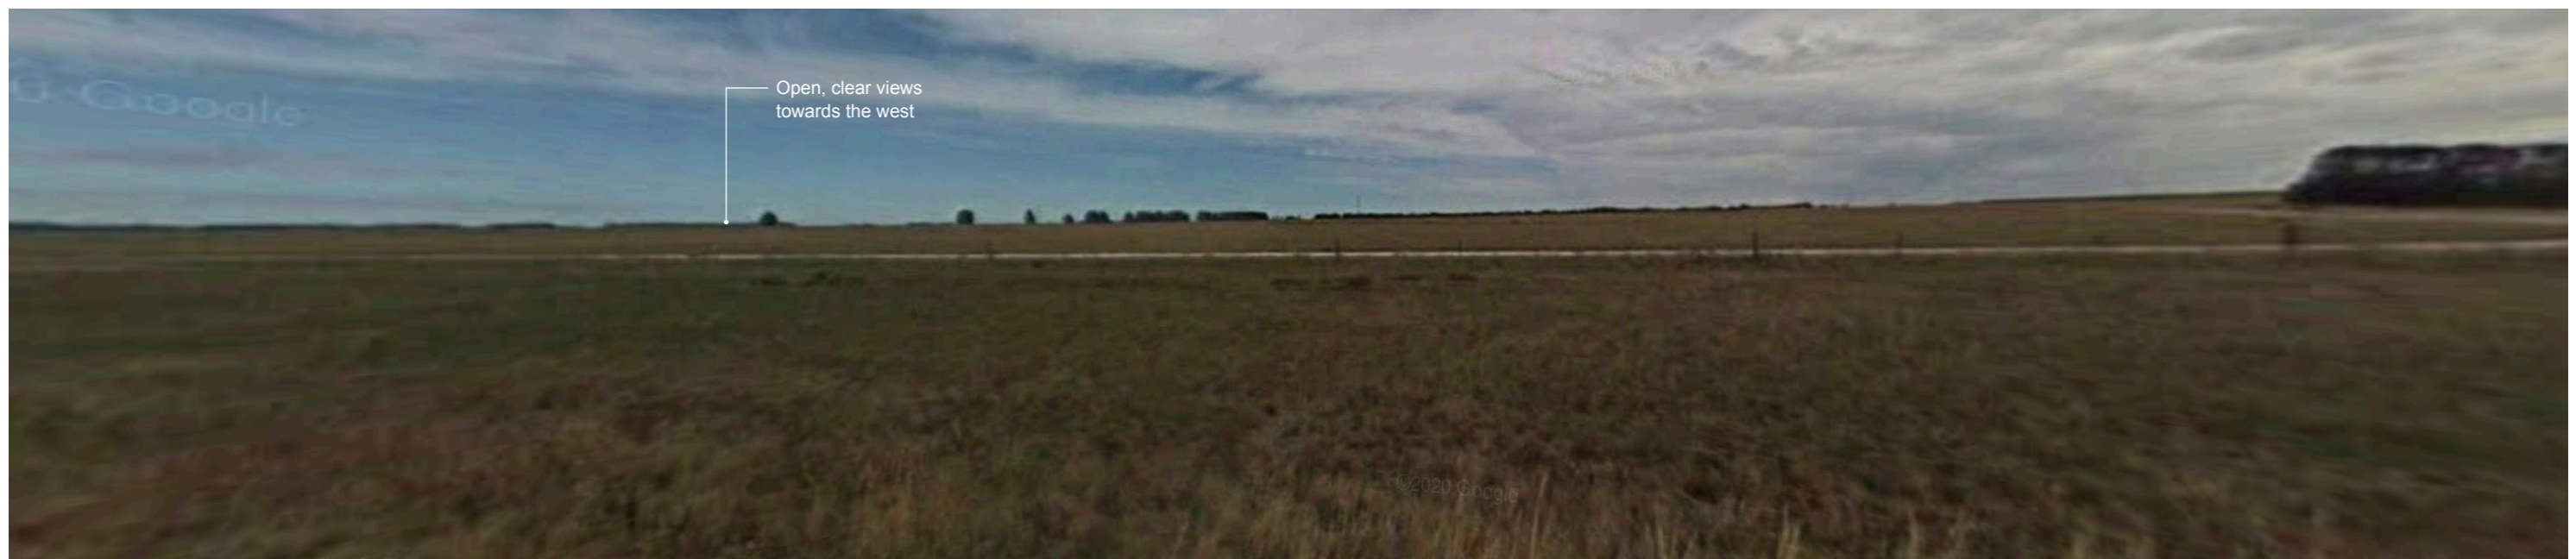
Dwelling 134 - Existing View
View from Linton-Naringhil Road near mailbox of Dwelling 134 (Image Source: Google Street View 2008)

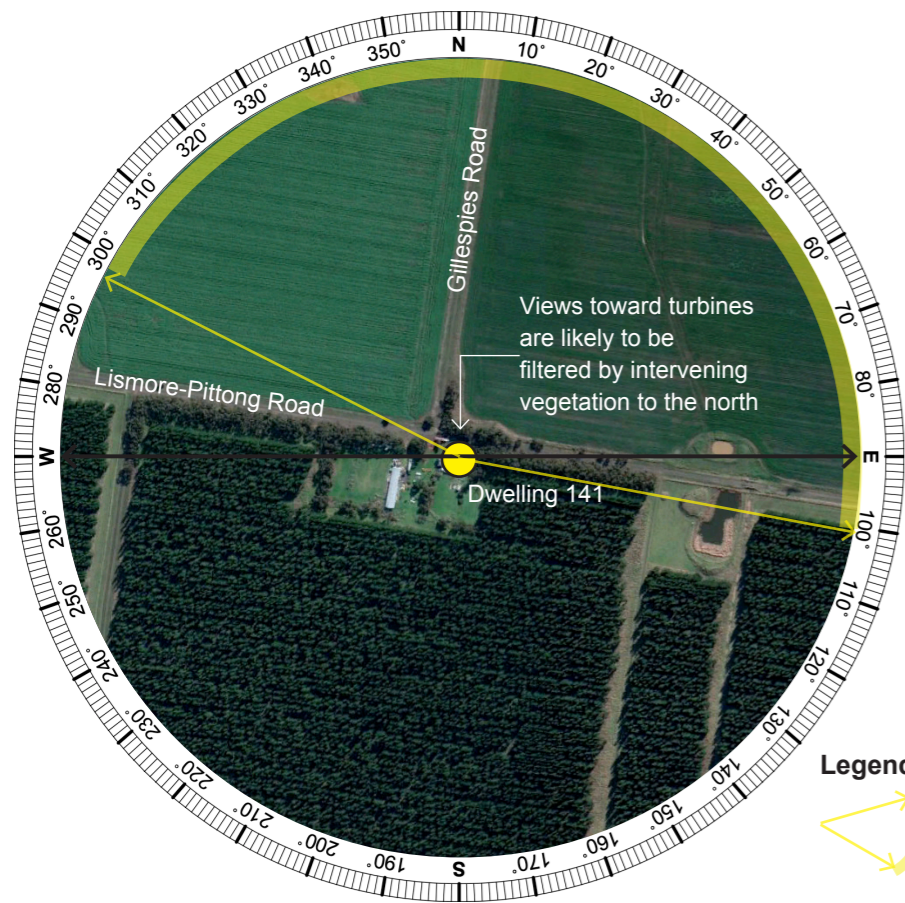
Dwelling 141 - Aerial Image
Location Plan (Image Source: Google Earth 2022)

Due to the proximity, majority of turbines are likely to be visible from Dwelling 141 which is located within 2000 m of the nearest turbine. The dwelling is located on flat terrain. Aerial imagery indicates patchy to dense roadside vegetation to the north of the dwelling in addition to dense vegetation surrounding the property. It is likely that views in the northern direction will be filtered by the vegetation to the north. A combination of distance from Project and existing screening elements suggest that filtered views of the Project are likely to be available at this dwelling.

Distance to Nearest Turbine:	1.49 km
Number of potentially visible turbines (based on topography alone):	58 turbines (All at hub height)

It is likely that filtered views of the Project will be available from this dwelling. If deemed necessary, additional screening can be provided in the immediate foreground of this dwelling on the northern side. Consultation with the landowner will be required before recommending any additional planting.
