Dwelling Analysis

Dwelling Analysis Locations Moreton Hill Wind Farm

Appendix A Dwelling Analysis locations (Map Source: VicPlan 2023)

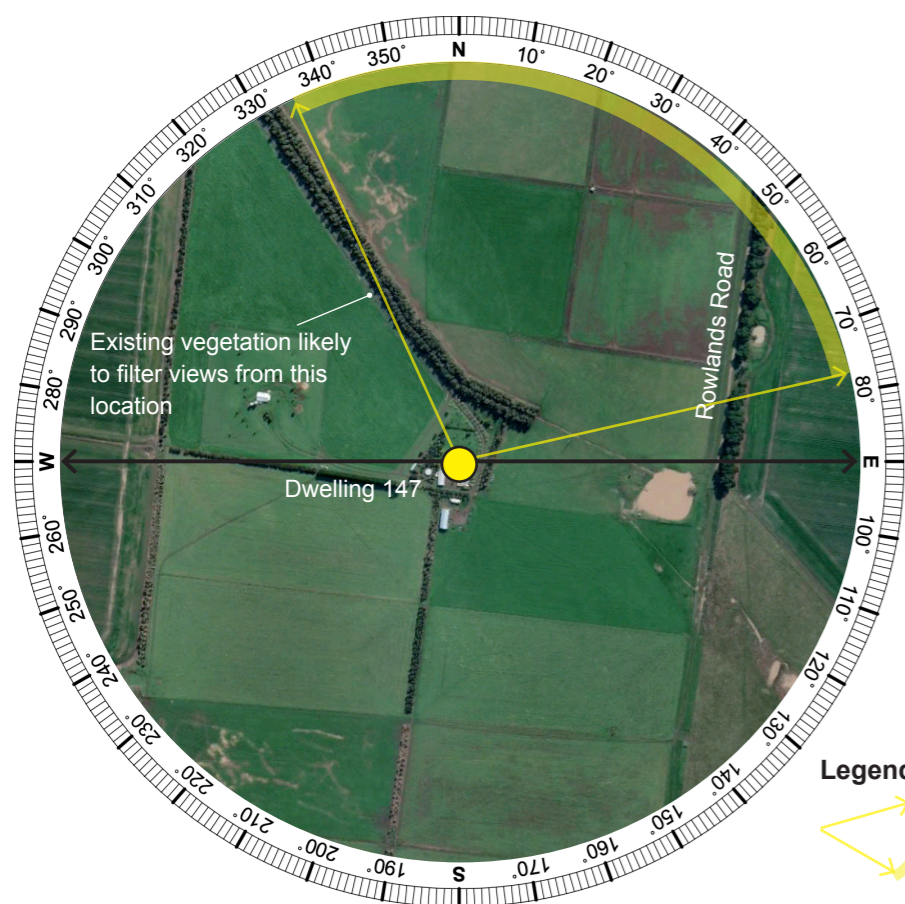
Dwelling 147 - Aerial Image
Location Plan (Image Source: Google Earth 2022)

An assessment based on topography alone suggests that all turbines are likely to be visible from Dwelling 147 which is located within 4000 m of the nearest turbine. The dwelling is located on flat terrain. Aerial imagery indicates that the dwelling's northern driveway is bounded by dense screening vegetation, as well as pine forests north of the dwelling. The existing vegetation surrounding the property is likely to filter the majority of views from this location.

Distance to Nearest Turbine:	3.84 km
Number of potentially visible turbines (based on topography alone):	48 turbines (All at hub height)

It is likely that views of Project will be screened by existing vegetation. However, gaps in existing vegetation may allow views of some turbines. If deemed necessary, additional screening can be provided to the north of the dwelling. Consultation with the landowner will be required to recommend any additional planting.

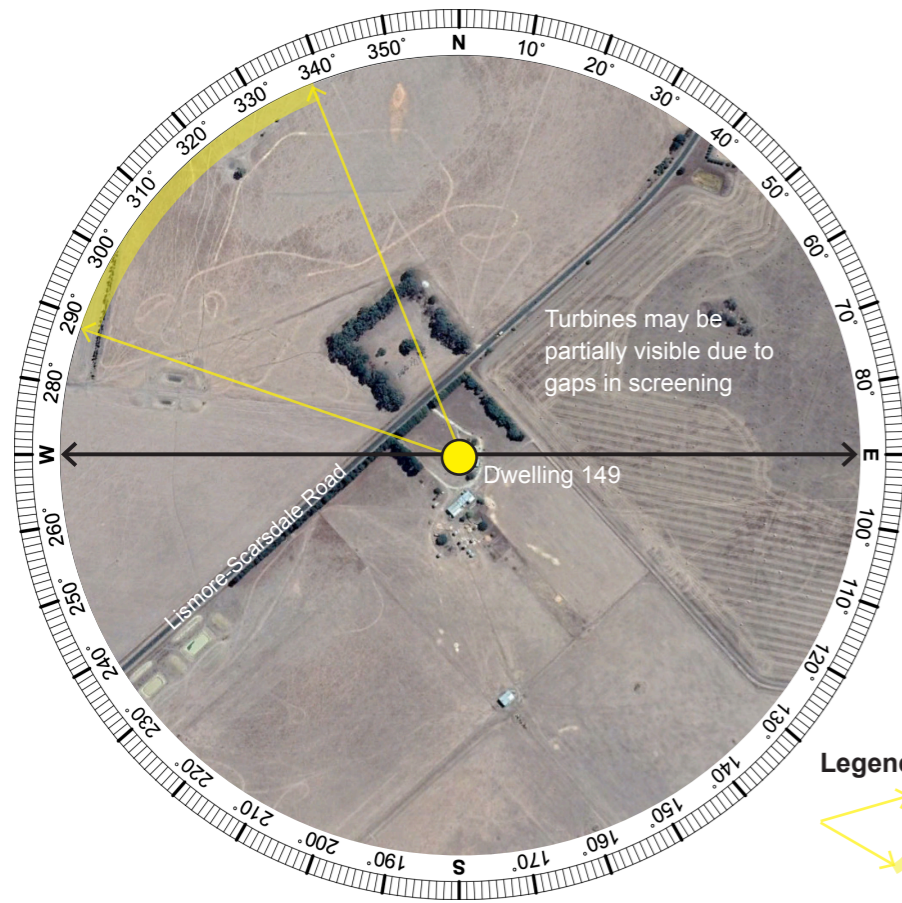
Dwelling 149 - Aerial Image
Location Plan (Image Source: Google Earth 2022)

Dwelling 149 is located within 6000 m of the nearest turbine. The dwelling is located on flat terrain. Aerial imagery indicates a dense row of vegetation along the roadside of the property edge to the north. This existing vegetation will screen views of the Project.

Distance to Nearest Turbine:	5.29 km
Number of potentially visible turbines (based on topography alone):	16 turbines (All at hub height)

Mitigation not deemed necessary for this dwelling.
