**Final Report: Aquatic Habitat Assessment
The Fingerboards Mineral Sand Project**

Aquatic Habitat Assessment

The Fingerboards Mineral Sand Project

Report prepared for Kalbar Resources Ltd
c/- Ecology & Heritage Partners Pty Ltd and Coffey

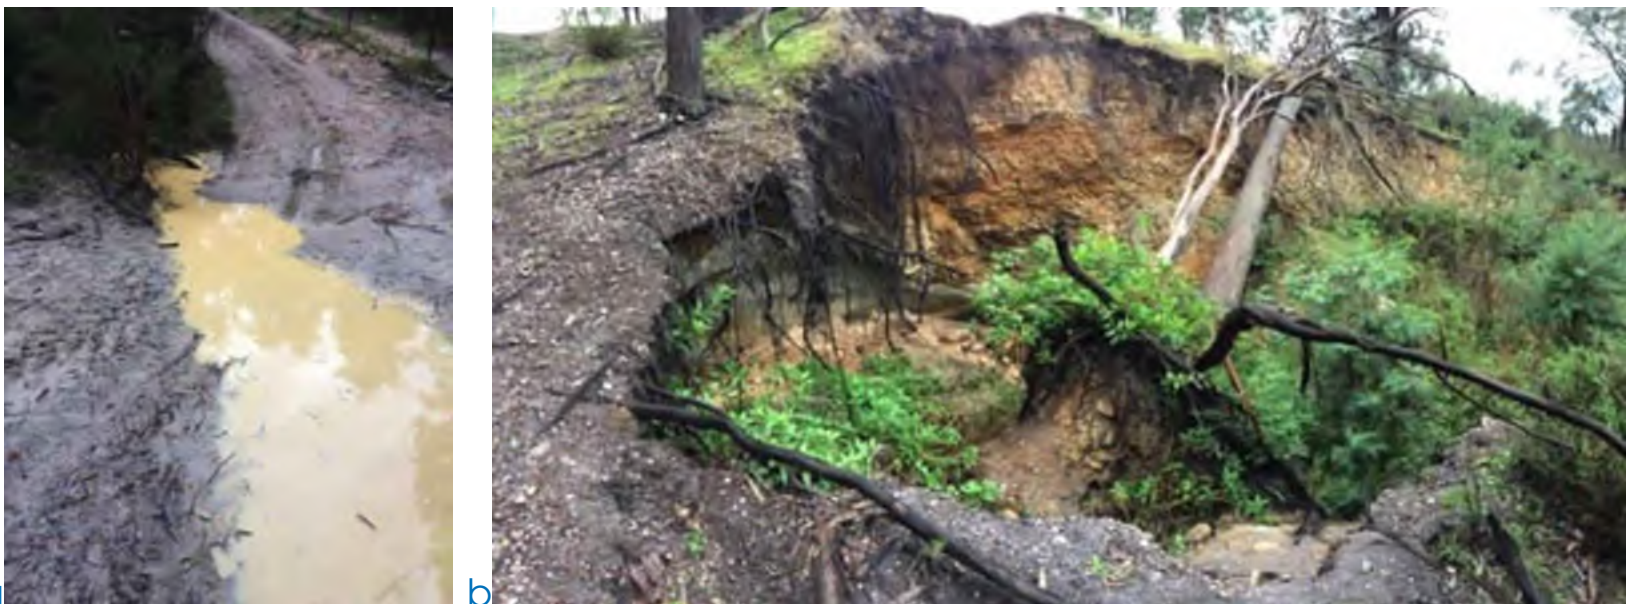
Across the sites measured pH, electrical conductivity and dissolved oxygen were similar and within normal ranges for a highly modified and ephemeral waterway. Turbidity varied more widely, primarily due to the highly erosive nature of the geology in the vicinity of the waterways. In most instances where higher turbidity was measured (or observed) there was nearby point-source stemming from active erosion (see Plate 2a and b).

Plate 2 a. Turbid water near Site 1 (Perry Gully), b. Active erosion and the source of the turbidity

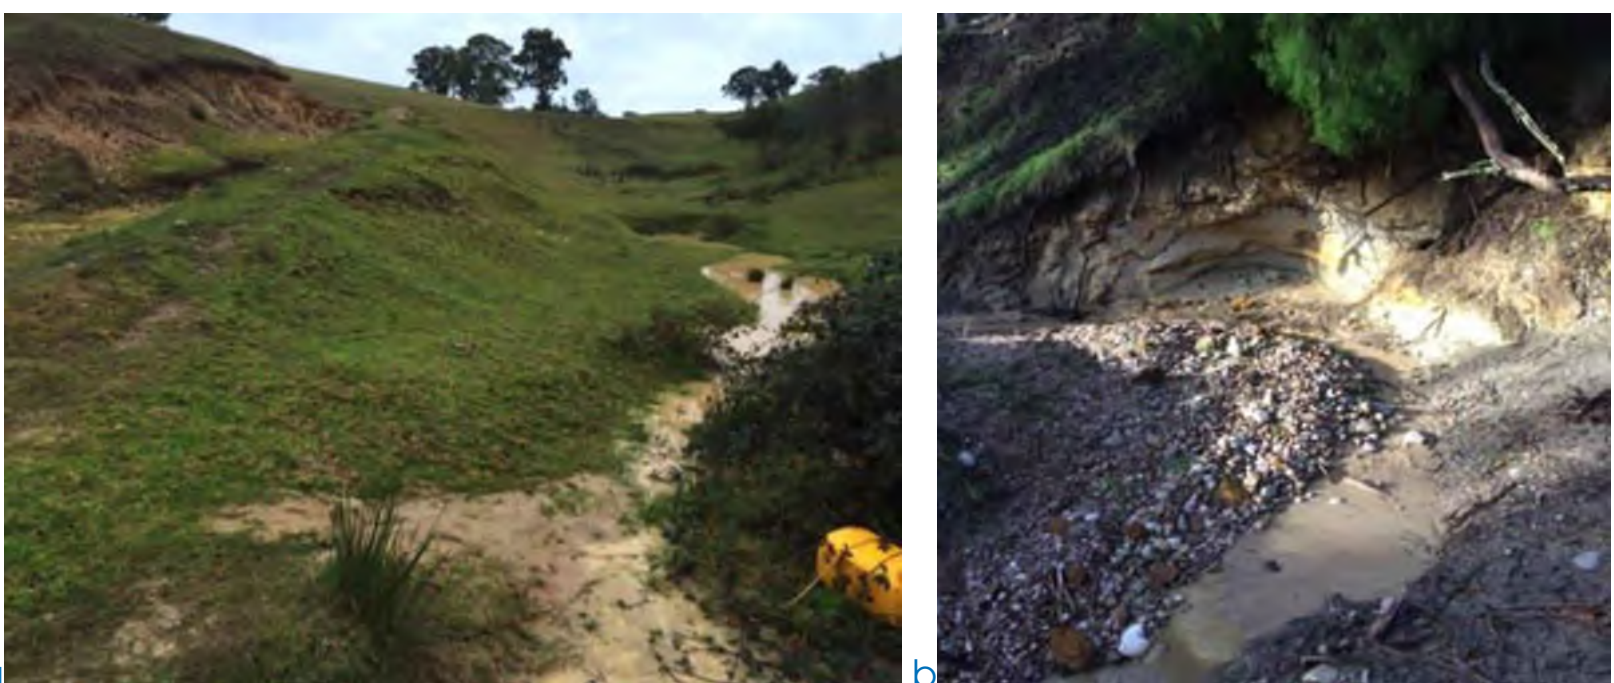
Plate 3 a. Turbid water downstream of Site 7 (Simpson Gully), b. Erosion site upstream of Site 11

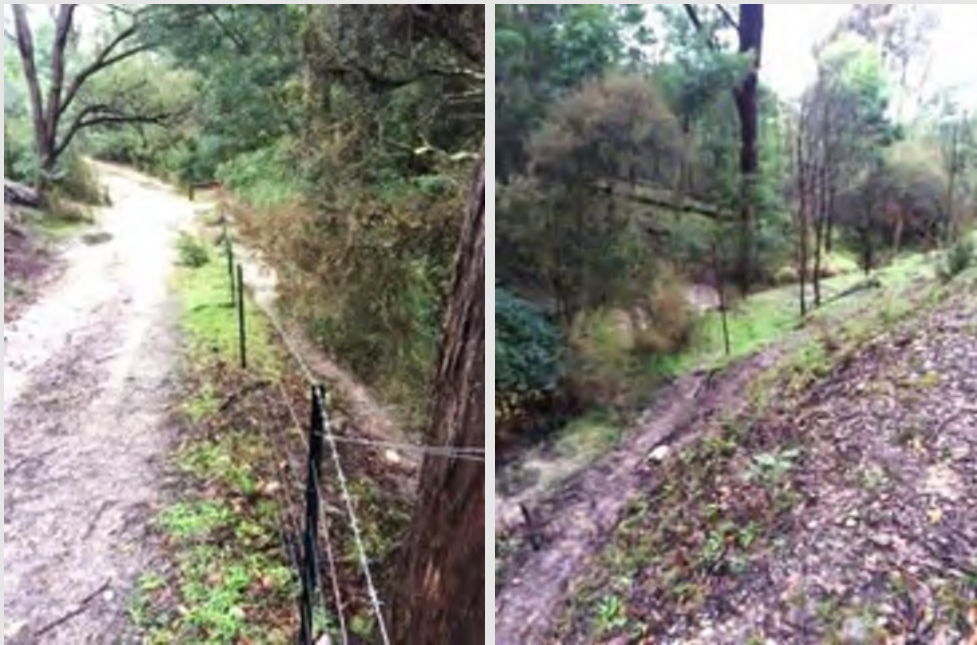
Site No.	Latitude	Longitude	Altitude (m)	Site Description	Site Photo
1	-37.789903	147.342255	83.2	<p>Perry Gully</p> <p>Located in a moderately steep vegetated valley. Minor fresh flow with high turbidity observed, but due to upstream erosion event (see Site 2) and recent rains.</p> <p>Site likely dry unless recent rains.</p> <p>No aquatic habitat.</p>

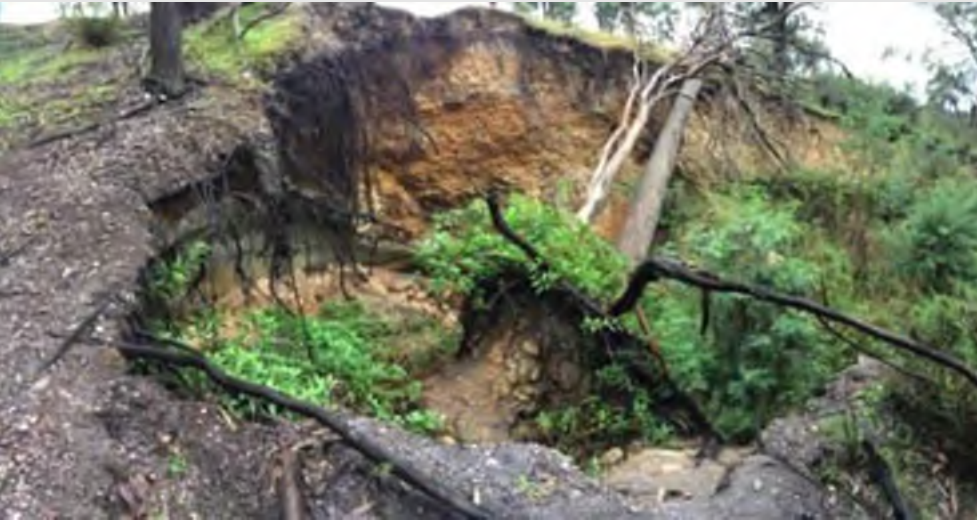
2	-37.790671	147.339826	104.1	<p>Perry Gully.</p> <p>Major erosion (not waterway).</p> <p>No aquatic habitat.</p>

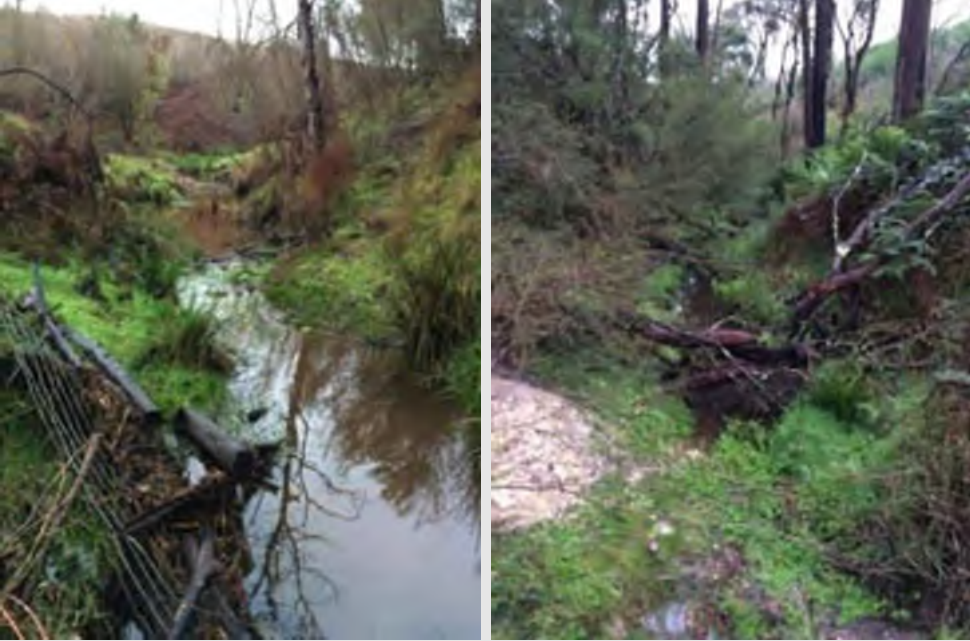
Site No.	Latitude	Longitude	Altitude (m)	Site Description	Site Photo
3	-37.791035	147.339704	90.7	<p>Perry Gully. Located in a moderately steep vegetated valley. Minor flow with small shallow pooled area. Some aquatic/bog/emergent vegetation indicating moderate periods of retained water/wetness. Site likely dry during lower rainfall periods, but retaining a small pooled area. Disturbance by stock access and some oily sheen. Minimal aquatic habitat.</p>

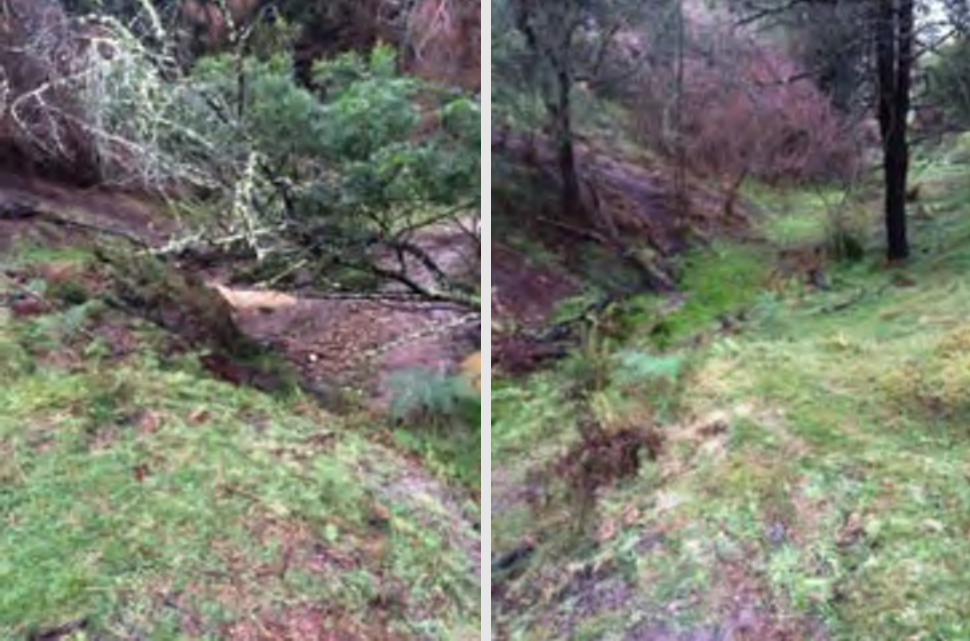
4	-37.790804	147.335707	102.7	<p>Perry Gully Located in a shallow partially vegetated valley. Valley opening up to pasture at higher elevations. No flow but small shallow turbid pools due to recent rain event and stock disturbance. Site likely dry unless immediately after rainfall events. Disturbance by stock access. Minimal aquatic habitat.</p>

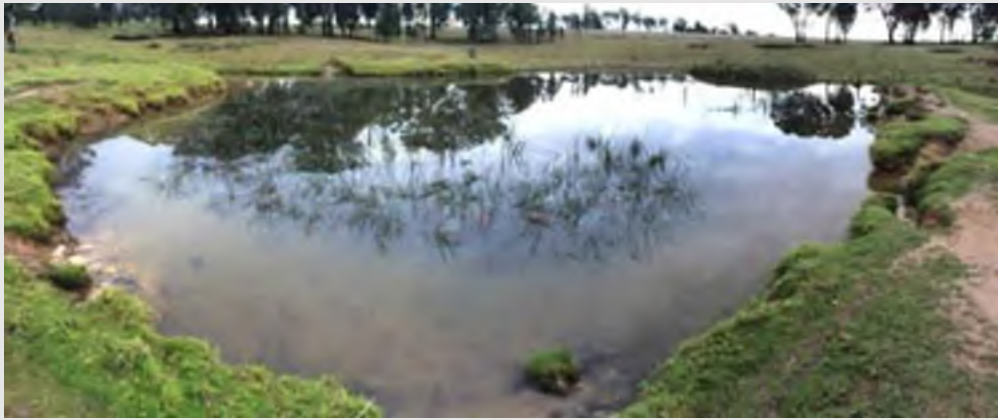
Site No.	Latitude	Longitude	Altitude (m)	Site Description	Site Photo
5	-37.792569	147.331255	120.3	<p>Dam on Perry Gully Located at upper extent of Perry Gully. Aquatic vegetation including <i>Azolla</i> sp. and <i>Eliocharis</i> sp. Potential aquatic fauna, however, connectivity to downstream water bodies limited due to steep valley and ephemeral nature of Perry Gully. Moderate aquatic habitat.</p>

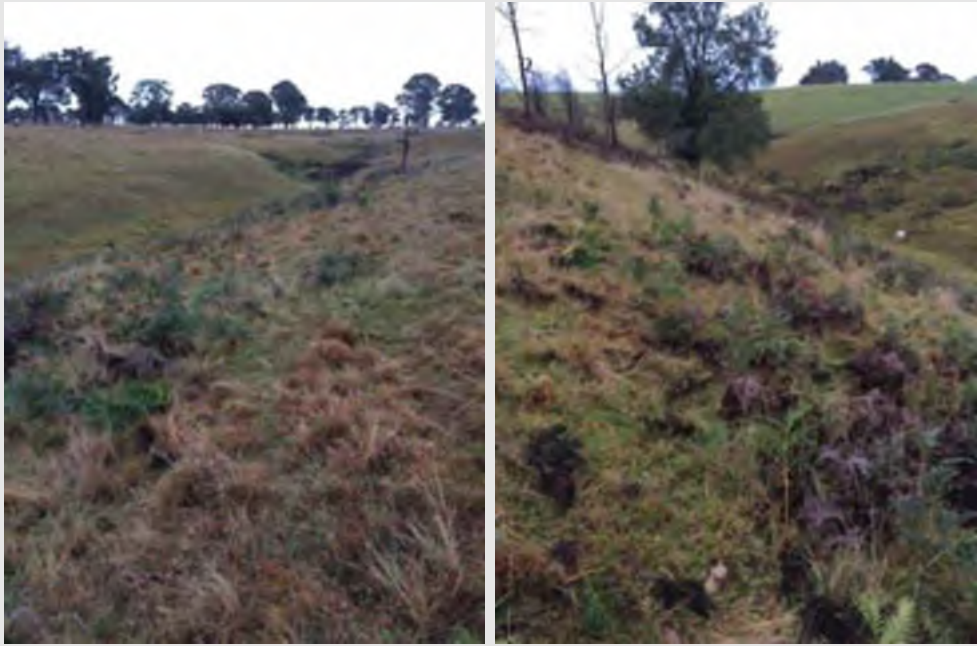
6	-37.797379	147.344934	112.4	<p>Simpson Gully. Shallow open valley at upper reach of waterway. Open pasture with stock access. No water despite recent rain. No aquatic habitat.</p>

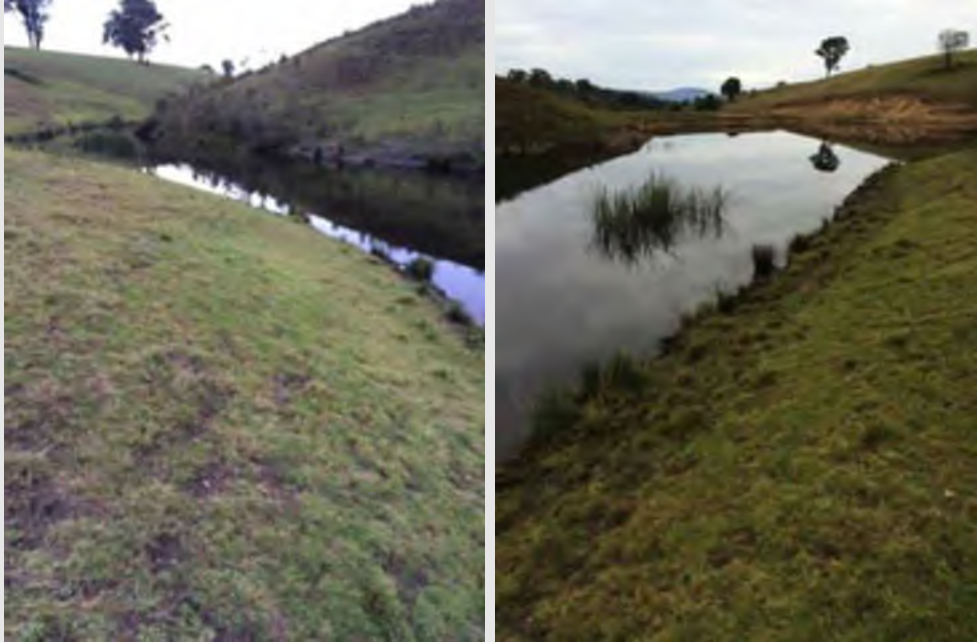
Site No.	Latitude	Longitude	Altitude (m)	Site Description	Site Photo
7	-37.797597	147.348981	98.9	<p>Dam on Simpson Gully. Shallow open valley. Aquatic vegetation including <i>Azolla sp.</i>, <i>Myriophyllum sp.</i> and <i>Eliocharis sp.</i> Significant erosion activity immediately downstream of dam. Potential aquatic fauna, however, connectivity to downstream water bodies limited due to steep valley and ephemeral nature of Simpson Gully. Moderate aquatic habitat.</p>

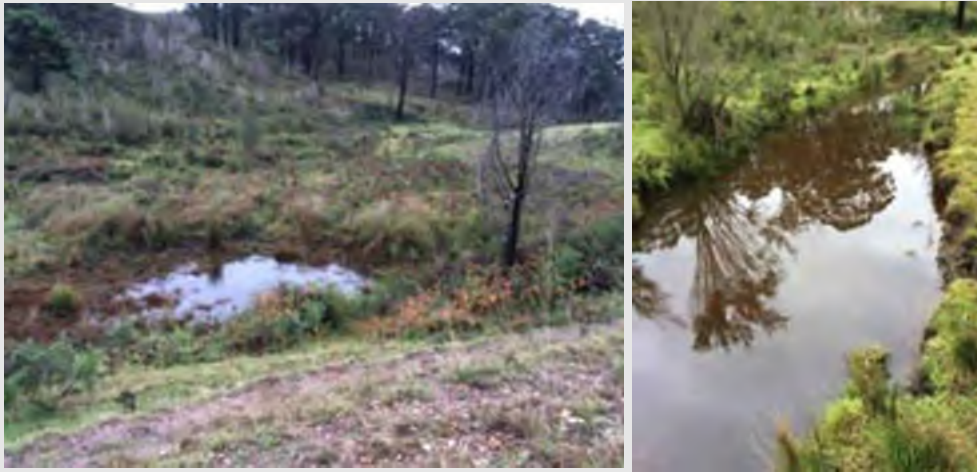
8	-37.795462	147.35406	86.9	<p>Simpson Gully. Shallow open valley with mix of remnant vegetation, pasture and grassland. Obvious impacts due to stock access. A number of wetland/pool areas, with aquatic/emergent/wetland flora species, indicating water may be present during drier times. Possible spring/groundwater fed. Some potential aquatic fauna. Minimal aquatic habitat.</p>

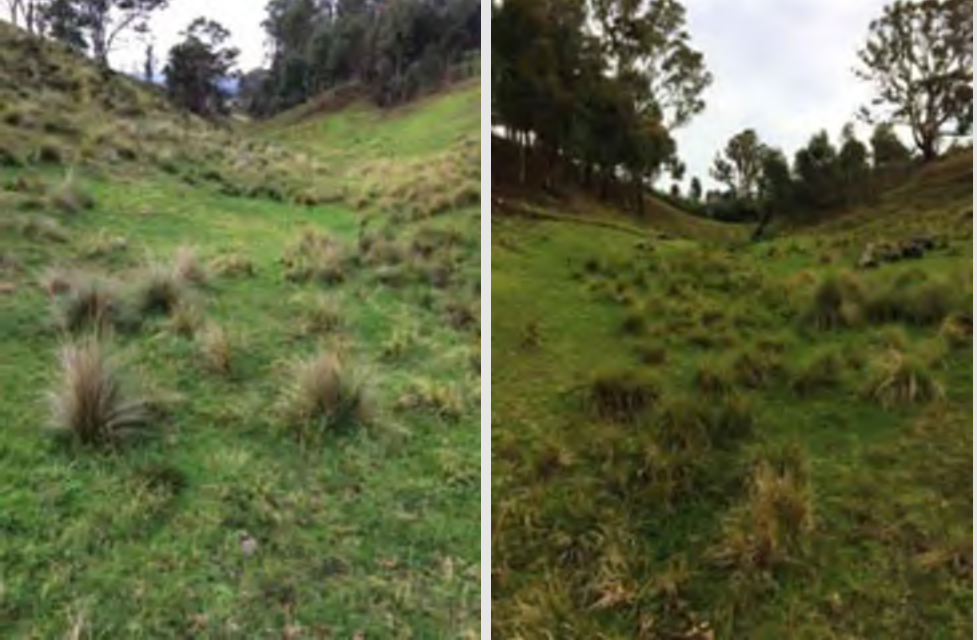
Site No.	Latitude	Longitude	Altitude (m)	Site Description	Site Photo
9	-37.786058	147.36027	71.3	Unnamed gully Shallow open valley. Open pasture with stock access. No water despite recent rain. Discharges directly to Mitchell River. No aquatic habitat.

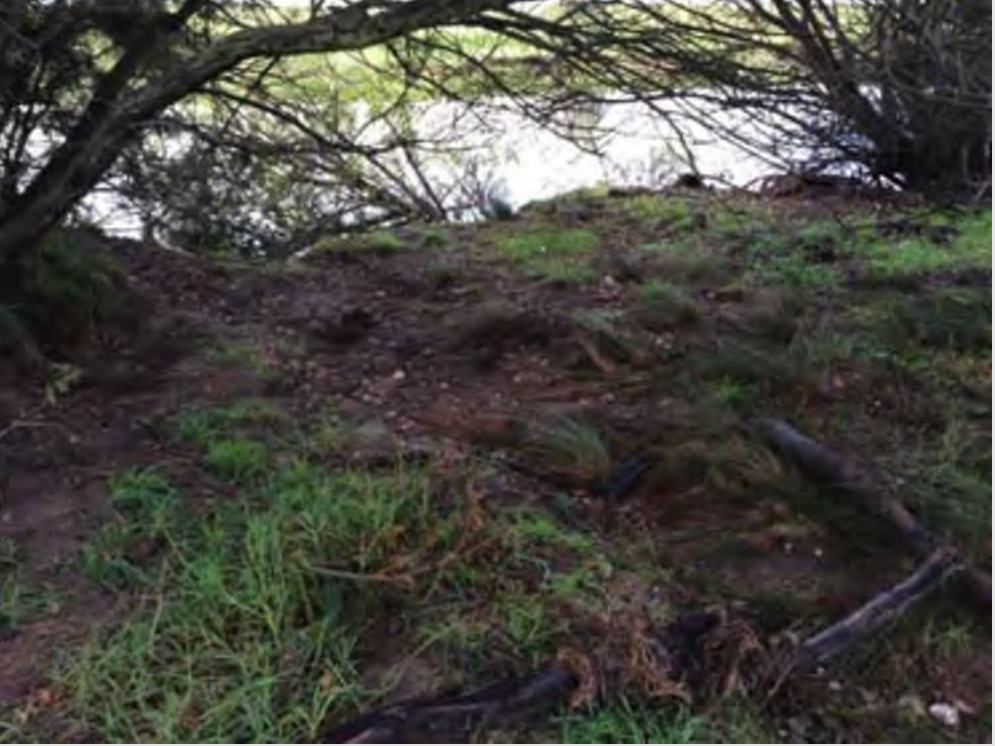
10	-37.780923	147.360191	42.8	Perry Gully discharge to Mitchell River. No flow but small shallow turbid pools due to recent rain event. Minimal aquatic habitat (excluding Mitchell River).

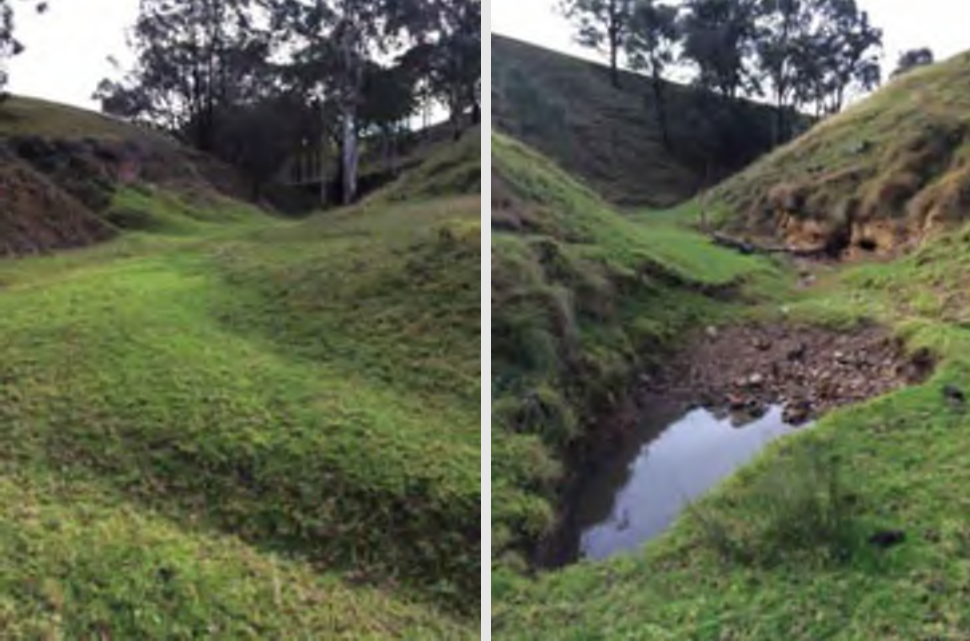
Site No.	Latitude	Longitude	Altitude (m)	Site Description	Site Photo
11	-37.782981	147.35834	48.2	<p>Perry Gully Located in a shallow open/grazed valley. No flow but small shallow turbid pools due to recent rain event. Site likely dry unless immediately after rainfall events. Disturbance by stock access. Minimal aquatic habitat.</p>

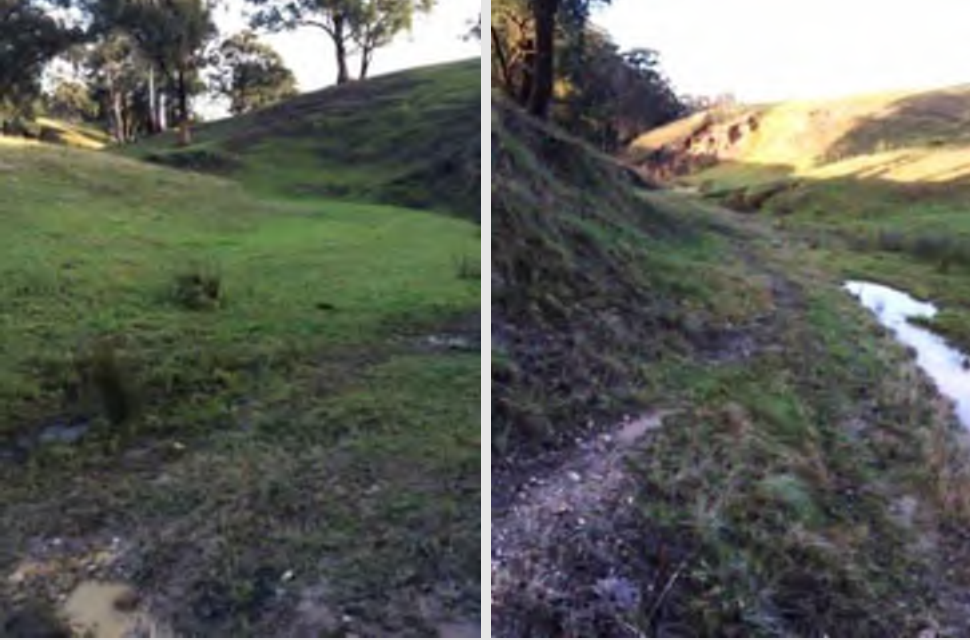
12	-37.783545	147.354954	55.6	<p>Perry Gully. Located in a shallow open/grazed valley. No flow but small shallow turbid pools due to recent rain event. Site likely dry unless immediately after rainfall events. Disturbance by stock access. Minimal aquatic habitat.</p>

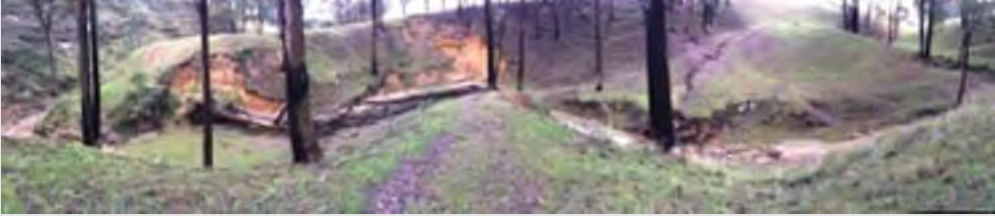
Site No.	Latitude	Longitude	Altitude (m)	Site Description	Site Photo
13	-37.790992	147.365294	71	<p>Simpson Gully. Most downstream site in Simpson Gully. Very steep gully with large areas of bank/bed erosion. Stock access. High levels of turbidity stemming from erosion points. Moderate aquatic habitat.</p>

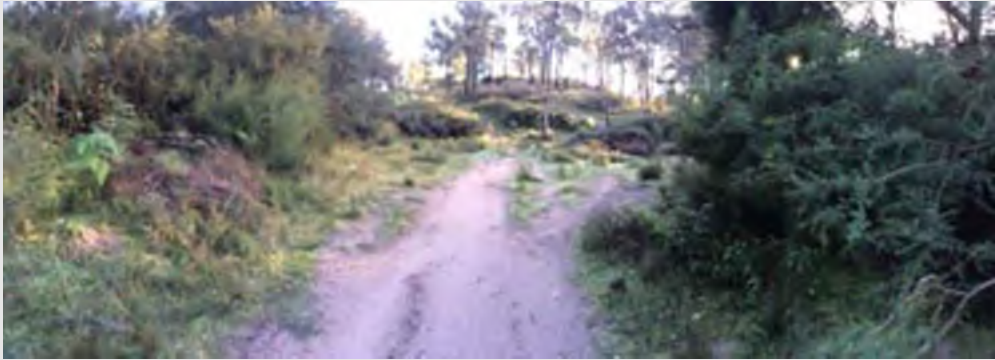
14	-37.804114	147.368299	79.4	<p>Lucas Creek. Shallow open valley at upper reach of waterway. Dense under/mid-story vegetation including weeds (namely Blackberry). Appears some earthworks/vegetation clearing has occurred. Stock access and obvious impacts. Undefined gullies, with multiple options for flow. No water despite recent rain. No aquatic habitat.</p>

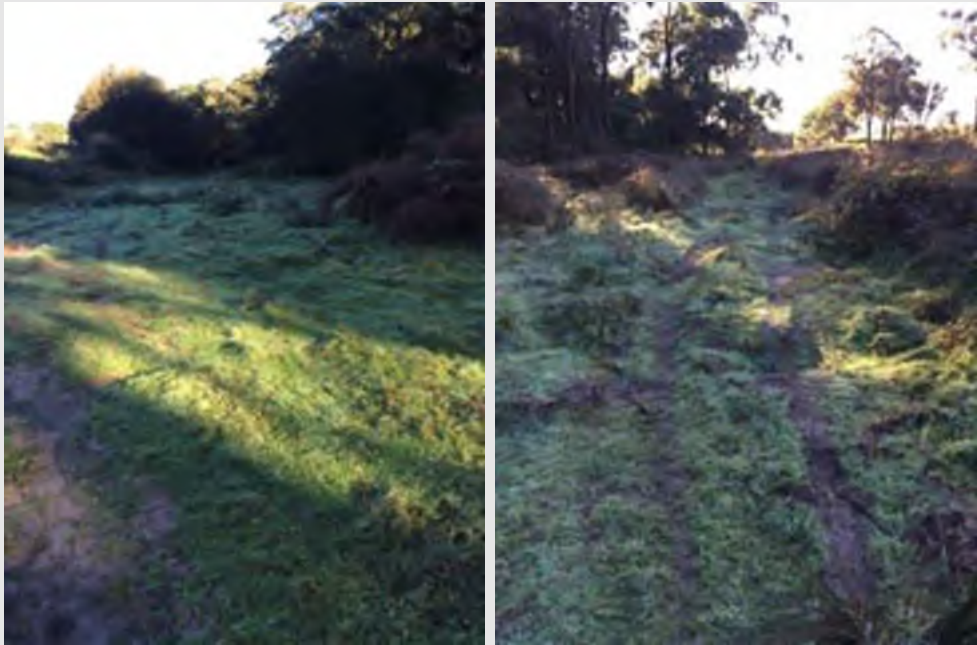
15	-37.803517	147.375571	70.3	<p>Lucas Creek. Shallow open valley at upper reach of waterway. Patchy under/mid-story vegetation including weeds (namely Blackberry) and pasture. Appears some earthworks/vegetation clearing has occurred. Stock access and obvious impacts. Undefined gully. No water despite recent rain. No aquatic habitat.</p>

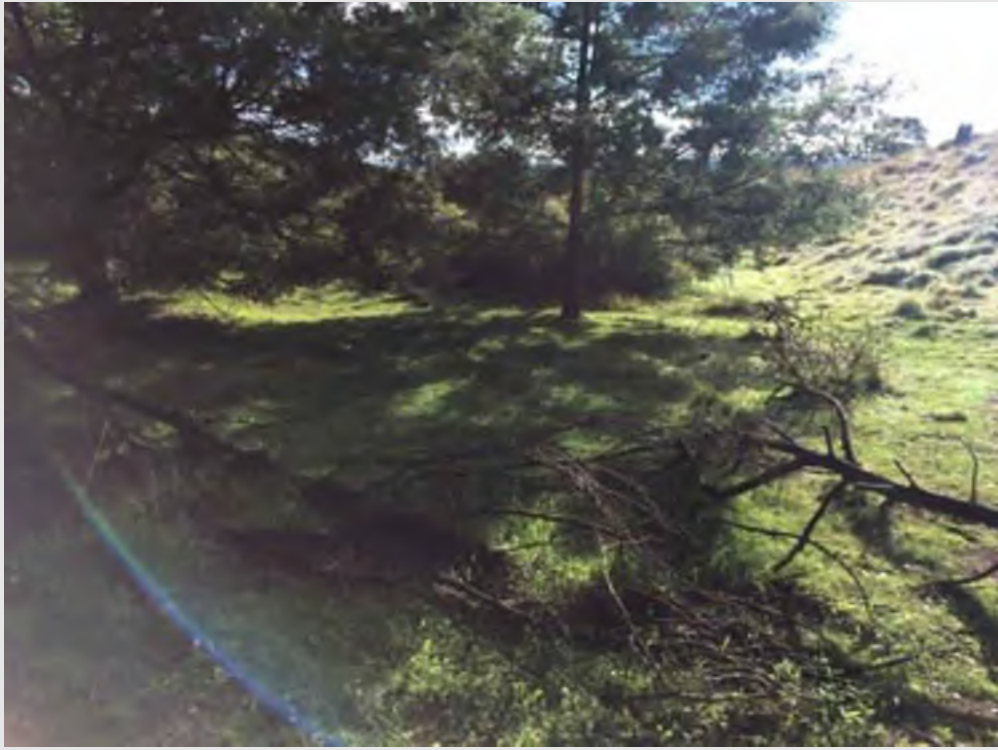
Site No.	Latitude	Longitude	Altitude (m)	Site Description	Site Photo
16	-37.805589	147.381697	80.3	<p>Lucas Creek tributary. Shallow open valley at upper reach of waterway. Patchy mid-story vegetation (Wattle) including weeds (Blackberry) and open pasture. Stock access. No water despite recent rain. No aquatic habitat.</p>

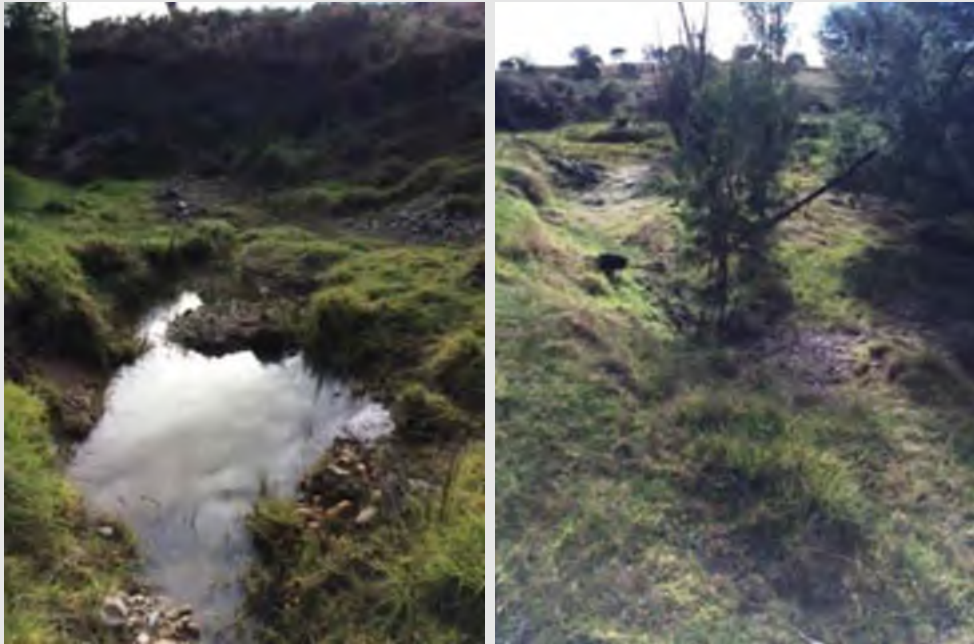
17	-37.799607	147.381186	58.6	<p>Lucas Creek Located in a shallow open/grazed valley. Patchy mid/understorey and mixed pasture grass species. No flow but small shallow turbid pools due to recent rain event. Site likely dry unless immediately after rainfall events. Disturbance by stock access. Minimal aquatic habitat.</p>

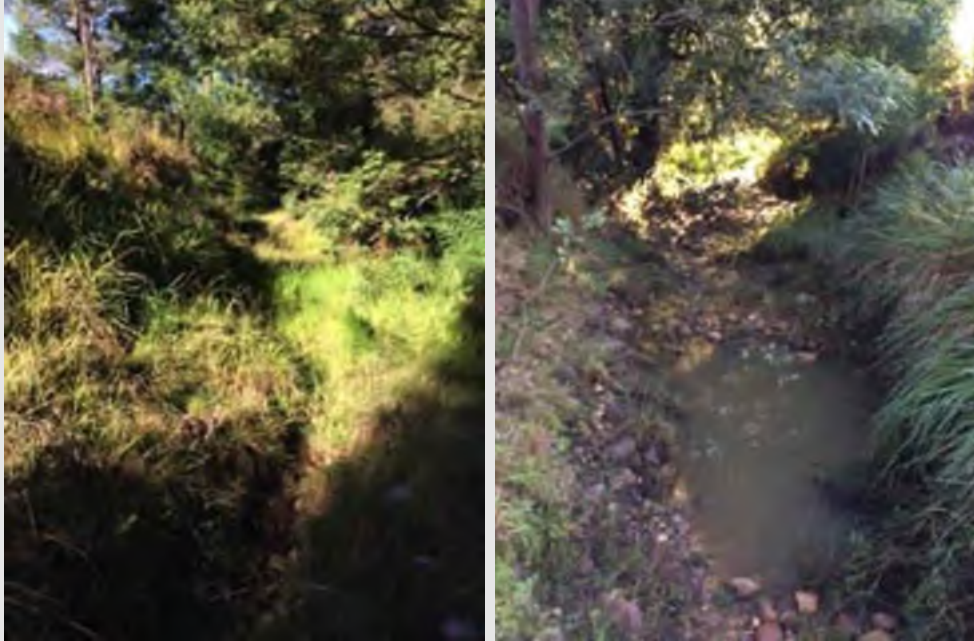
Site No.	Latitude	Longitude	Altitude (m)	Site Description	Site Photo
18	-37.794645	147.381139	45.8	<p>Lucas Creek</p> <p>Located in a shallow open/grazed valley.</p> <p>Patchy/dense mid/under story and some mixed pasture grass species.</p> <p>No flow but small shallow turbid pools due to recent rain event.</p> <p>Site likely dry unless immediately after rainfall events.</p> <p>Disturbance by stock access.</p> <p>Unlikely to support significant aquatic fauna.</p> <p>Minimal aquatic habitat.</p>

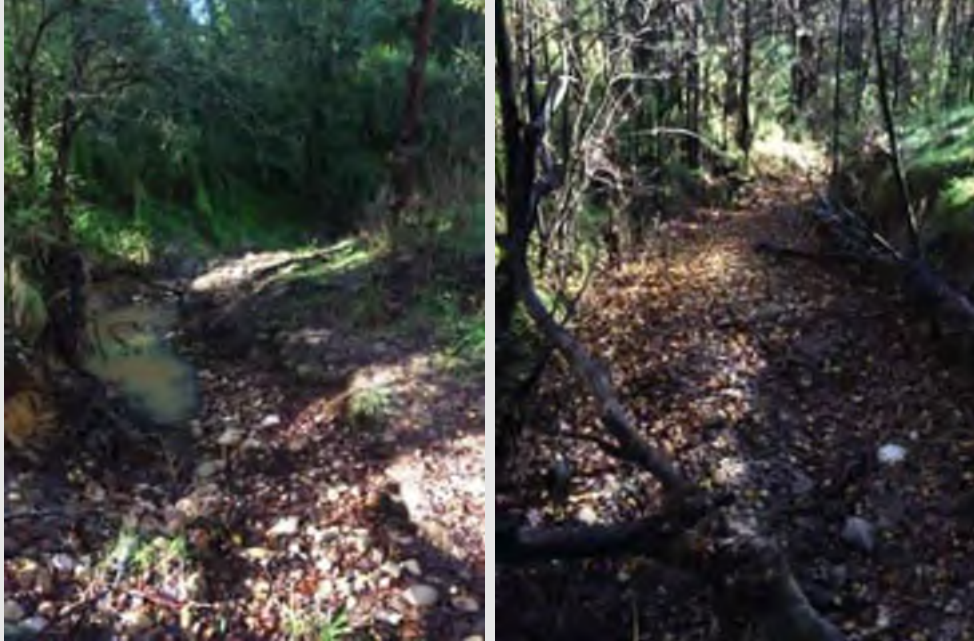
19	-37.790495	147.383975	38.7	<p>Lucas Creek</p> <p>Dense weedy over storey with weedy understorey (mostly pasture grasses and Blackberry).</p> <p>No flow but small shallow turbid pools due to recent rain event.</p> <p>Pools characterised by pebbles indicating flow events are rapid and eroding of smaller/finer sediments.</p> <p>Site likely dry unless immediately after rainfall events.</p> <p>Unlikely to support significant aquatic fauna.</p> <p>Minimal aquatic habitat.</p>

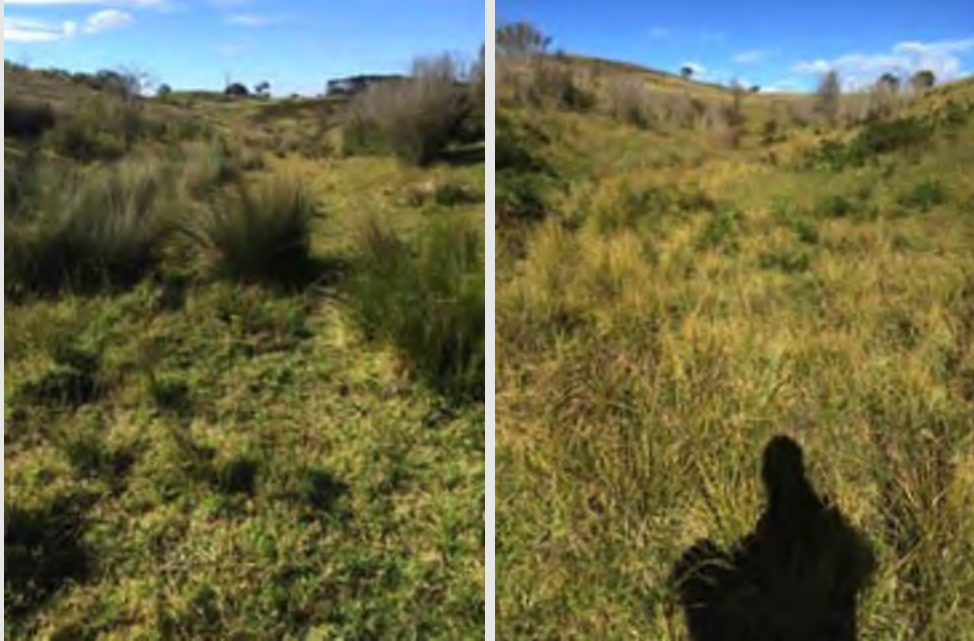
Site No.	Latitude	Longitude	Altitude (m)	Site Description	Site Photo
20	-37.782137	147.337523	73.2	<p>Tributary of Moilun Creek Shallow open valley with open pasture and rushes. Stock access. No water despite recent rain. No aquatic habitat.</p>

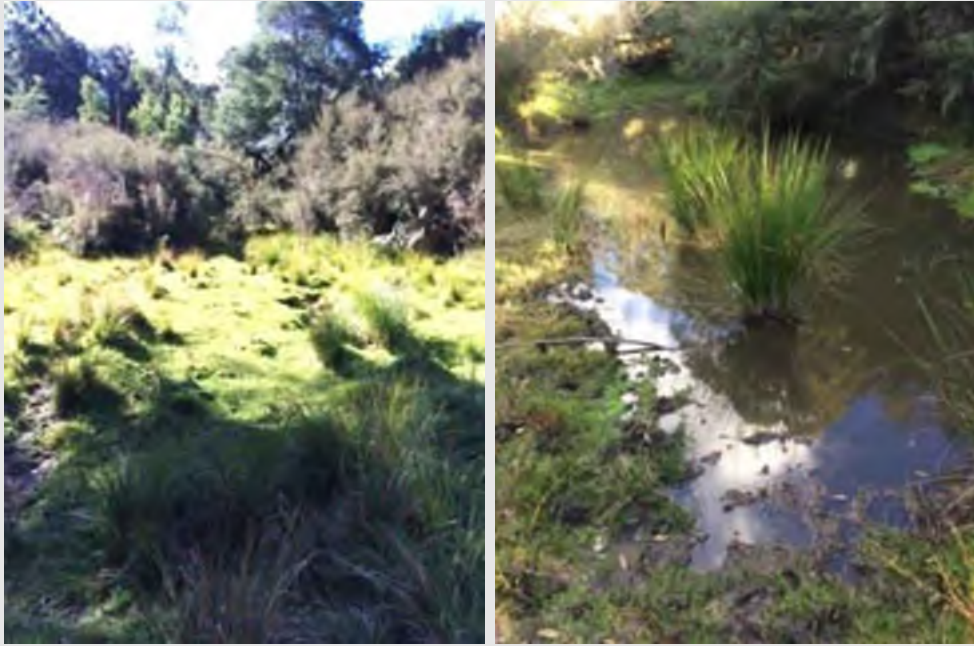
21	-37.78377	147.33452	80.6	<p>Tributary of Moilun Creek Shallow open valley with open pasture and rushes. Stock access. Overgrown pool with aquatic/emergent vegetation indicating retains water for some time. Unlikely to support significant aquatic fauna. Minimal aquatic habitat.</p>

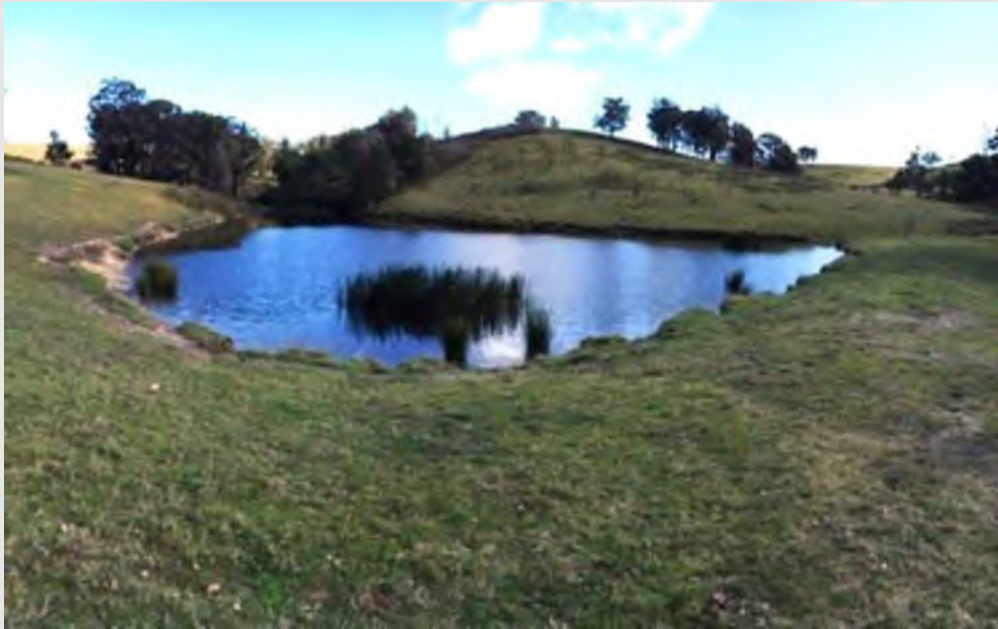
Site No.	Latitude	Longitude	Altitude (m)	Site Description	Site Photo
22	-37.784767	147.332513	91.9	<p>Dam on tributary of Moilun Creek Shallow open valley. Aquatic vegetation including <i>Azolla sp.</i>, <i>Myriophyllum sp.</i> and <i>Eliocharis sp.</i> Potential aquatic fauna, however, connectivity to downstream water bodies limited due to steep valley and ephemeral nature of the gully. Moderate aquatic habitat.</p>

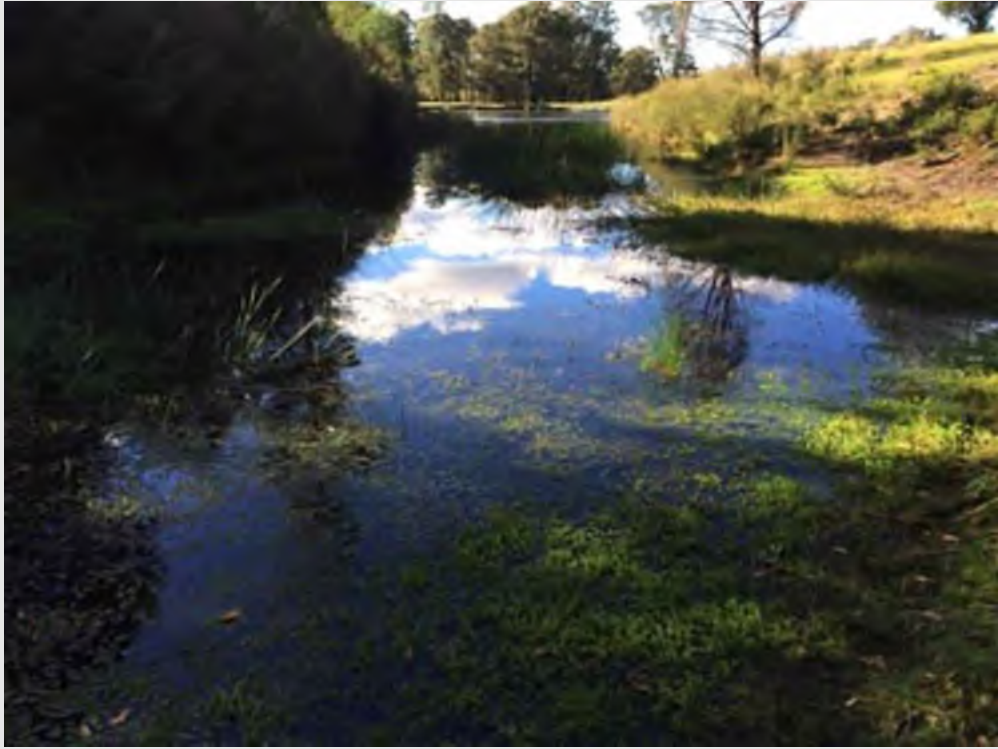
23	-37.804024	147.305075	114.5	<p>Dam on tributary of Honeysuckle Creek. Large number of calling frogs (<i>Crinia sp.</i>) indicating waterway supports aquatic fauna. Likely retains water through drier periods. Supports aquatic fauna including frogs and possibly fish. Connectivity to downstream water bodies not clearly delineated and not obvious at Sites 28-30 during survey. Good aquatic habitat.</p>

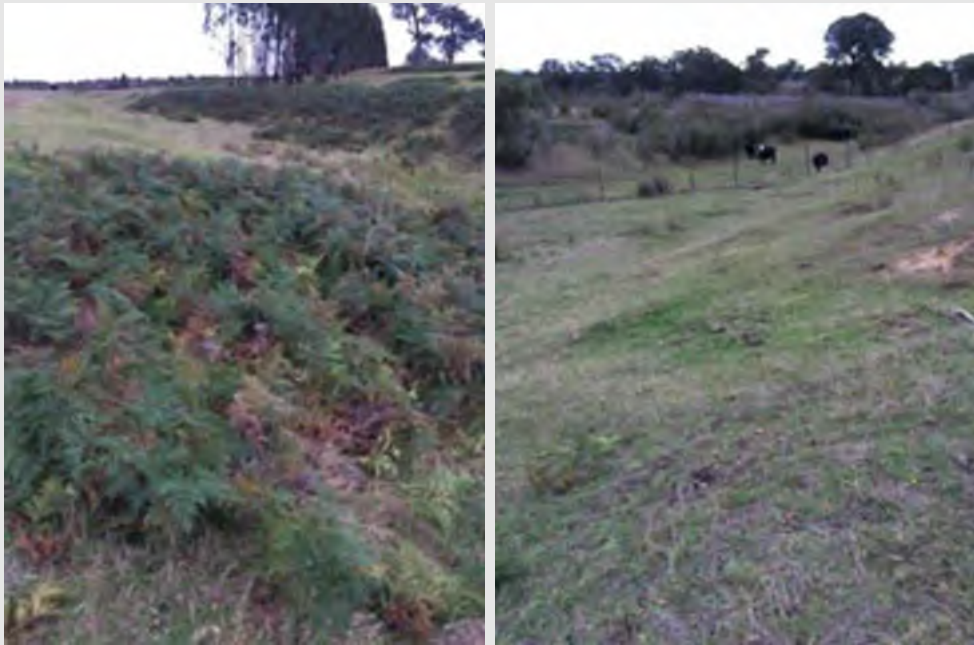
Site No.	Latitude	Longitude	Altitude (m)	Site Description	Site Photo
27	-37.791014	147.318594	126.4	<p>Tributary of Moilun Creek Shallow open valley with open pasture and rushes. Stock access. No water despite recent rain. No aquatic habitat.</p>

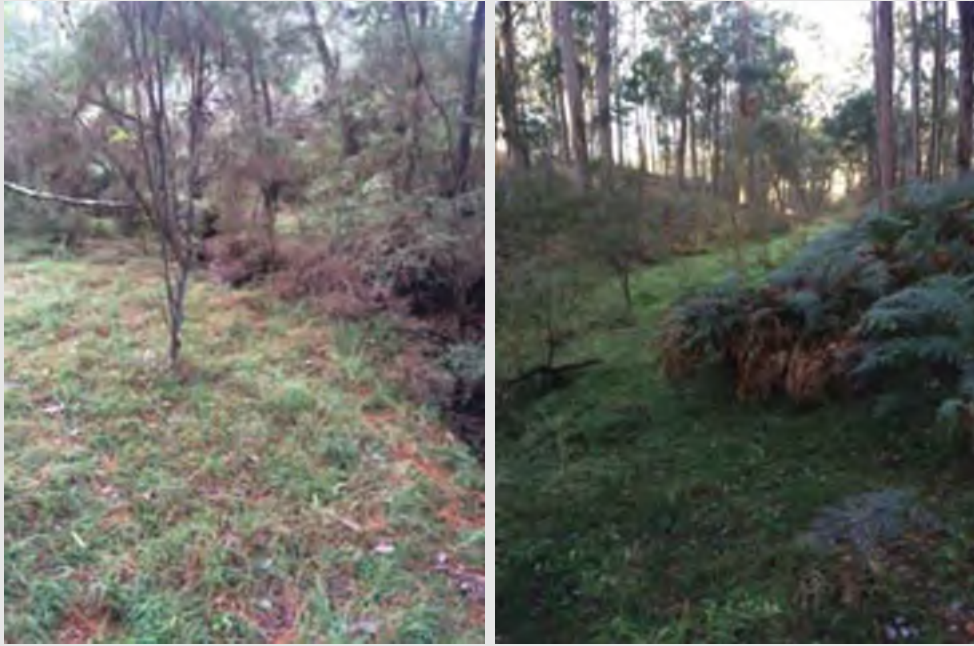
28	-37.8713	147.292351	81.1	<p>Tributary of Honeysuckle Creek Most downstream site on this waterway. No obvious surface water, suggesting water/flow observed upstream goes below ground through pine plantation. Large unsighted dam downstream of this site. No water. No aquatic habitat.</p>

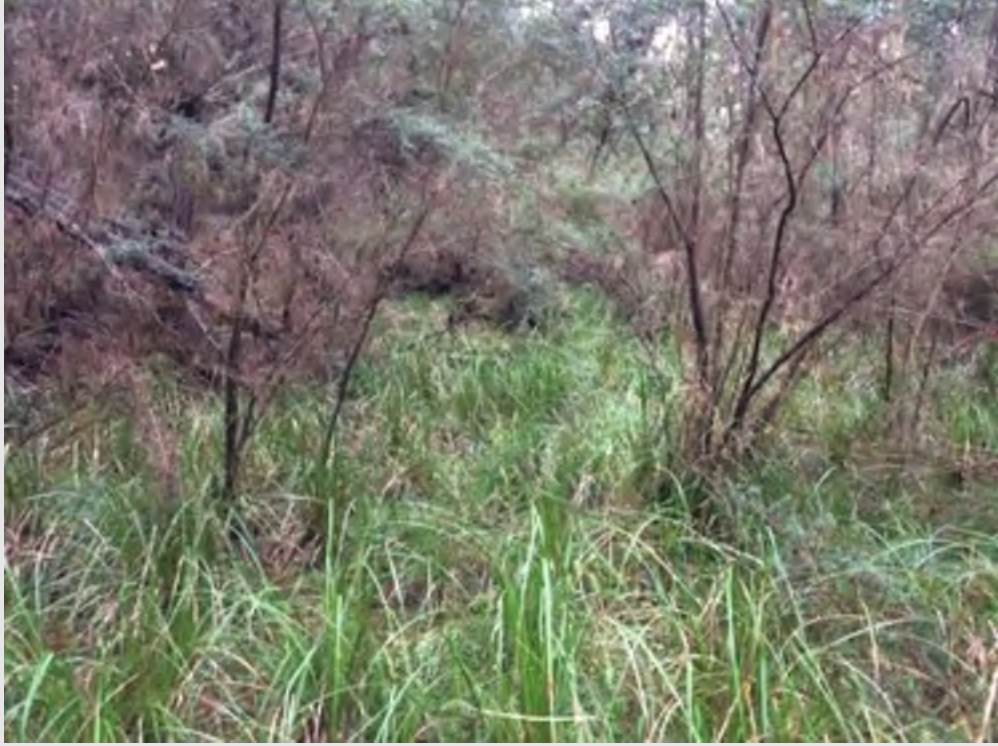
Site No.	Latitude	Longitude	Altitude (m)	Site Description	Site Photo
29	-37.81463	147.290779	100.8	<p>Tributary of Honeysuckle Creek Set in pine plantation No obvious surface water, suggesting water/flow observed upstream goes below ground through pine plantation. Large unsighted dam downstream of this site. No water. No aquatic habitat.</p>

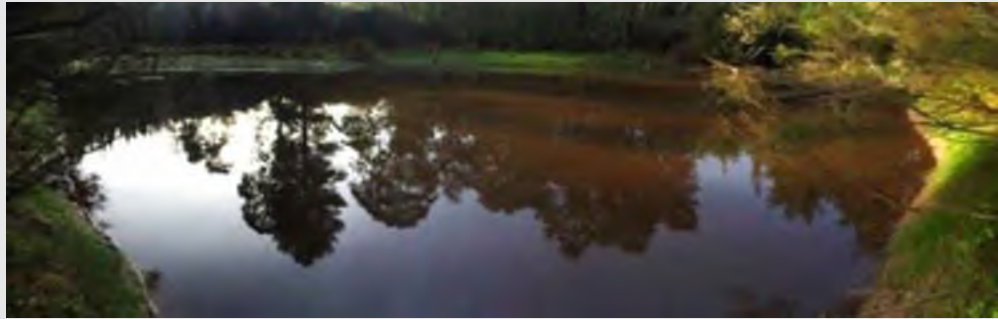
30	-37.808011	147.293543	99.2	<p>Dam on tributary of Honeysuckle Creek Track-side dam formed by track bund. Set in dense mid-story vegetation with weeds (Blackberry) within pine plantation. Limited stock and wildlife access. Aquatic vegetation characterised by <i>Triglochin sp.</i> Moderate aquatic habitat.</p>

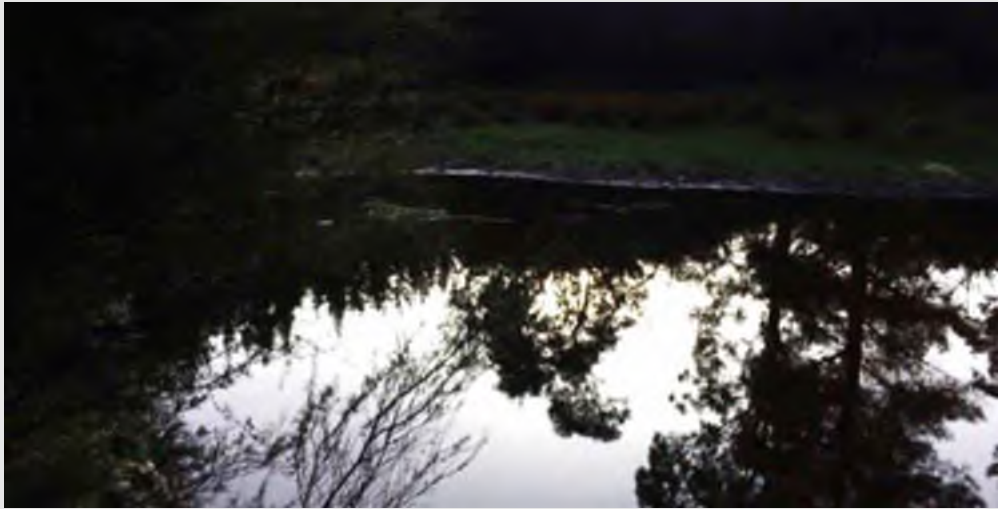
Site No.	Latitude	Longitude	Altitude (m)	Site Description	Site Photo
31	-37.802754	147.296918	110.3	<p>Dam on tributary of Honeysuckle Creek Track-side dam. Track-side dam formed by track bund. Set in dense mid-story vegetation with weeds (Blackberry) within pine plantation. Limited stock and wildlife access. Aquatic vegetation characterised by <i>Triglochin sp.</i> Moderate aquatic habitat.</p>
