## **Delburn Wind Farm, Gippsland Victoria**

### *Desktop Assessment of Potential Geotechnical, Contaminated Land and Hydrogeological Constraints*

19130636-001-Rev0

26 November 2019

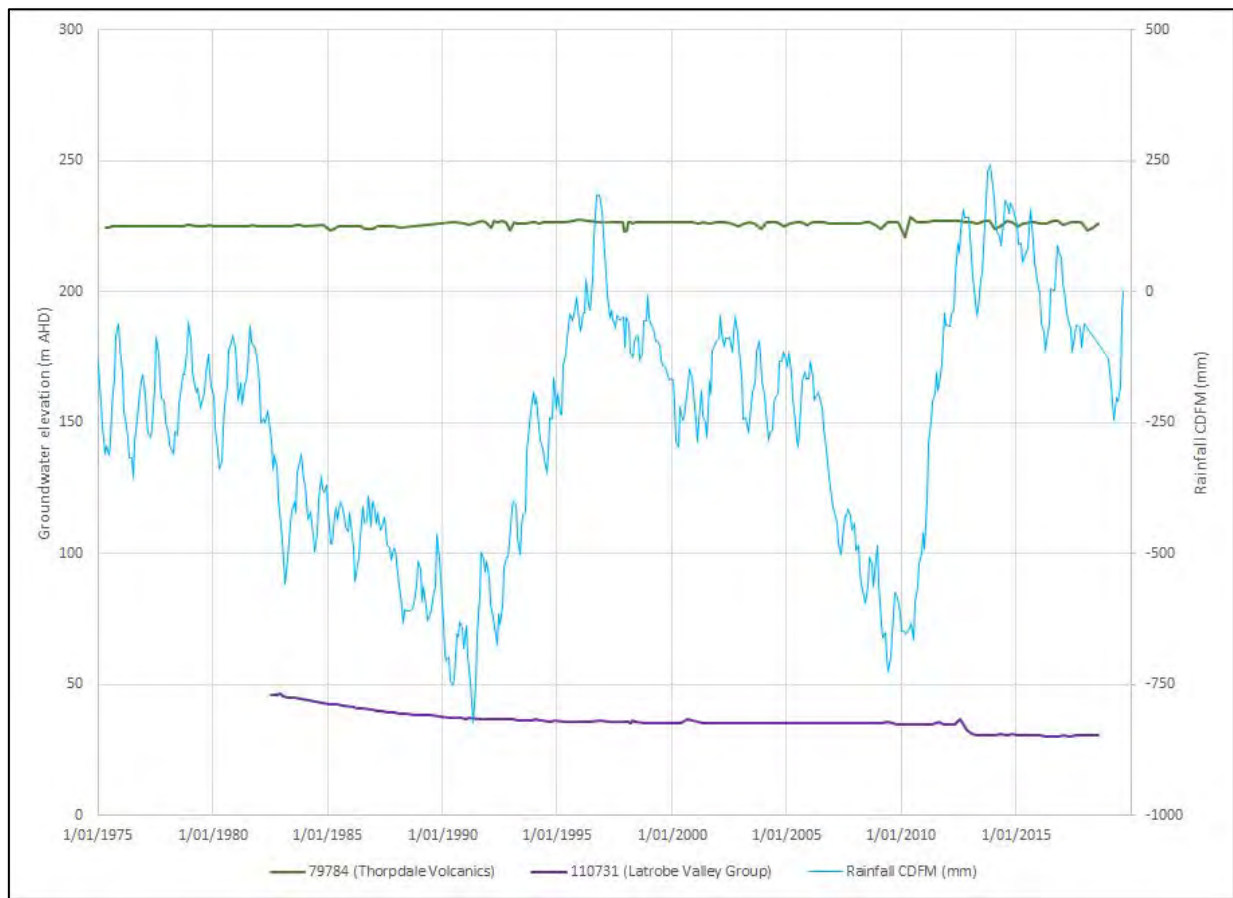
**Plate 2: Groundwater level at registered wells**

Bore 110731, located approximately 2.5 km to the east of the project area, is recorded as 200 m deep, but the screened interval and lithology is not reported. Based on the surface geology and depth, this bore is likely to intersect the Latrobe Valley Group. A declining in groundwater level of approximately 9 m was recorded between 1982, when the well was installed, and 2000. Groundwater level then remained relatively stable from 2000 to 2012, declined by approximately 4 m from 2012 to 2013, then remained relatively stable to 2018. The most recent groundwater level recorded (August 2018) indicates a depth to water of approximately 62 m, corresponding to an elevation of approximately 30 m AHD.

Bore 79784, located approximately 4.9 km to the west, is screened from 21 m bgl to 37 m bgl, within the Thorpdale Volcanics. The groundwater level has remained relatively stable over the period of monitoring (from 1975 to 2018). The most recent groundwater level (August 2018) records indicate groundwater to be approximately at the ground surface level, corresponding to an elevation of 226 m AHD.

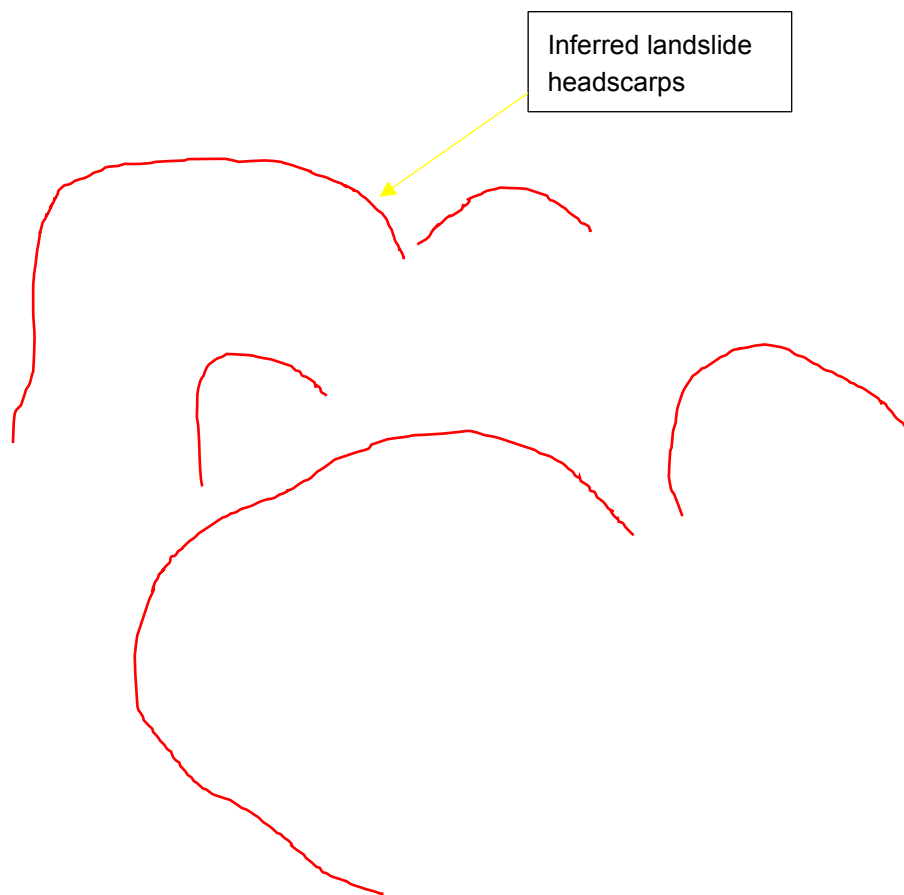
**Plate 3: Example of inferred landslide within project area**

Review of the digital terrain model by a principal engineering geologist has been undertaken to identify areas that appear to have been subject to previous slope instability. The residual soils of the Thorpdale Volcanics are known to be susceptible to landslides, with several landslides previously occurring around the Thorpdale area. Relict landslides have been identified based on indications in the digital terrain model, similar to that presented in Plate 3.

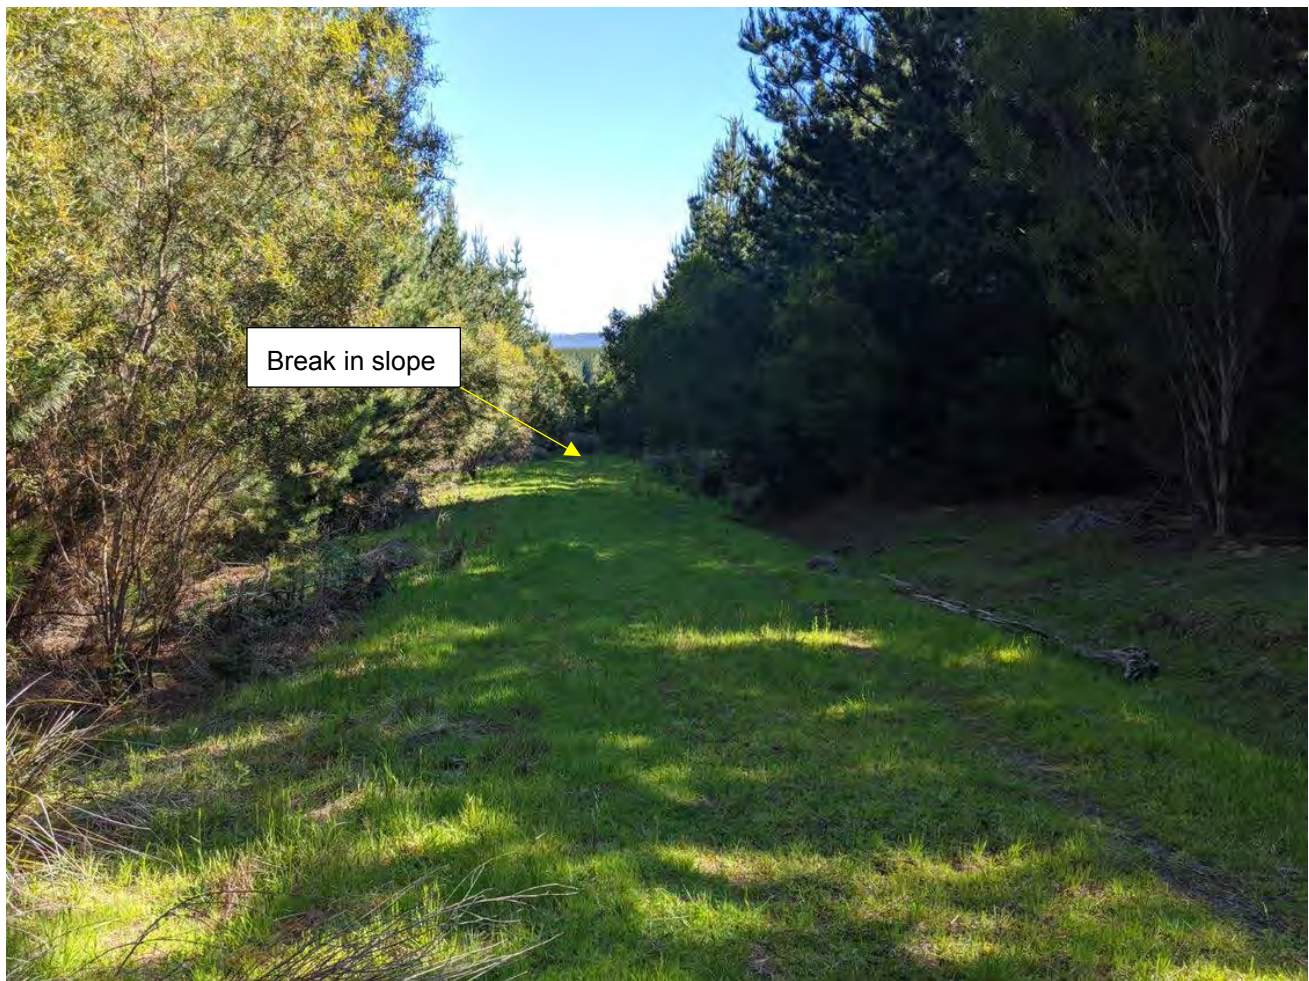
**Plate 4: Example of stepped ground, track into WTG41**

Field visit suggested that whilst there is evidence for past large scale landslide activity, there is no evidence for recent large scale landslide activity. Slightly hummocky and stepped ground observed in some locations appears to be indicative of historical landslides, probably thousands of years old. An example of stepped ground is presented in Plate 4 where the distance between breaks in slope is several hundred metres.

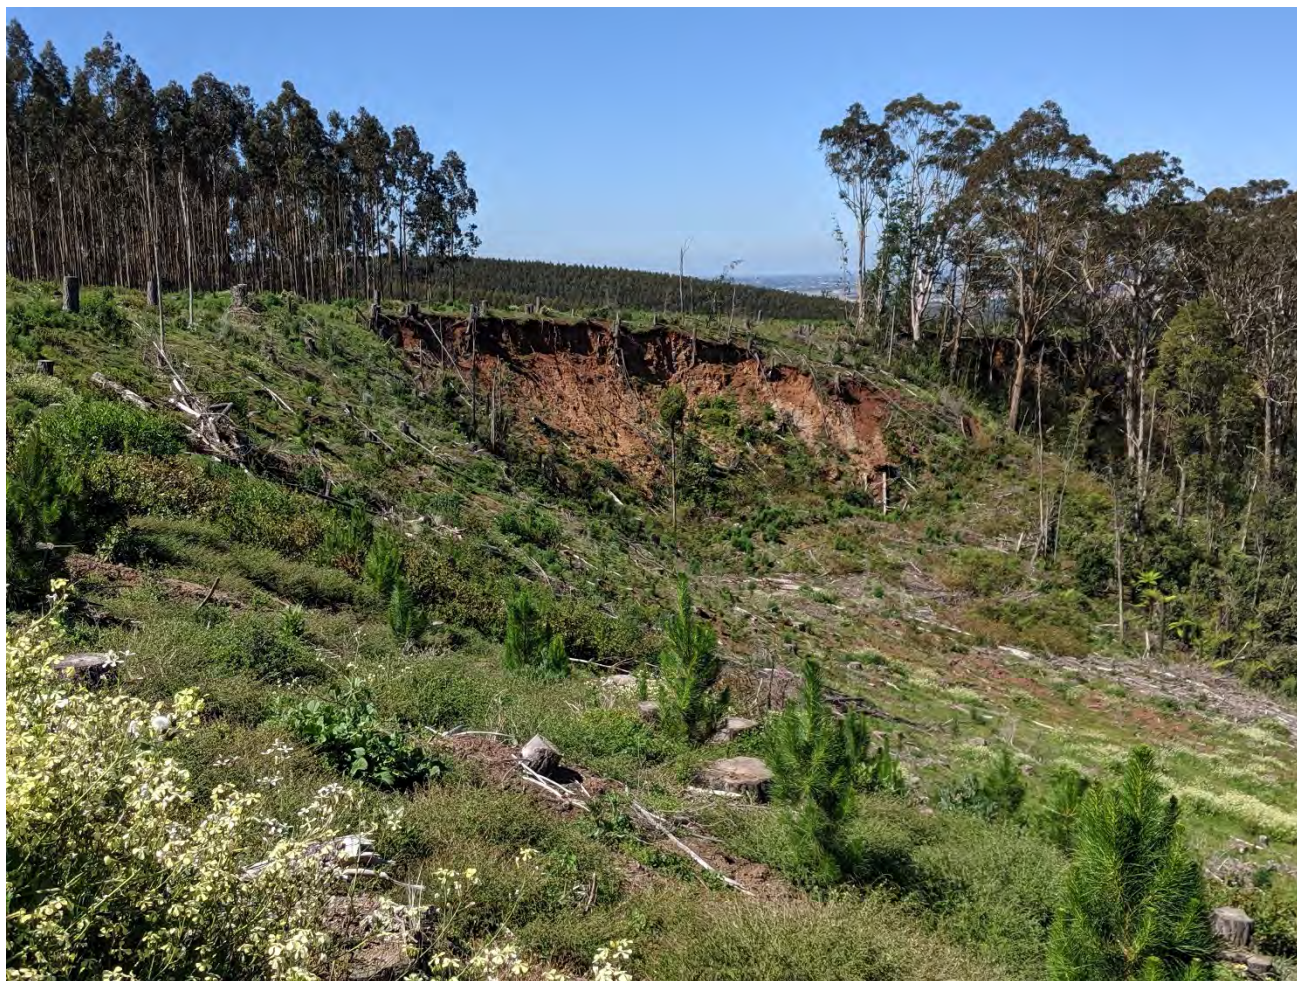
**Plate 5: Example of recent landslide, traverse between WTG 8 and WTG 9**

One example of a recent landslide was observed whilst traversing between WTG 8 and 9, noting that the landslide was not observed to be at a WTG location. The landslide was observed to be about 30 m wide and had occurred on an approximately 30 degree slope, noting that this is one of the steepest slopes within the proposed wind farm area.

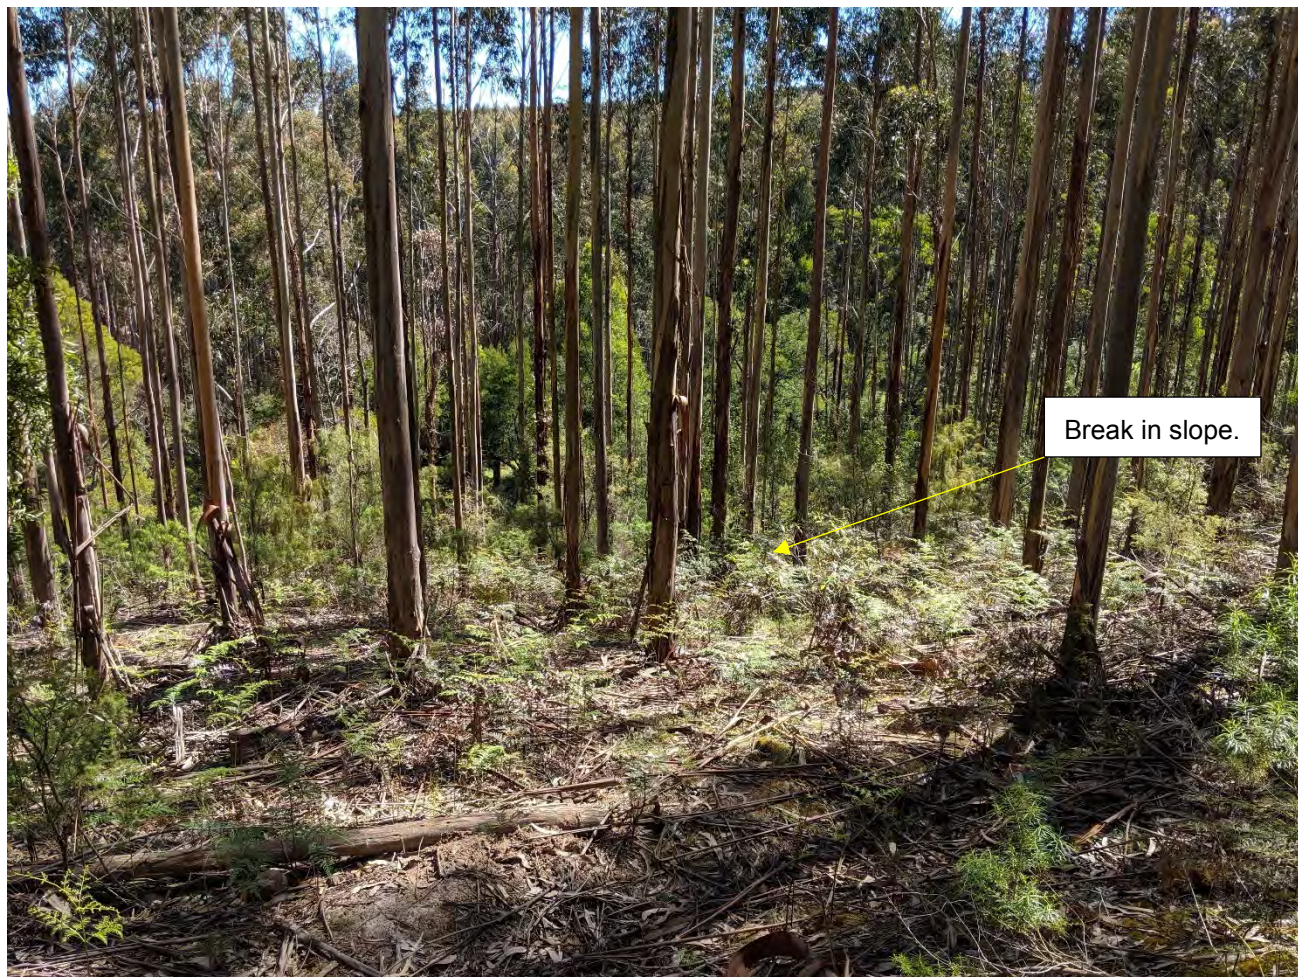
There is some evidence for previous landslide movement about 50 m to the south west of the proposed WTG location, however not within the inferred zone of influence of the proposed WTG. The slope angle in this area is about 10° and there is no evidence for recent landslide movement.

*View towards south west of WTG07 showing break in slope and irregular surface characteristic of past landslide movement.*

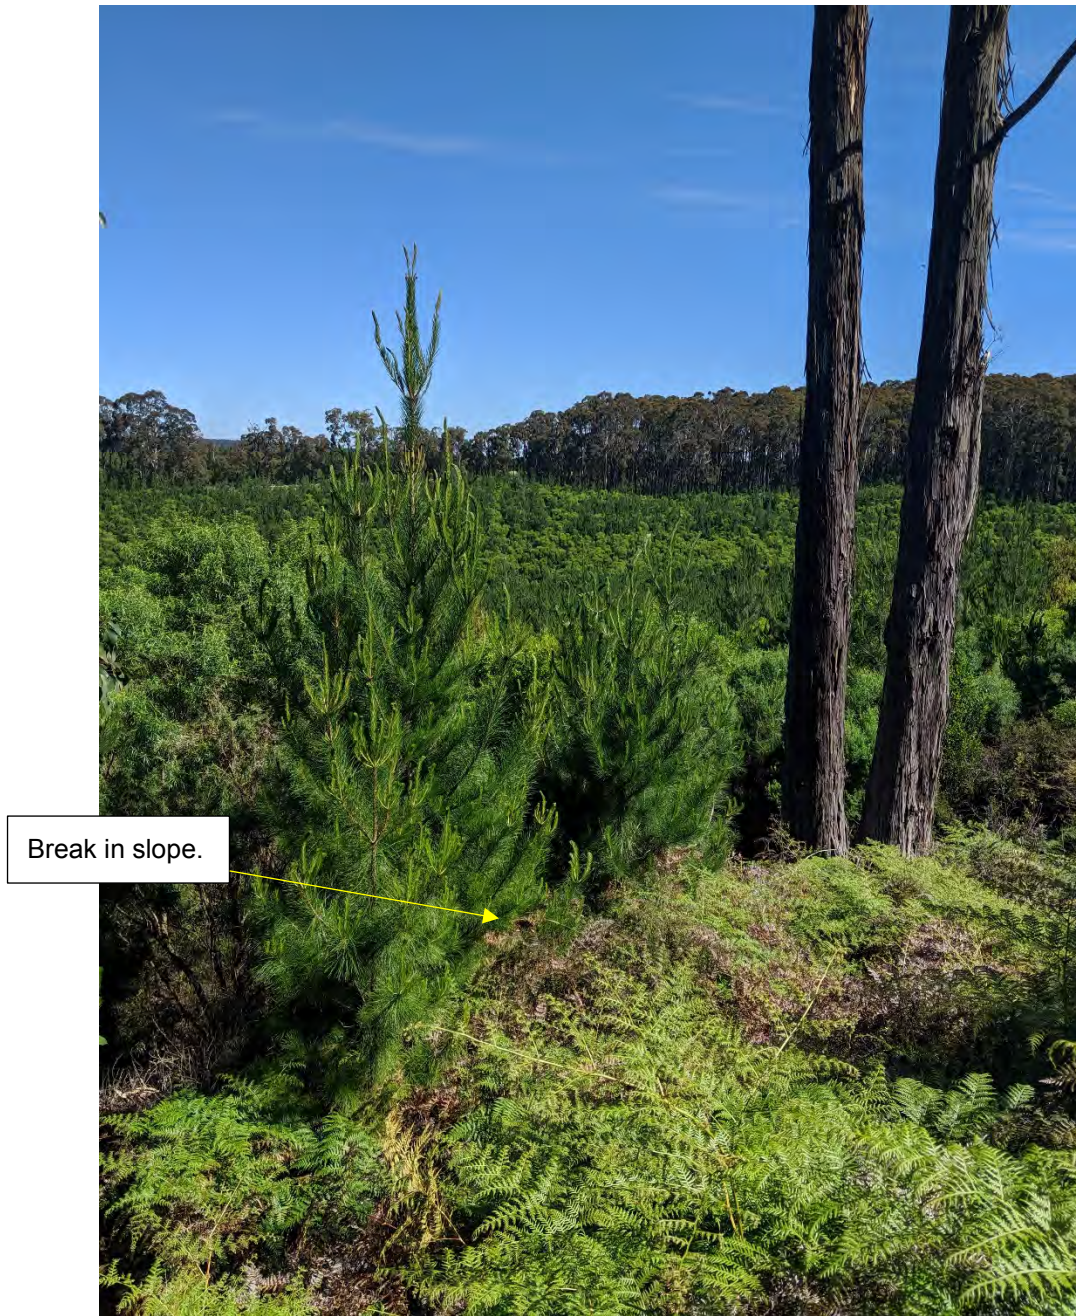
There is evidence for past landslide movement to the south of the proposed location of WTG09. Based on the presence of mature vegetation and subdued or 'rounded' morphology of the landscape, the landslide movement is inferred to be relict. No evidence of recent landslide was observed.

*View to south from near proposed location of WTG09, showing break in slope due to inferred relict landslide activity.*

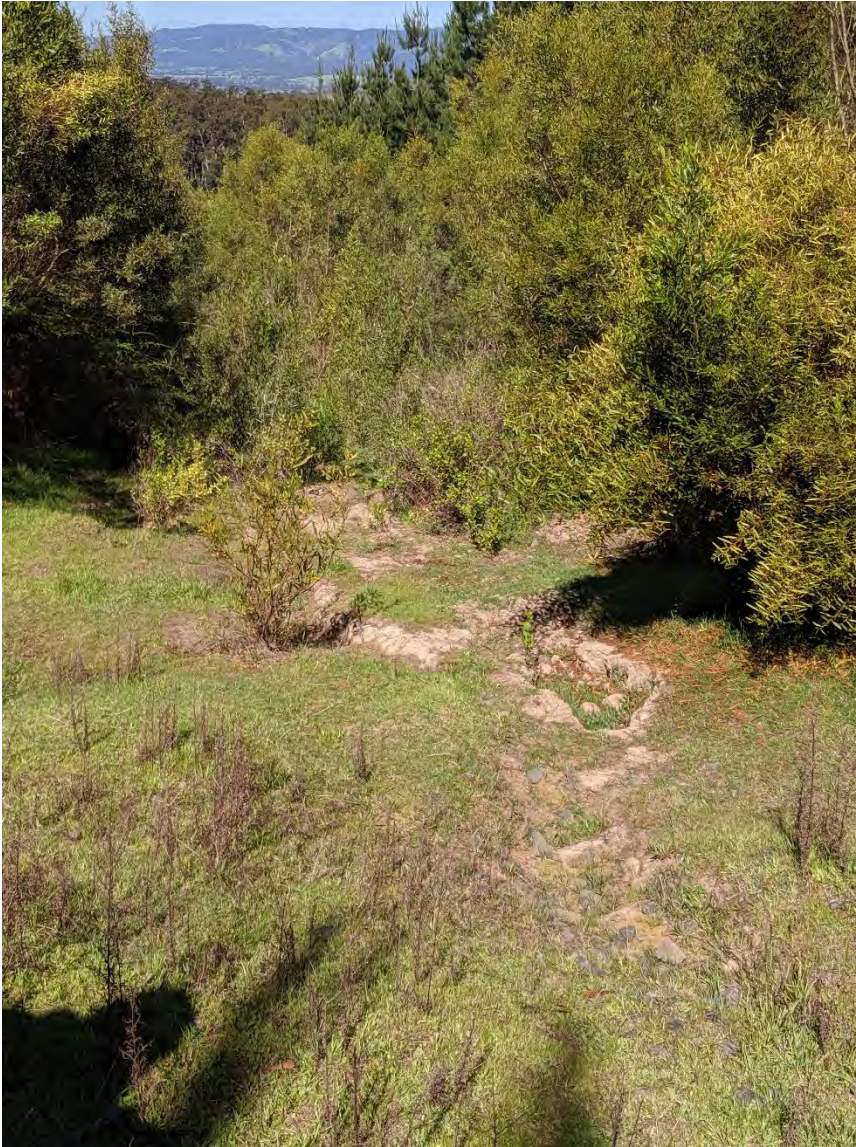
There is irregular and hummocky ground at the proposed turbine location indicative of past large scale landslide movement. However, the slope angle is about 8° and there is no evidence for recent landslide movement. There is also minor evidence of shallow erosion.

*View to east from WTG38 location showing irregular ground surface with some evidence of shallow erosion*

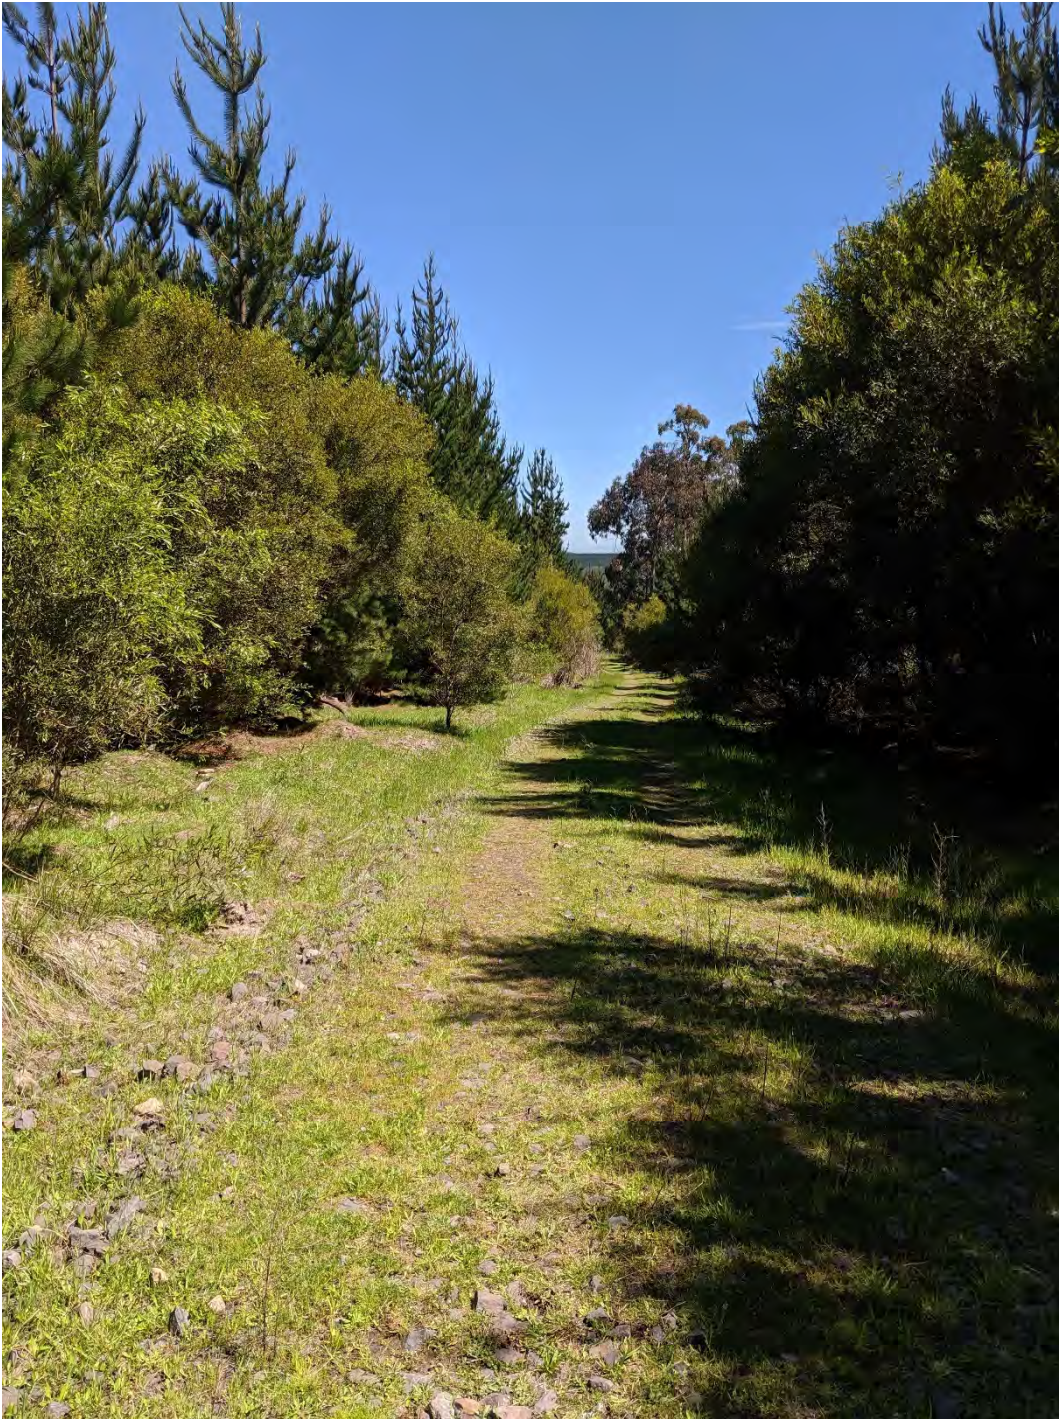
The ground at the location of WTG39 has some irregularity, however has a slope angle of about 6° and does not show evidence for recent slope instability.

*View to north showing relatively flat ground near proposed location of WTG39*

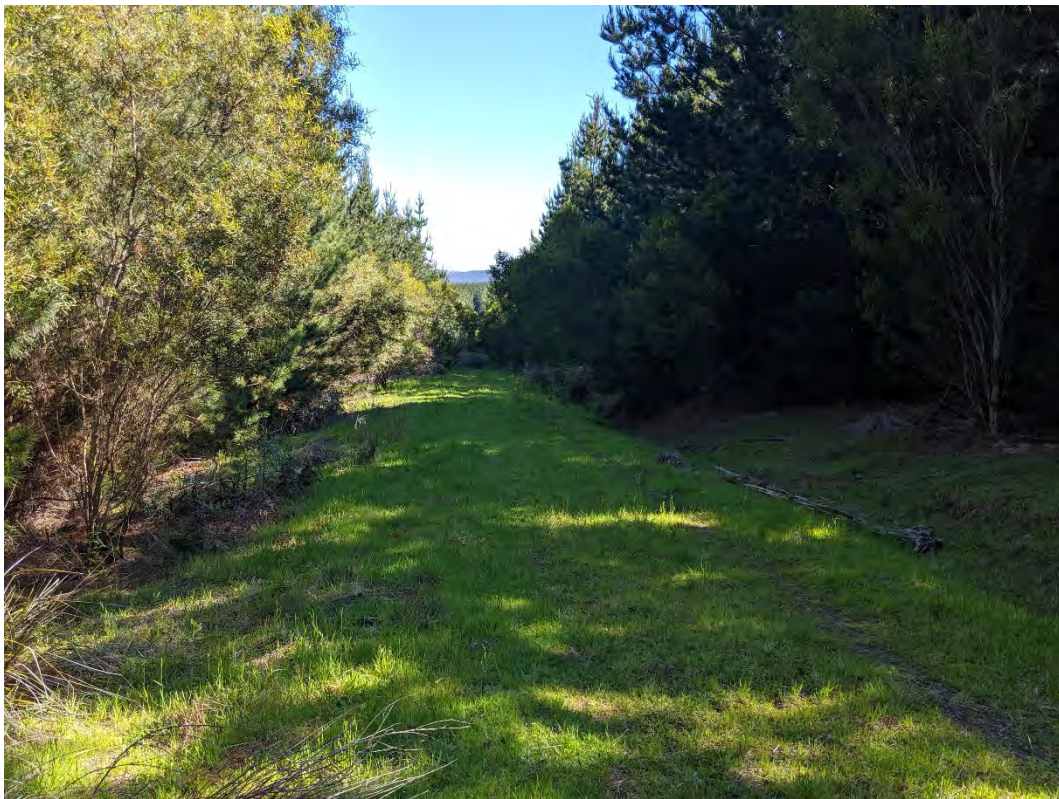
Slightly irregular terrain, possibly indicative of past landslide was observed at the location of WTG41. However the slope angle is 6° to 7° and there is no evidence for recent slope instability.

*Slope near WTG41 showing relatively flat, slightly irregular slopes.*

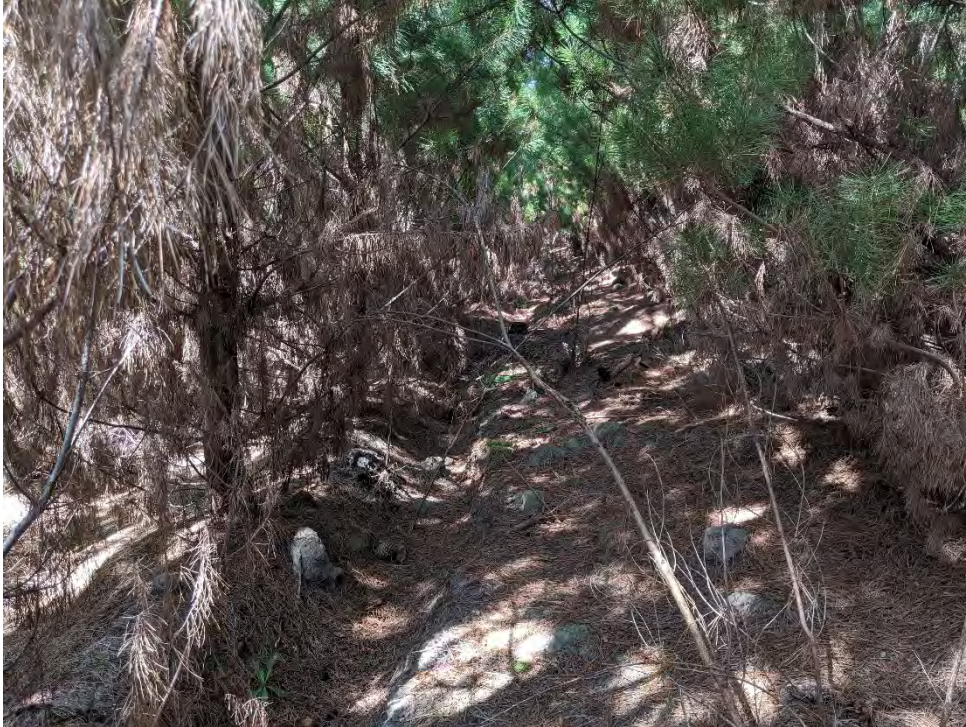
Slightly irregular slopes were observed at the location of WTG45. Ground to the east of the proposed WTG location is furrowed. There appears to be no evidence for recent slope instability.

*Slope to the east of WTG45 location showing furrowed ground.*

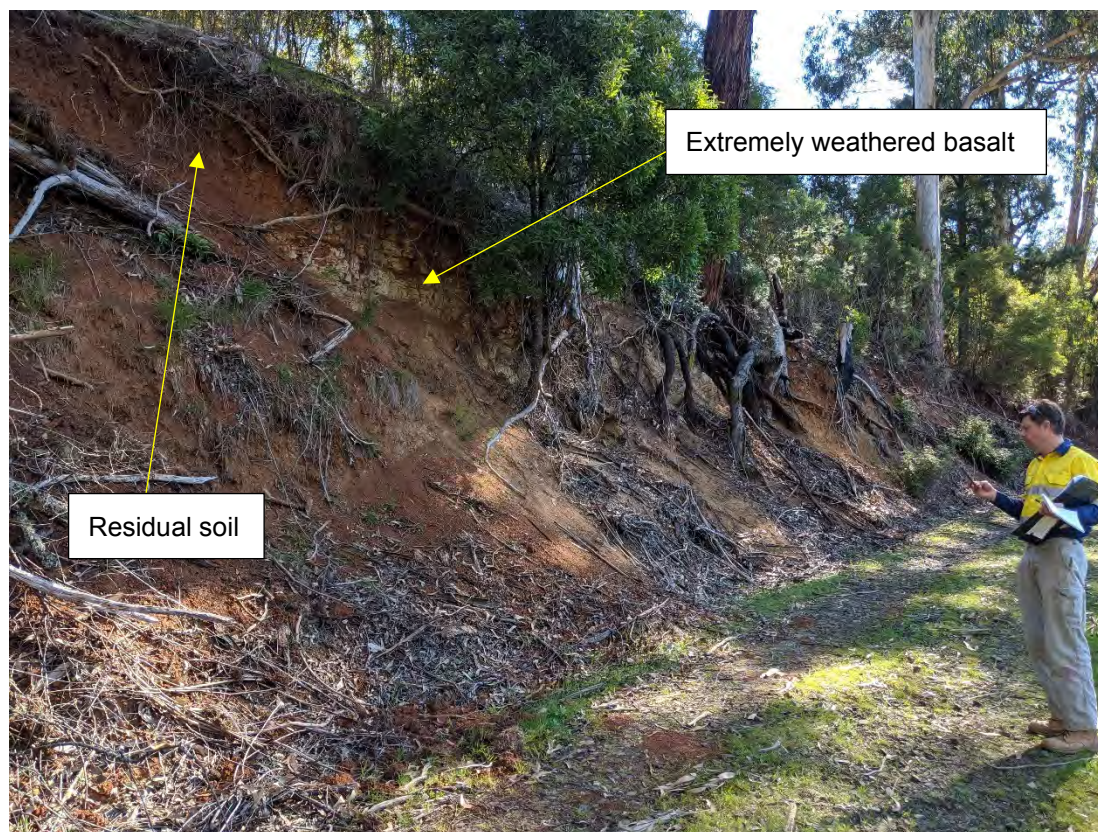
The location of WTG46 is near the crest of a knoll within highly vegetated terrain and inaccessible at the time of the site visit. However, a road cutting located about 200 m to the north of the proposed WTG location exposed a thin cover of residual soil overlying extremely weathered basalt.

*Cutting exposed about 100 m to the north of WTG46*

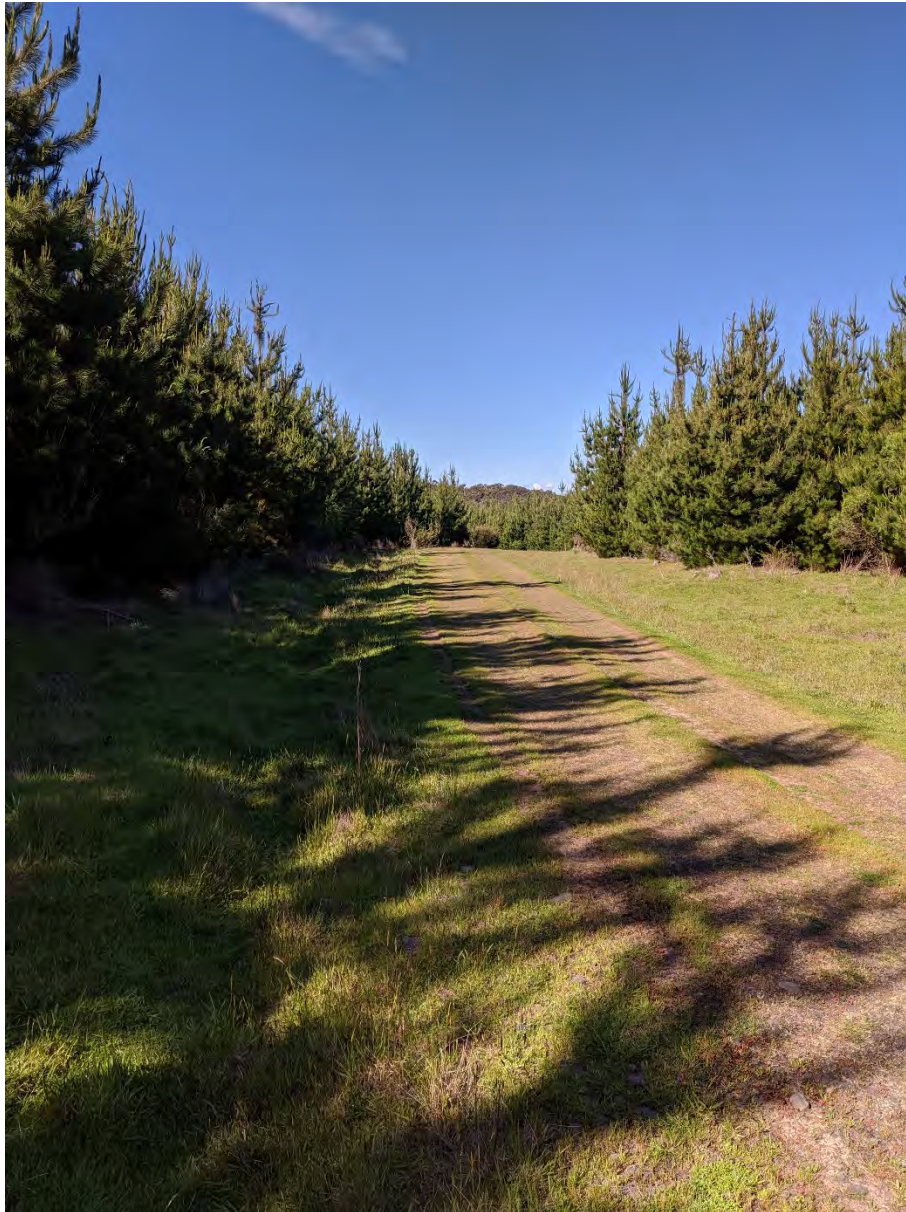
Geological maps indicate that WTG48 may be underlain by alluvium. However, observations made at the site are not consistent with the indications of the geological map. The WTG location is near the top of a low rise which is inconsistent with its being underlain by alluvium. It is inferred that this site is underlain by Thorpdale Volcanics.

*Low rise at proposed location of WTG48, inconsistent with geological map indications of alluvium.*
