Geotechnical Desktop Assessment

Document no: IA5000PB-0000-GT-RPT-0001

Melbourne Water

Silvan High Security Fence

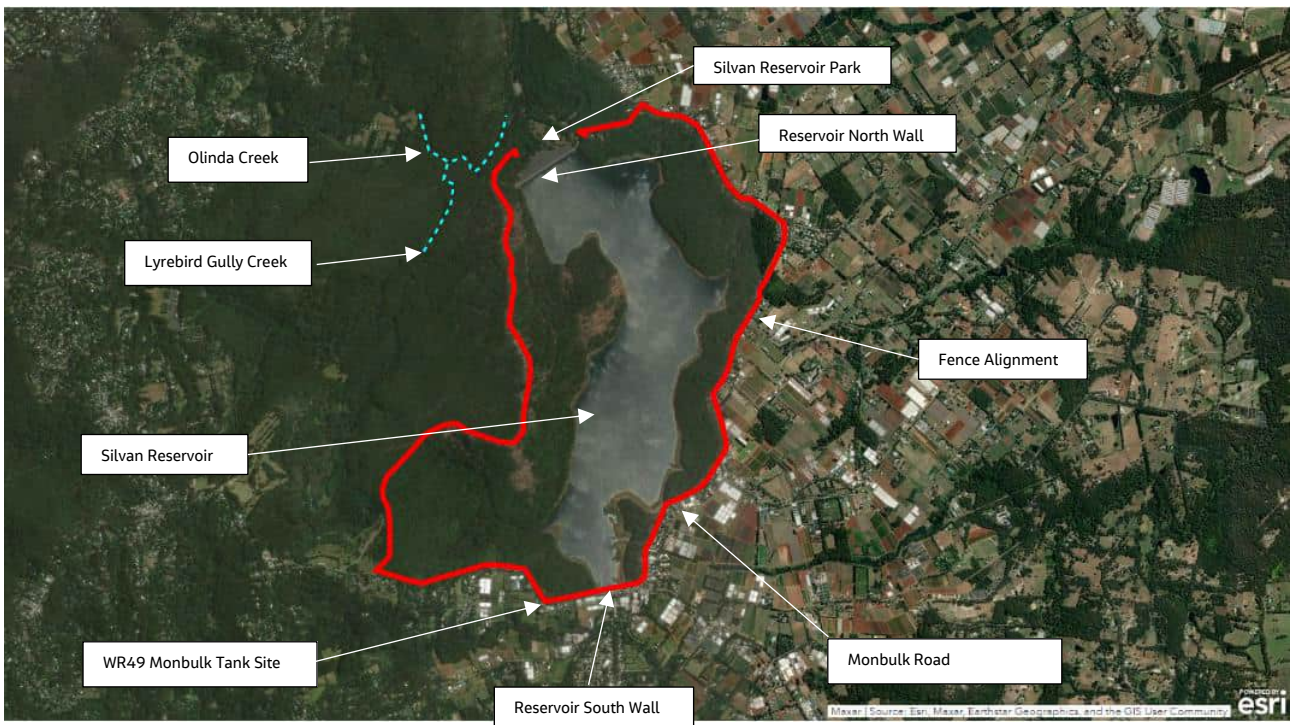
Figure 2-1 Silvan High Security Fence Project Area, VIC 3794 (Copyright © Esri, 2024)

Figure 2-1 below shows the approximate alignment of the existing security fencing whilst a detailed plan view is presented in Appendix A that illustrates key utilities and infrastructure both within and surrounding the project area.

The two primary waterways near to the project area are Lyrebird Gully Creek and Olinda Creek, located to the northwest (refer Figure 2-1). Whilst both creeks are close, neither intersects the existing fence alignment, though it is noted they may influence decisions around temporary access during construction. Throughout the remainder of the project area are numerous drainage paths and gullies which typically drain centrally to the reservoir itself.
